City of Emeryville

Spot Repair Schedule of Descriptions

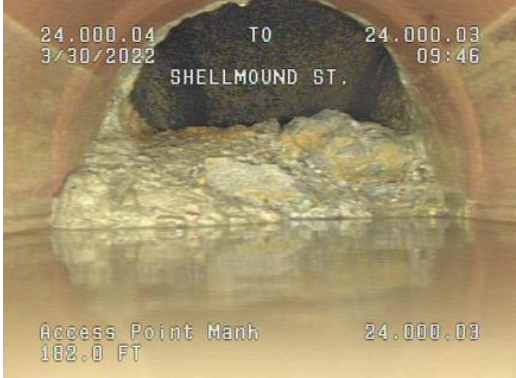
20	Shellmound St

MAP GRID C4				
	Repair Length				??
	Pipe Diameter				8"
	Pipe Material				VCP
Pipe Reach	24.000.04–24.000.03				
Rim to Invert	15.9 FT	Distance from Upstream MH:	182.0 FT	Price	
Defect	Heavy Mineral Deposits (Concrete)				
Repair	Chip away deposits accessible through Maintenance Hole. dig up and replace one length of pipe.			\$	
Description	Replace pipe from Manhole to next upstream joint, approximately 7'-0" of pipe. Open cut/trench required. Remove debris within manhole at joint with Pipe to ensure free flow of wastewater into manhole.

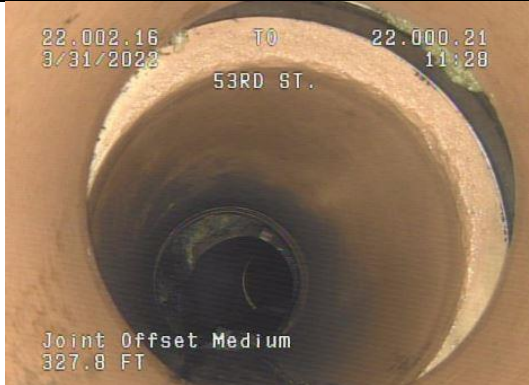
21	53 rd St at Hollis St

MAP GRID D4				
	Repair Length				??
	Pipe Diameter				15"
	Pipe Material				VCP
Pipe Reach	22.002.16–22.000.21				
Rim to Invert	9.1 FT	Distance from Upstream MH:	327.8 FT	Price	
Defect	Joint Offset Medium				
Repair	Replace (2) segments of Sewer Main starting from downstream maintenance hole towards the upstream direction.			\$	
Description	The length of sewer from joint to joint is assumed to be 7'-0" per segment.

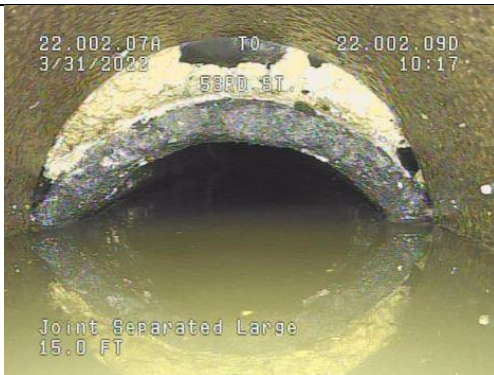
22	53 rd St at Emery Bay Dr

MAP GRID D4				
	Repair Length	??			
	Pipe Diameter	6"			
	Pipe Material	VCP			
Pipe Reach	22.002.07A-22.002.09D				
Rim to Invert	3.2 FT	Distance from Upstream MH:	15.0 FT	Price	
Defect	Joint Separated Large				
Repair	Open Cut and replace full segment with HDPE SD 17.			\$	
Description

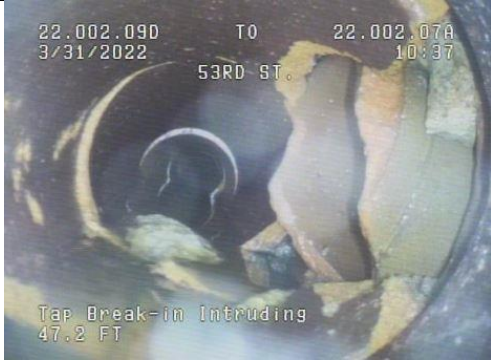
22	53 rd St at Emery Bay Dr

MAP GRID D4				
	Repair Length				??
	Pipe Diameter				6"
	Pipe Material				VCP
Pipe Reach	22.002.09D-22.002.07A				
Rim to Invert	5.1 FT	Distance from Upstream MH:	47.2 FT	Price	
Defect	Tap Break-in Intruding				
Repair	Open Cut and replace full segment with HDPE SD 17.			\$	
Description

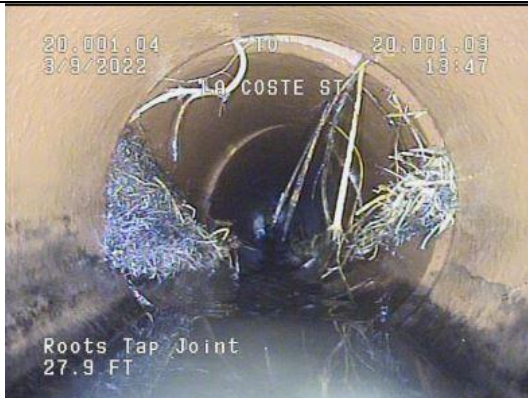
23	65 th St near Lacoste and Ashby

MAP GRID C1				
	Repair Length				??
	Pipe Diameter				12"
	Pipe Material				VCP
Pipe Reach	20.001.04- 20.001.03				
Rim to Invert	6.0 FT	Distance from Upstream MH:	27.9 FT	Price	
Defect	Roots Tap Joint, Broken Pipe, and Roots Medium				
Repair	Open Cut and replace full segment with HDPE SD 17.			\$	
Description	Approximately 40' in roadway, remainder in unpaved/landscaping area.

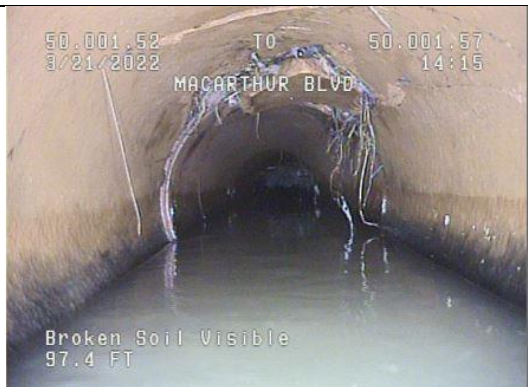
24	West MacArthur Blvd near Emery ST

MAP GRID D5							
	Repair Length							??
	Pipe Diameter							12"
	Pipe Material							VCP
Pipe Reach	50.001.52- 50.001.57							
Rim to Invert	10 FT	Distance from Upstream MH:	94.2 FT	Price				
Defect	Broken – Soil Visible, Fracture Longitudinal (Continuous)							
Repair	CIPP liner for full segment				\$			
Description

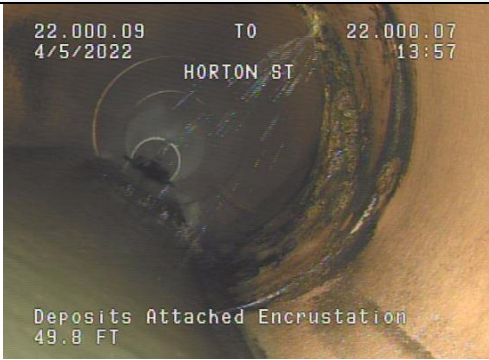
25	UPRR near Bay St Complex

MAP GRID C4				
	Repair Length				??
	Pipe Diameter				24"
	Pipe Material				VCP
Pipe Reach	22.000.09-22.000.07				
Rim to Invert	14.9 FT	Distance from Upstream MH:	49.8 FT	Price	
Defect	Fracture Spiral, Deposit Encrustation, Infiltration Gusher				
Repair	Grout Injection at infiltration location.			\$	
Description	Trenchless repair

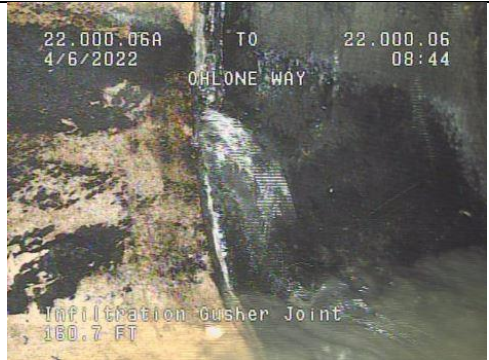
26	Bay St Complex

2	
	MAP GRID C4			
	Repair Length			??
	Pipe Diameter			24"
	Pipe Material			Steel
Pipe Reach	22.000.06A-22.000.06			
Rim to Invert	14.8 FT	Distance from Upstream MH:	160.7 FT	Price
Defect	Infiltration Gusher Joint			
Repair	Grout Injection at infiltration location.			\$
Description	Trenchless repair
