SBCA TREE CONSULTING

Location: Sherwin Williams Site on Horton St.

Subject: Tree condition and viability for retention.

Assignment: Arborist was asked to review the condition of the street trees bordering the old Sherwin Williams facility on Horton St. and Sherwin Ave. and to provide commentary and recommendations regarding the feasibility of retaining the trees.

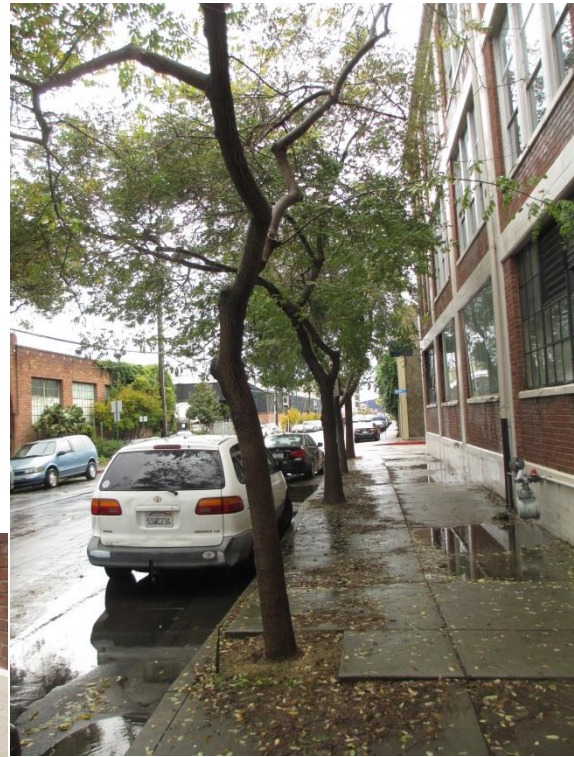
Photo 1. Photo to the right shows the aesthetic contribution to the streetscape offered by the trees. Tree # 5 is causing sidewalk pavement uplift and uplift to the gutter sufficient to affect drainage.

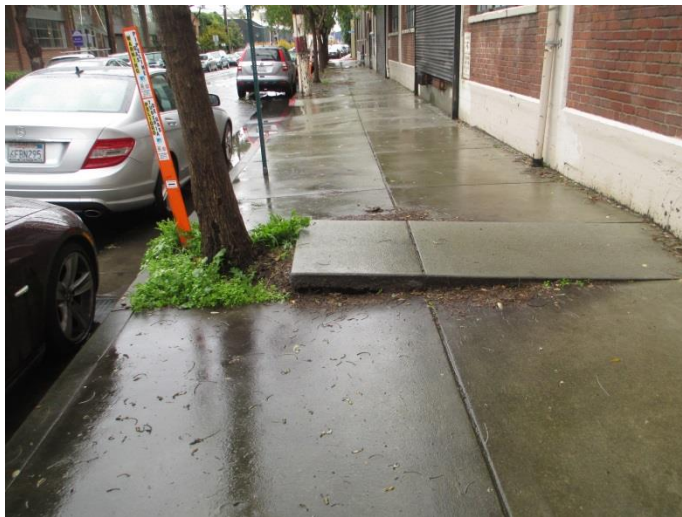
Photo 2. Photo to the left shows the sidewalk area having the most significant uplift. Because of the tree lean to the street, cutting the offending root may compromise the tree stability.

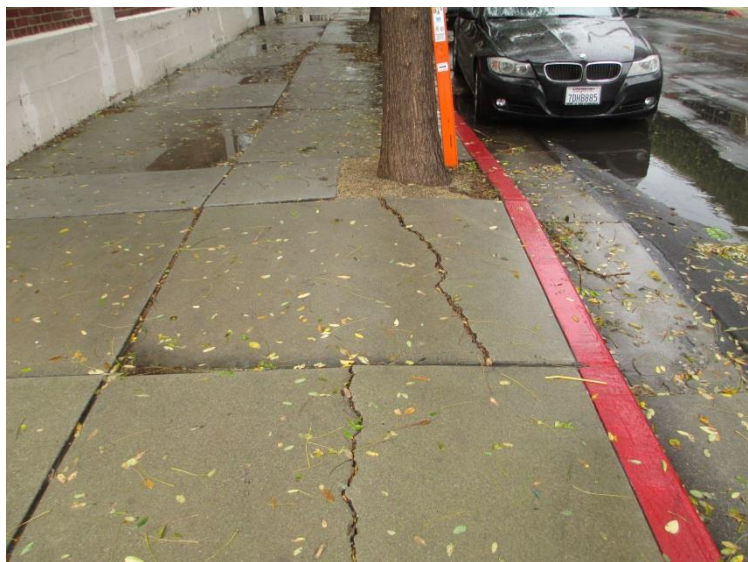
Photo 3. Photo to the right shows the Sophora tree closest to the corner of Sherwin St. Along with the sidewalk, the curb and street have been uplifted by the tree roots. Root pruning needed to accomplish the necessary repairs will likely compromise the future health and stability of this, the largest of the Sophora trees..

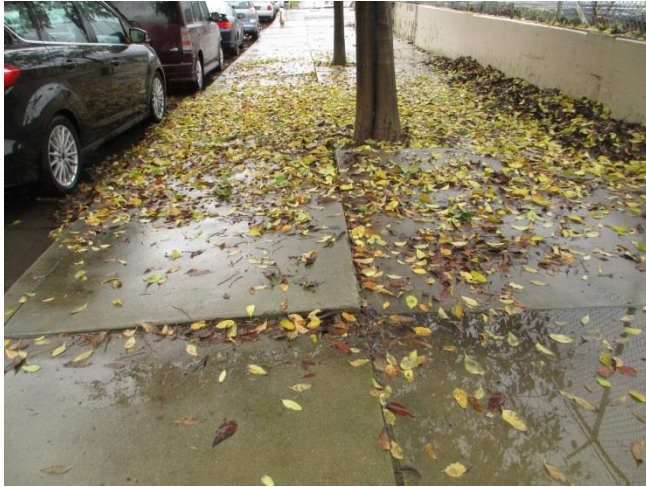
Photo 4. Photo to the left shows the bases of the two hackberry trees looking west with the larger tree in the foreground. The pavement uplift does indicate that the tree roots have developed near the surface, likely due to soil compaction.
