SBCA TREE CONSULTING

Date: March 21, 2018

Project Site: Shellmound, west side of Ikea

Subject: 8 Date Palms (*Phoenix dactylifera*)

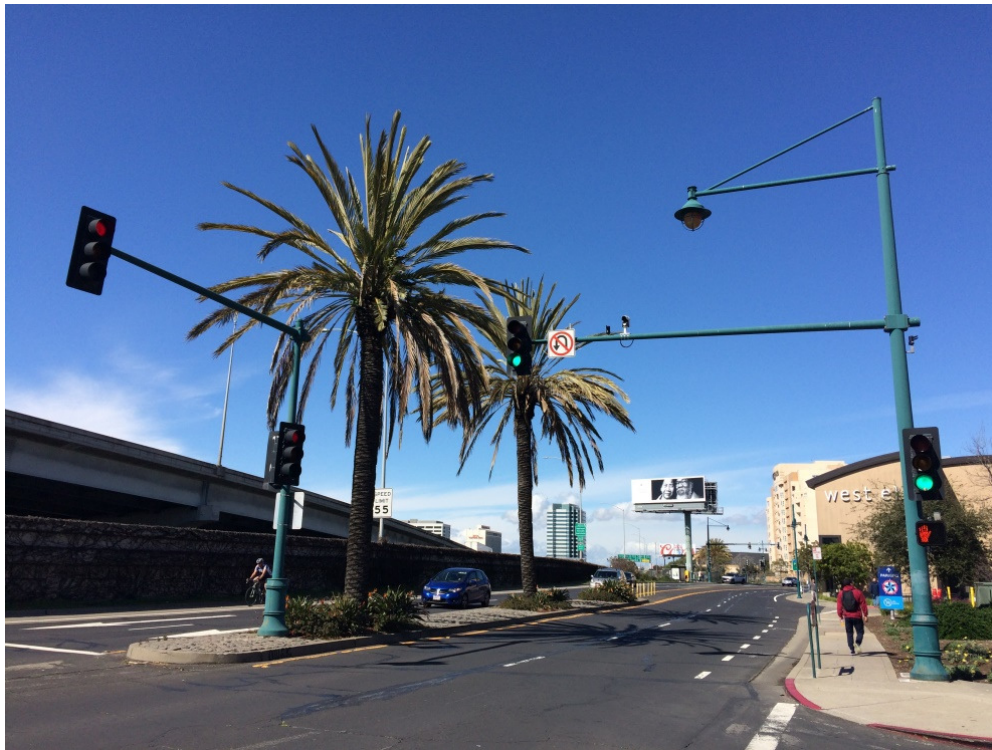
Photo 1. Photo to the left shows two northern palms. Foliage is sparse with browning fronds. Both are signs of marginal health. It is uncertain if the moisture and nutritional needs of the trees are being met. The median planting site does not likely offer a significant amount of rootable soil to draw water and nutrients.

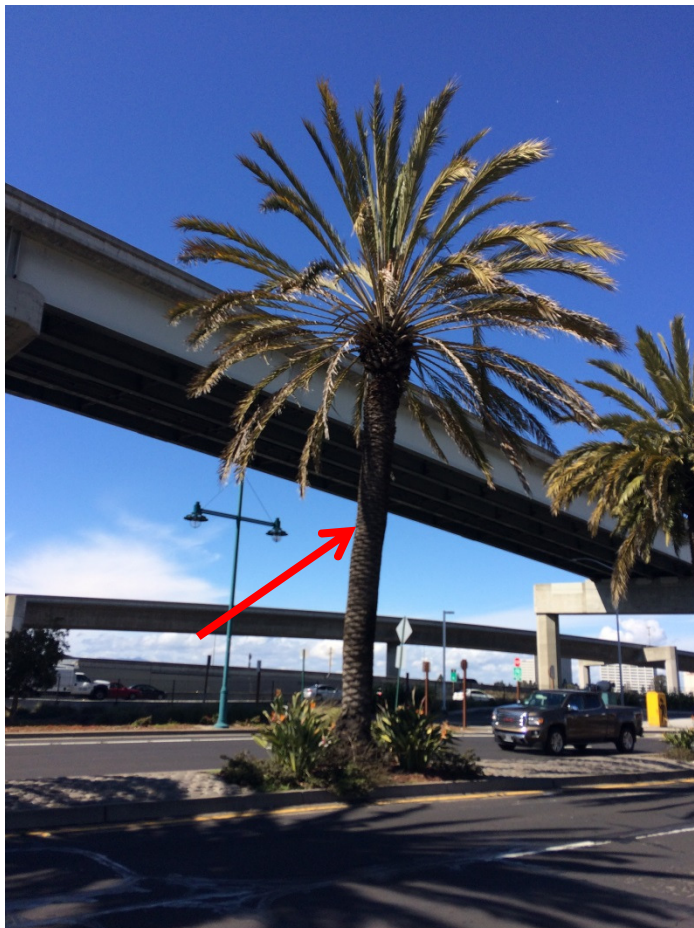
Photo 2. Photo to the right shows two southern palms. Arrow points to the “pencil” or reduced trunk diameter. Such reduced diameter is indicative of poor health.

The reasons for the poor health have not been determined.

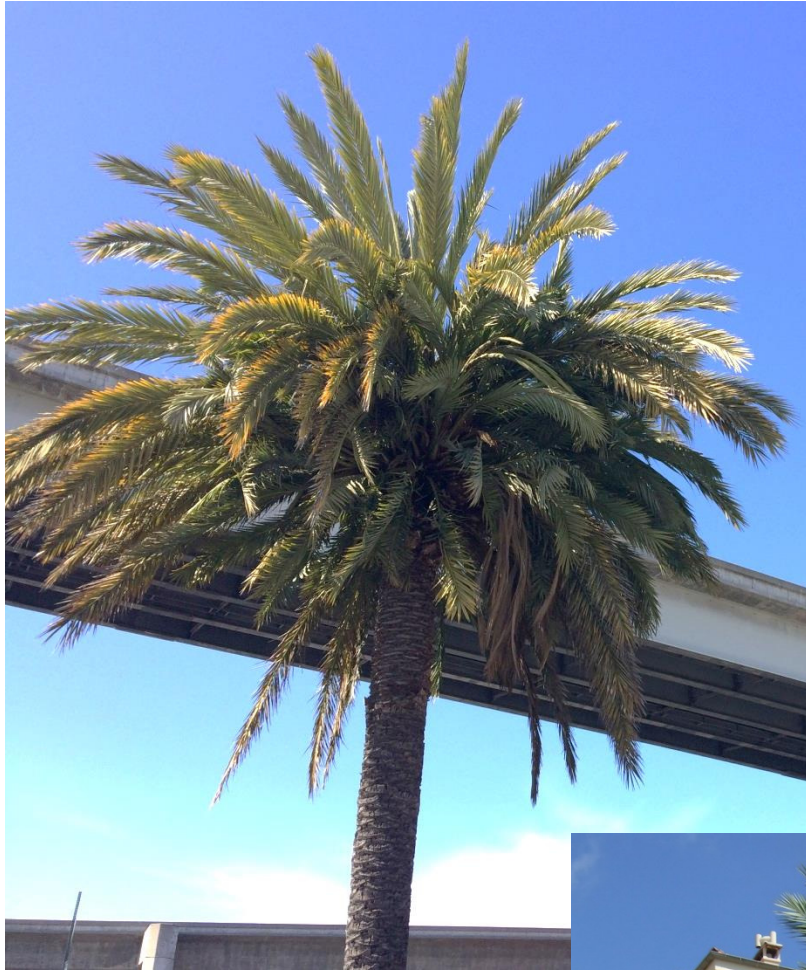
Photo 3. *Photo left shows the wayward fronds that are likely developing secondary stems. These are known be a safety issue when they fall out and therefore the tree is not a desirable specimen for relocation.*

Southern trees – It is likely not practical to relocate the trees. Considering the likelihood of success and the cost of relocation, the current value of the trees is not sufficient to warrant the effort. In addition to the cost of moving the trees to a new location, the cost of future maintenance, whatever it may entail, must be considered.

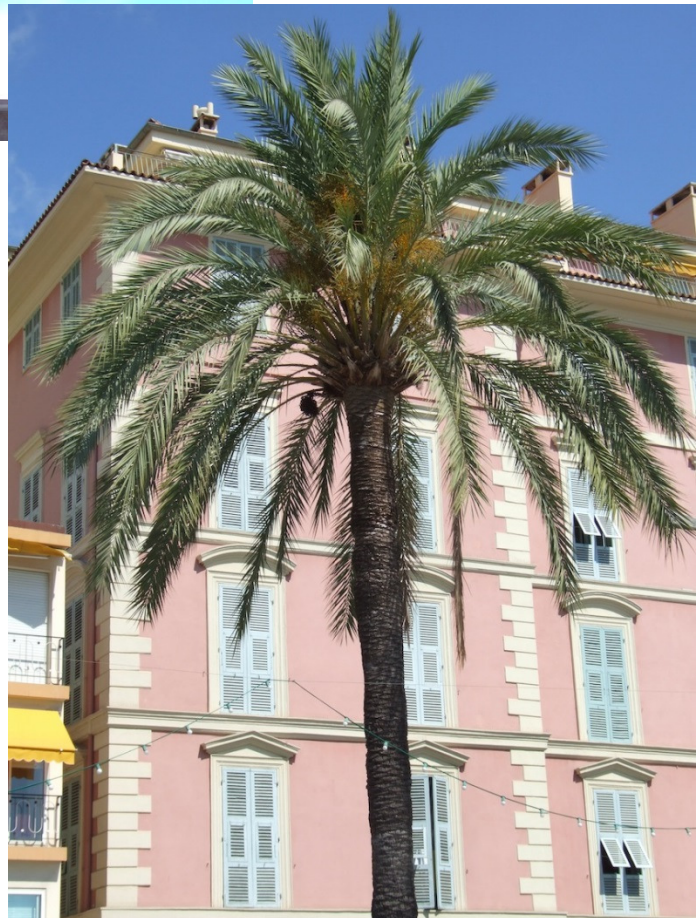
Photo 4. *Photo to the left shows what appears to be a healthy date palm located in Meton, France.*
