Date: Amended June 3, 2020

Subject: Arborist Peer Review of documents prepared by Inside Out:

Project: 47th Street Homes

Address: 1034 – 1042 47<sup>th</sup> Street

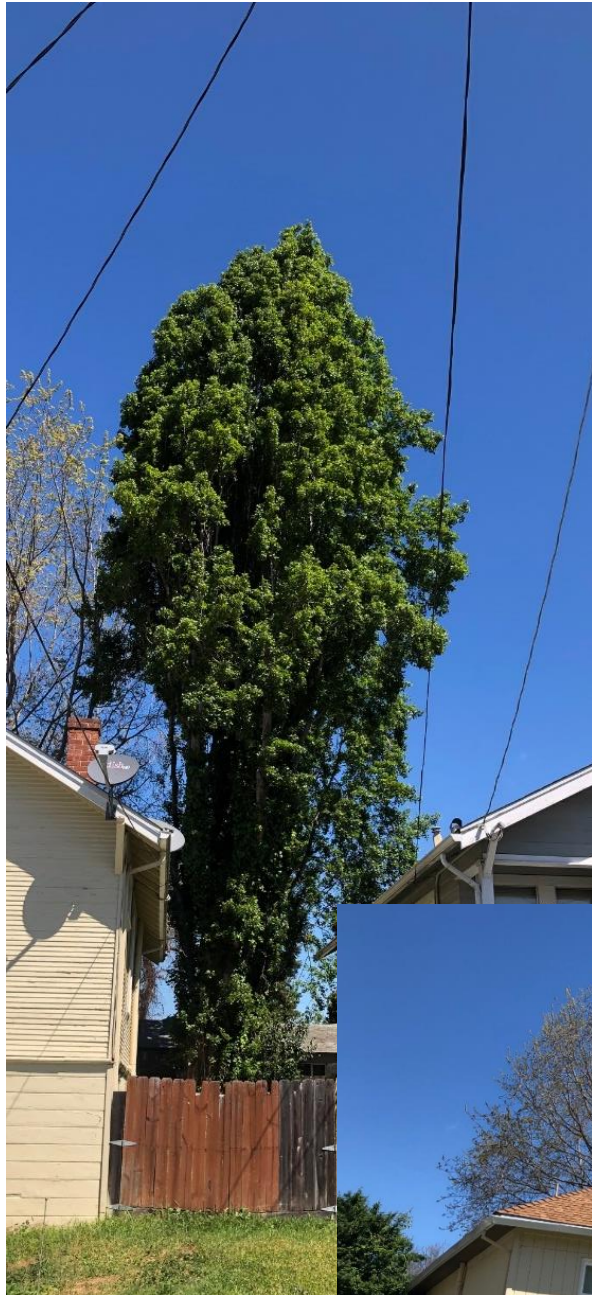
- **Lombardy Poplars #43 and 44** – During Arborist inspection on 4-24-20, the trees were fully leafed out and foliage appeared very dense and green. Recommend the health rating of both

**Photo 1.** Photo left was taken 4-24-20. Poplar #44 is shown very green with excellent leaf density. Health is rated at Good-Excellent.

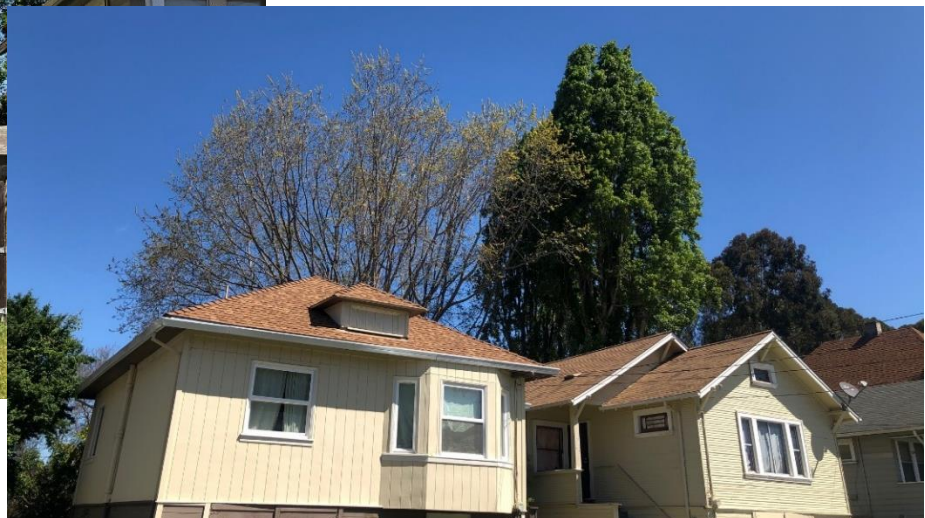
**Photo 2.** Photo below shows another angle of Poplar #44, with #43 behind. Silver Maple #42 can be seen to the left of the poplars just leafing out.

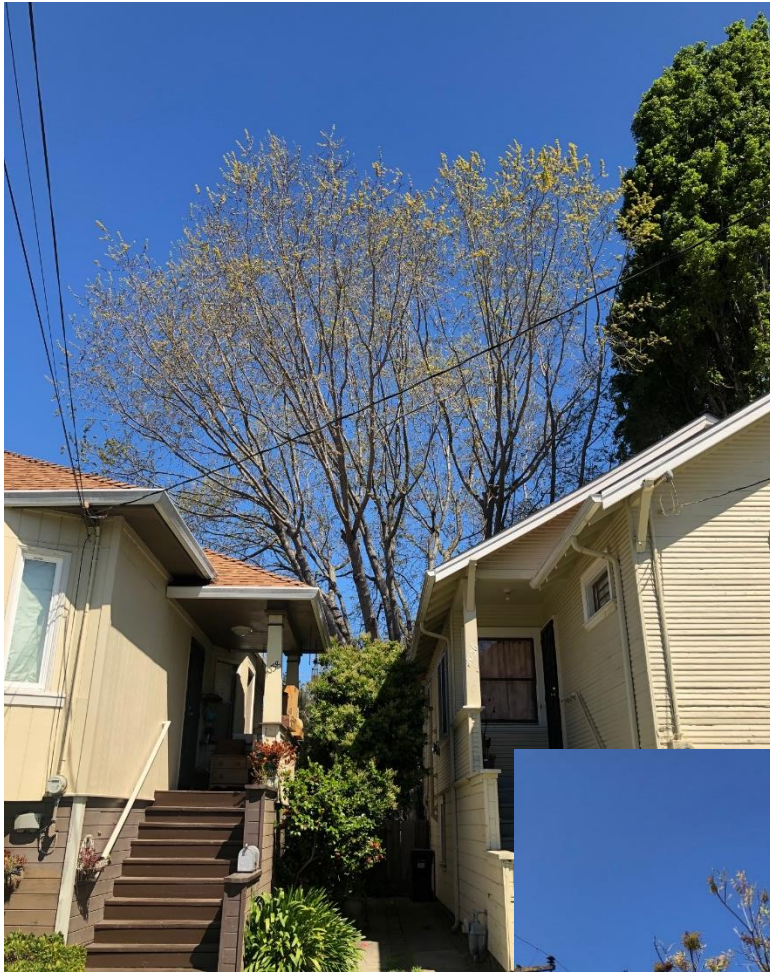
- **Silver Maple** – This tree is a very large specimen, with a canopy that spreads over two residences. Tree health could not be fully assessed due to spring season: the tree was in the process of leafing out during Arborist inspection. However, it is recommended the health rating be changed from Fair to Good. This is based on the amount of live buds present and no dead tips.
- **Feasibility of interior tree retention** – It should be clear that the reason why retention of the large Lombardy (*Populus nigra* 'Italica') and Silver Maple (*Acer saccharinum*) is not feasible is due to the potential for significant root loss from project construction which may compromise both health and stability of the trees.

**Photo 3.** Photo left shows Silver Maple #42. The tree is very large, with the canopy extending over two residences. The tree contributes significantly to the neighborhood and if removed, requires an equal or greater replacement planting.

- **Tree replacement** – The project proposes removal of three mature, large stature trees and two medium trees, yet only plans to replace with one large stature tree and six small in stature. The trees currently growing on site contribute significantly to the neighborhood. If removed, an equal or greater replacement planting is recommended. Landscape Architect is encouraged to review additional planting locations. It is recommended that large stature trees be utilized in replacement planting and be provided with soil volumes commensurate with their sizes at maturity.

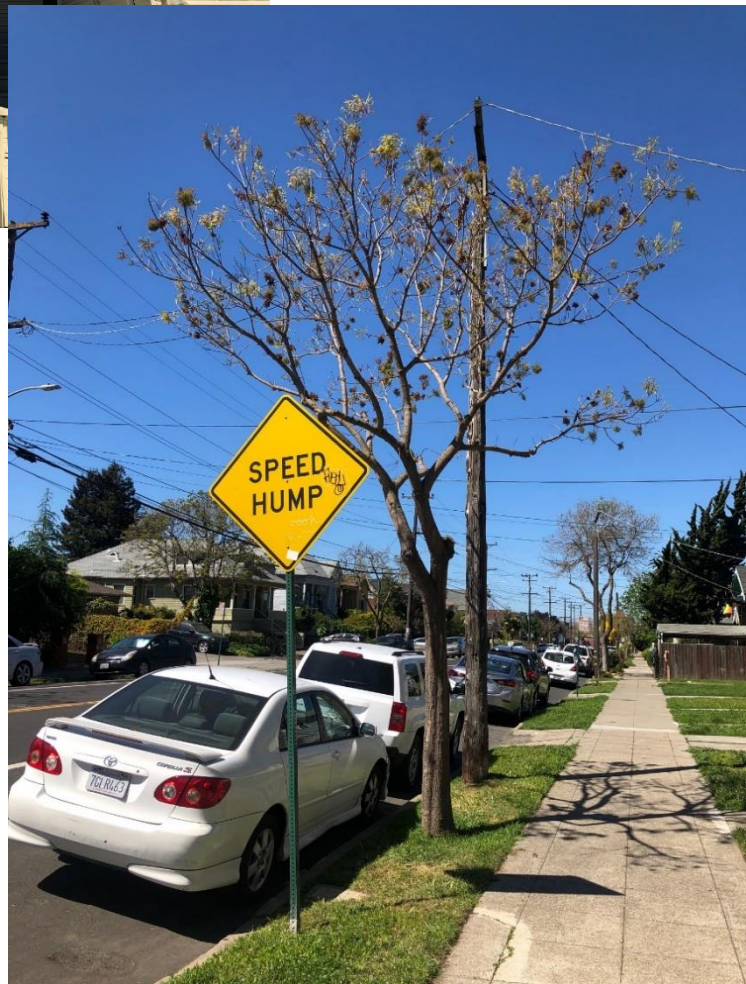
- **Street trees (*Pistacia chinensis*)** – Tree #48 has been removed. Only one street tree remains: Pistache #47 is codominant and was noted with a recent 3" diameter pruning cut. No root related hardscape displacement was noted adjacent to the tree, indicating roots may have developed deeper in the soil. We concur with the InsideOut report regarding retention value: "tree preservation recommended".

**Photo 4.** Photo right shows the last Chinese Pistache street tree. Google Street View shows three trees originally planted. Since InsideOut report in 2018, one large branch has been removed over the sidewalk, therefore destroying the balanced canopy noted in report.

- **Tree protection** – Tree #47 is suitable for protection. A Tree Preservation Plan should be submitted for review.
- **Increase street tree amount** – At the time *Addendum #1* was submitted in 2018, two street trees existed. With the removal of tree #48, three street trees are now suitable for replacement planting. Chinese Pistache is an acceptable species for use. City specified soil volume requirements for medium stature trees can be achieved with the use of structural soil under pavement.
