June 4, 2020

Addendum #2
Tree Inventory & Assessment at 1034 47th Street in Emeryville, California

Tree Inventory & Assessment at 1034 47th Street in Emeryville, California

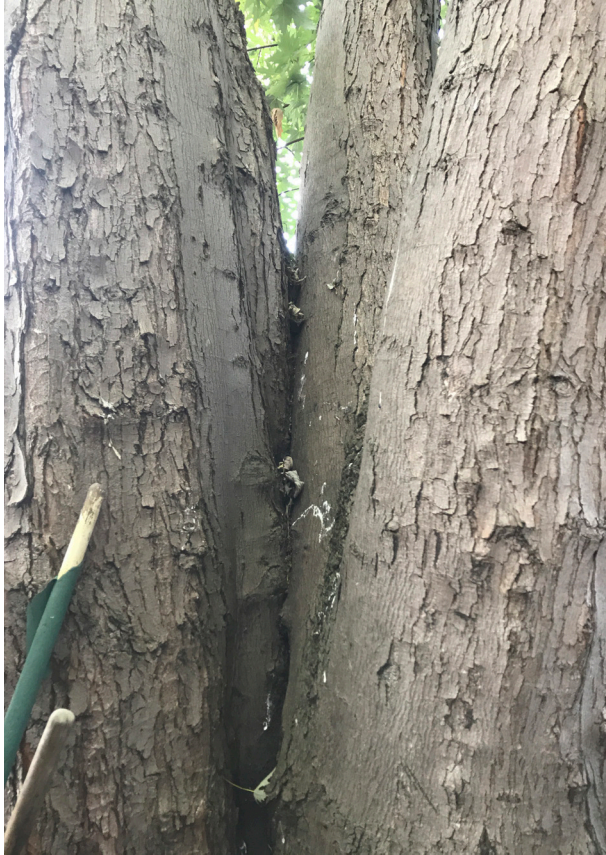
Tree #	SPECIES	DIA	H	S	RV	OBSERVATIONS/RECOMMENDATIONS
42	Silver maple	20, 21.5, 36, 44	3	2	2.5	Located in the rear yard of the existing single family residence along 1034 47 th Street (south of 1035 47 th Street). Chain embedded in 21.5" leader. Included bark ¹ noted at branch union between 36" & 44" leaders. <i>Poor to Moderate</i> tolerance to site disturbances ² .
43	Lombardy poplar	52	3	3	2.5	Located in the rear yard of the existing single family residence along 1034 47 th Street (south of 1035 47 th Street). Codominant branch union 6 feet above grade. While trees are in fair health, a poor retention value is given due to the following: <ul style="list-style-type: none"> Species does not perform well in mild-winter climates and near coastal areas Aggressive root systems crowd out other vegetation Roots damage infrastructure (some cities have banned them from being planted within 20 feet of roadways and sidewalks Profuse suckering

Included Bark at Tree #42

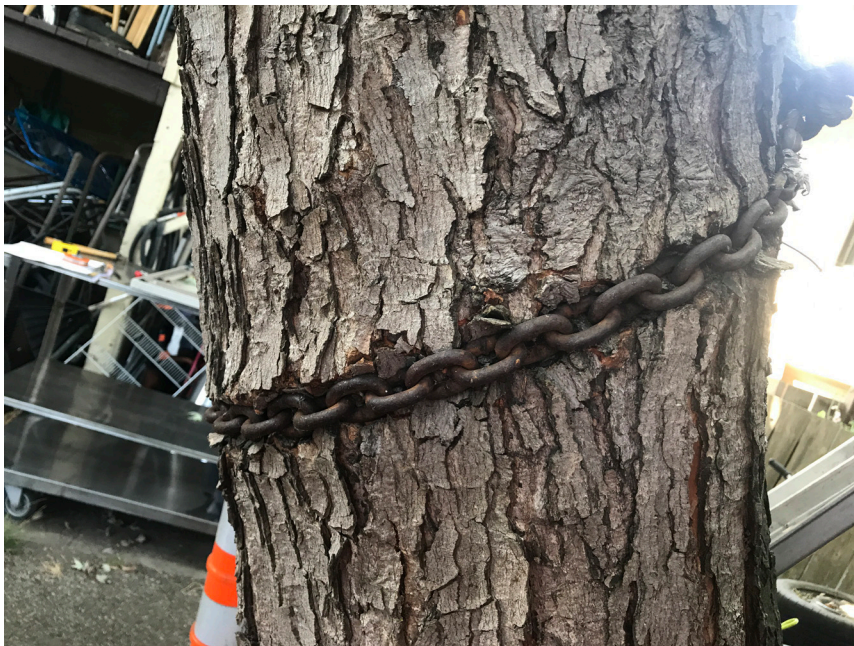
Embedded Chain at Tree #42

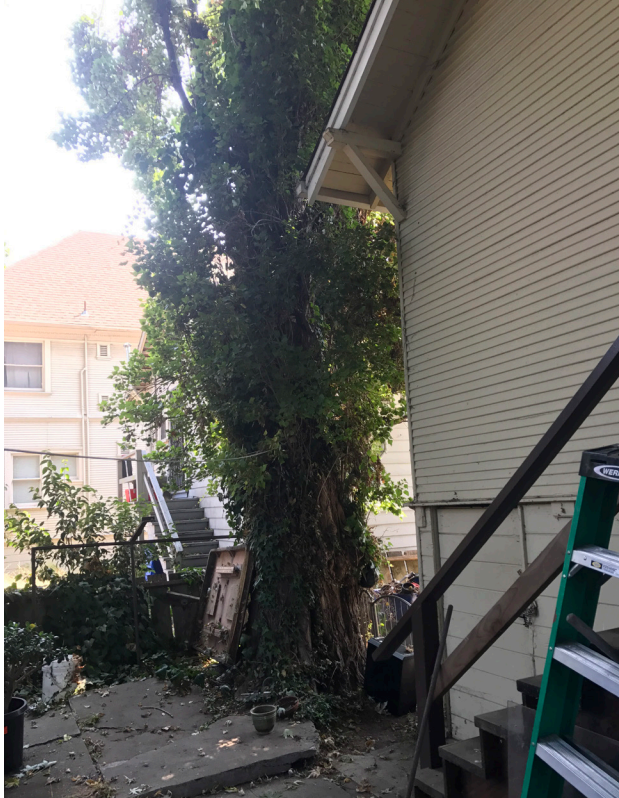
Tree #44

44	Lombardy poplar	36	3	3	2.5	Located in the rear yard of the existing single family residence along 1034 47 th Street (south of 1035 47 th Street). While trees are in fair health, a poor retention value is given due to the following: <ul style="list-style-type: none"> Species does not perform well in mild-winter climates and near coastal areas Aggressive root systems crowd out other vegetation Roots damage infrastructure (some cities have banned them from being planted within 20 feet of roadways and sidewalks Profuse suckering
45	Mimosa	9	3	2.5	2.5	Located in the rear yard of 1039 47 th Street. Poor branch union at 5 feet above grade with multiple attachments and Included bark ¹ .
46	Mimosa	10.5, 8.5	3	2.5	2.5	Located in the rear yard of 1039 47 th Street. Codominant branch union at grade. 10.5" leader grows northwest at 45 degree angle to grade. 8.5" leader lean to west. Lopsided canopy.
