1034-1040 47th St., Emeryville, CA

Housing Conditions

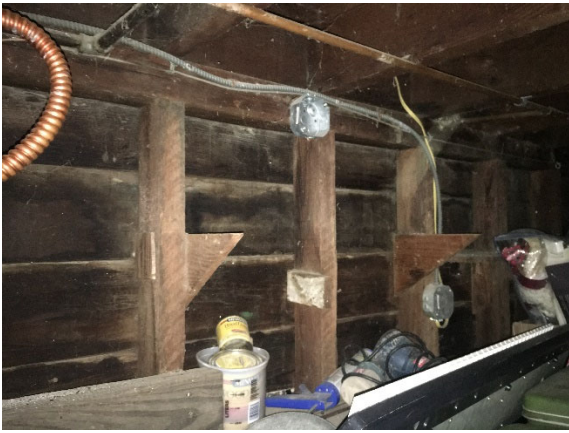
No shear walls

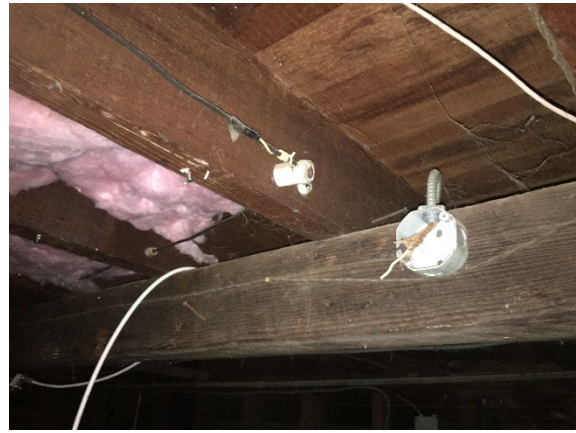
Exposed insulation; knob and tube wiring

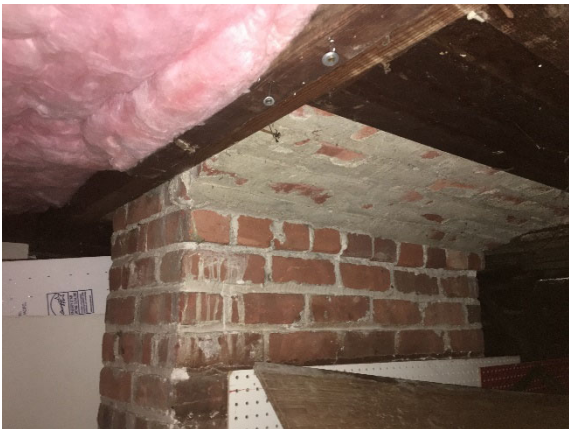
Unreinforced fireplace and hearth

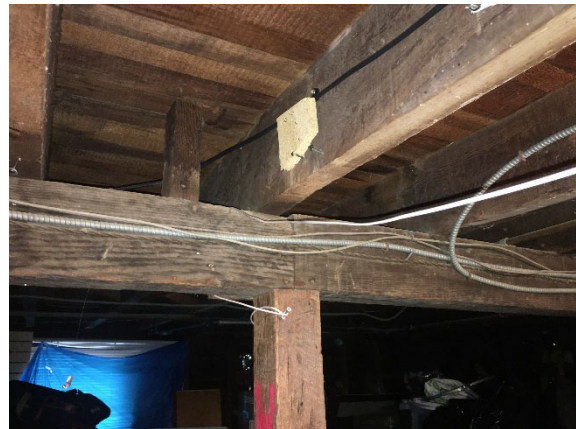
No seismic bracing/lateral ties

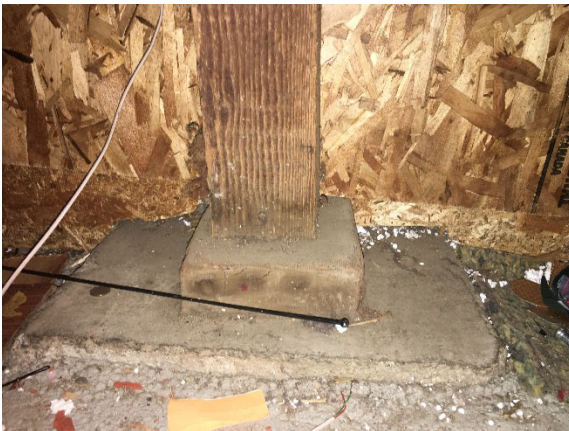
Unreinforced footings; failing footings

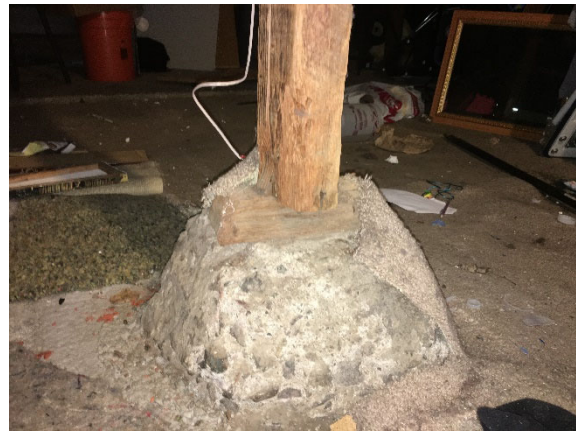
Unreinforced footings; failing footings

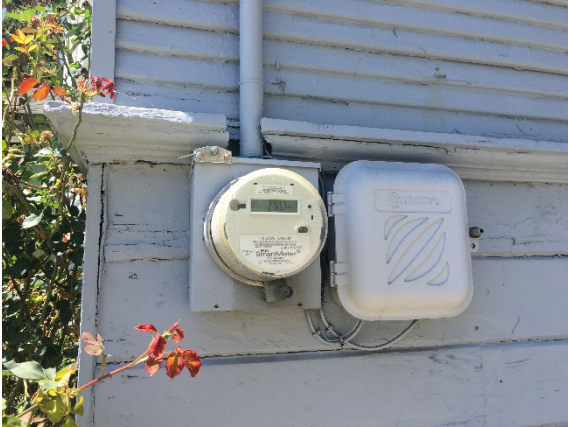
Knob and tube wiring; fuses, no circuit breakers

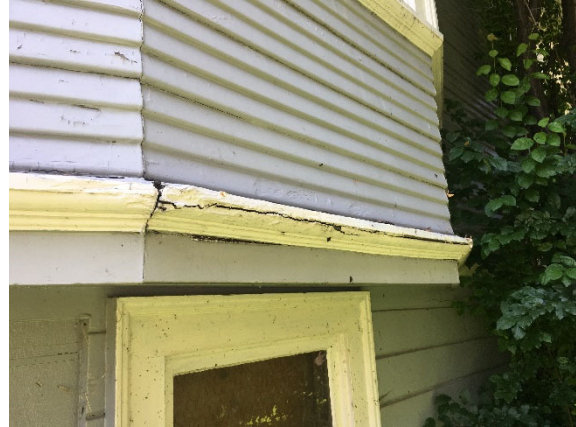
Dry rot

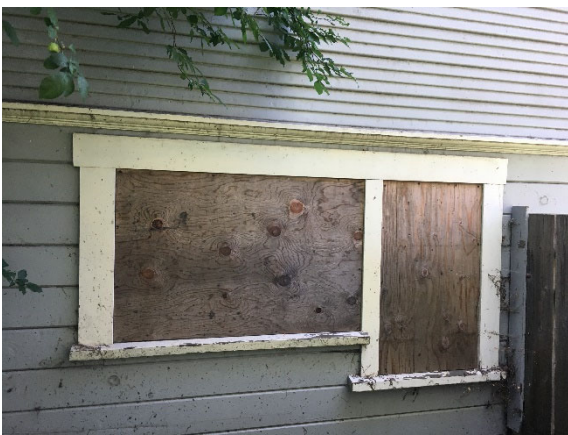
Missing windows due to repeated break-ins (side yard)

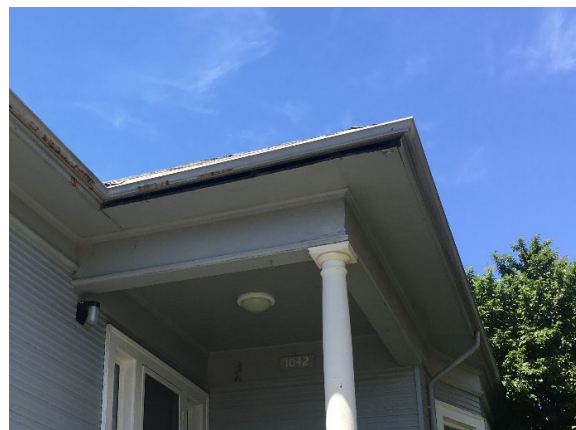
Separation between gutter and eave; roof rot

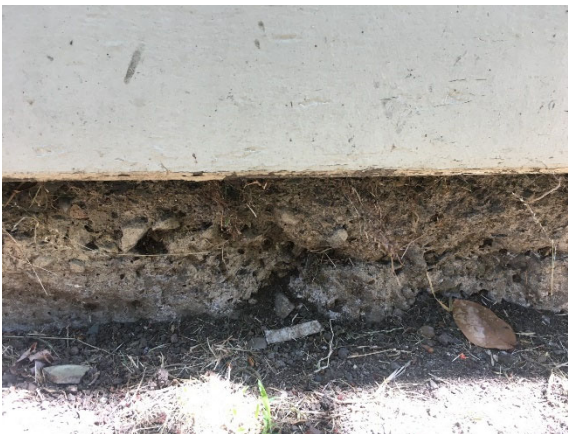
Foundation concrete leaching

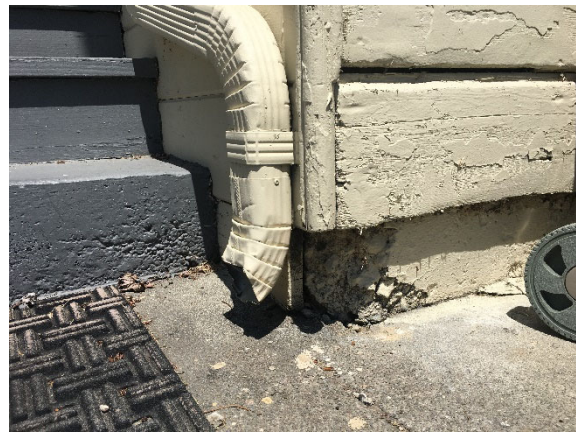
Foundation concrete leaching
