February 17, 2017

Project IR15165930

**Re: Comments on the 2016 Final Remedial Investigation Report  
Former Marchant/Whitney (FMW) Site  
5679 Horton Street, Emeryville, California**

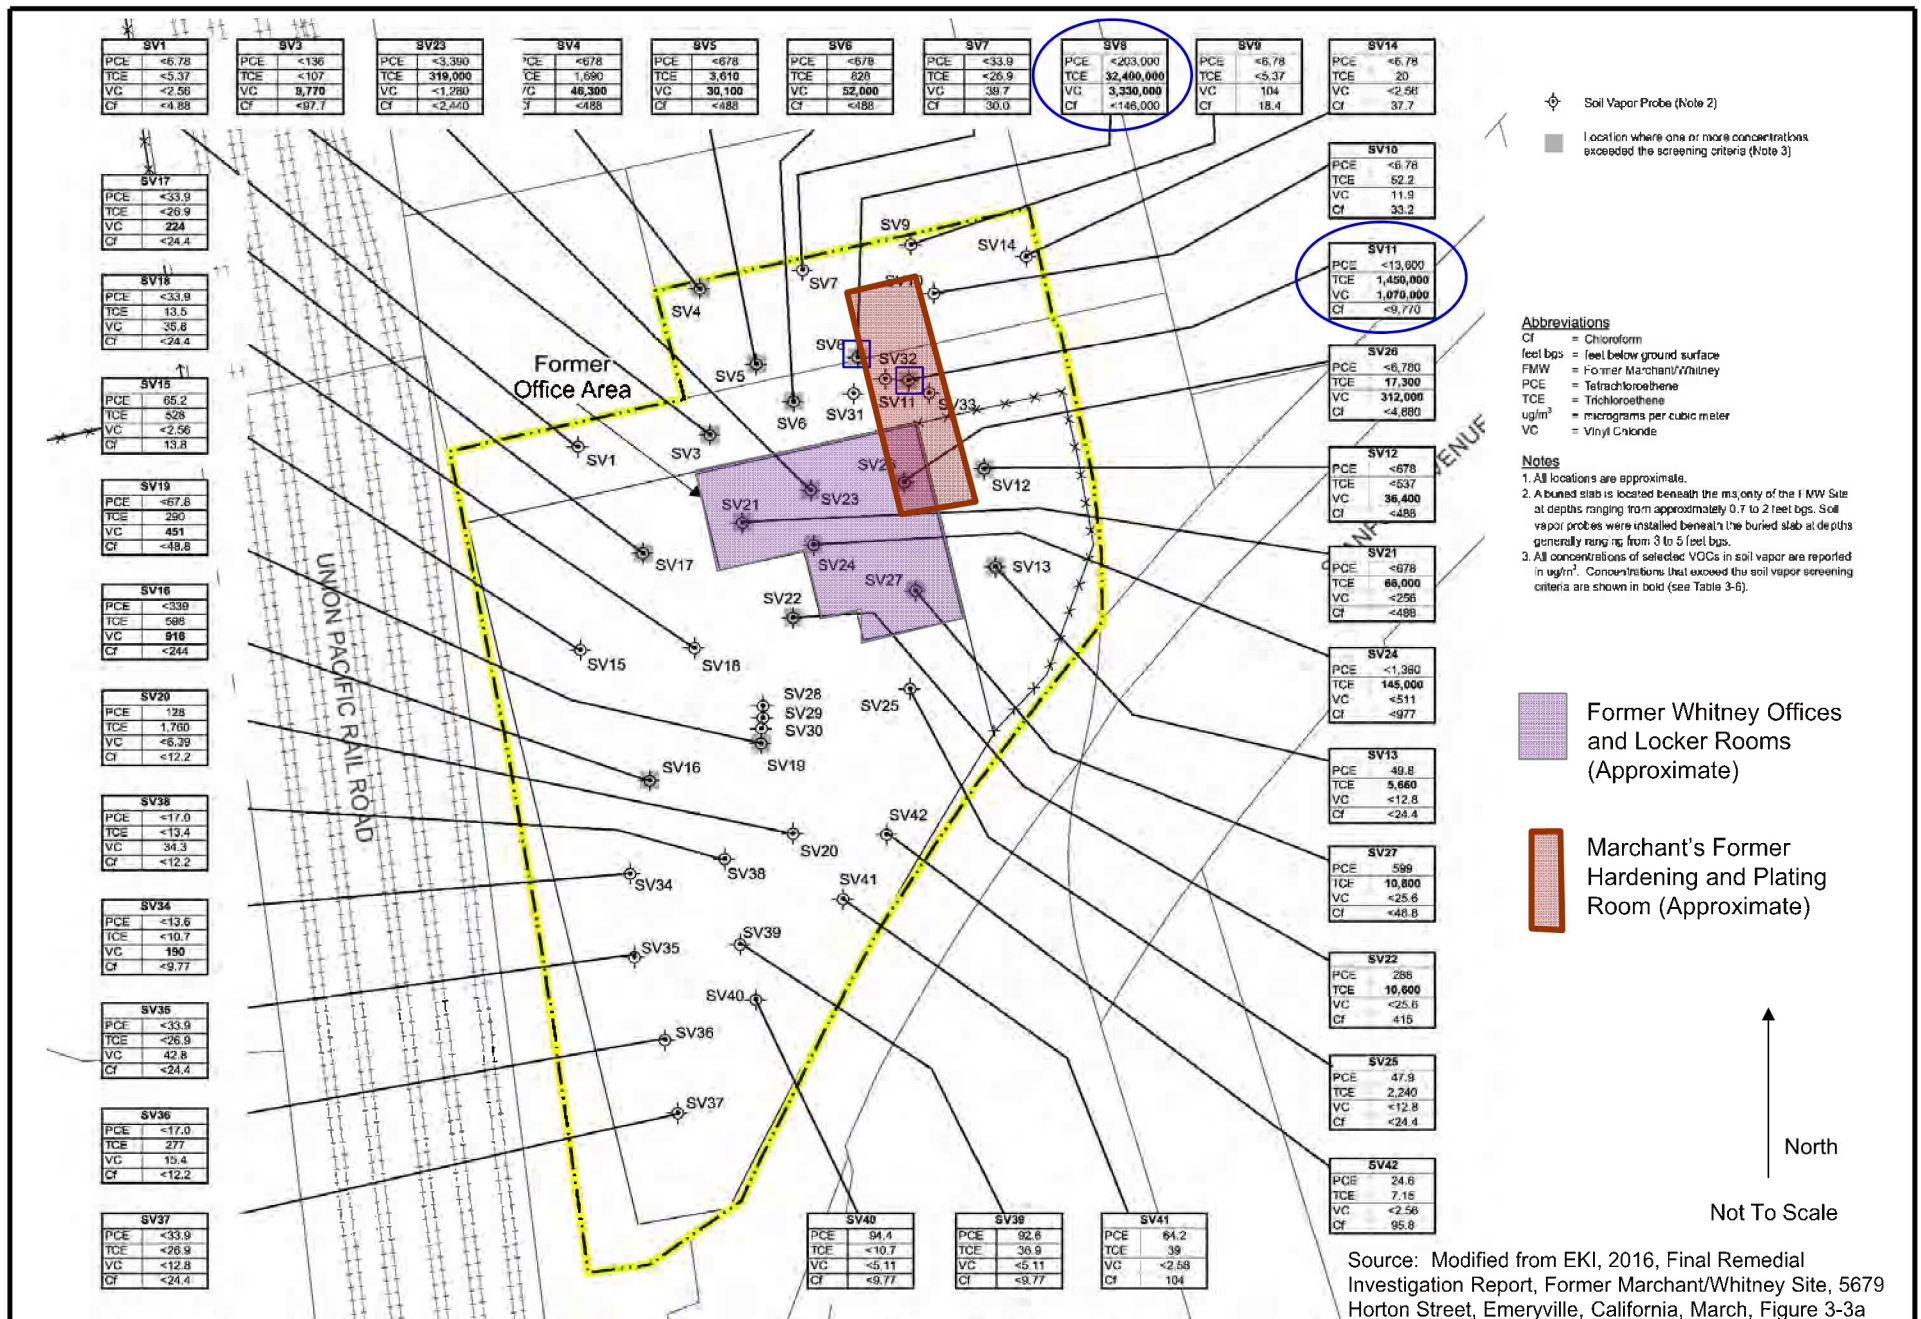
**Figure 8**  
Soil Vapor Sample Results (Below Old Slab)  
5679 Horton Street, Emeryville, California

The highest TCE vapor concentrations were observed at SV8 and SV11 (Figure 8), outside the northeast corner of the Current Building and where Whitney’s parking lot was located. The area in which SV8 and SV11 are located overlies the northern portion of Marchant’s hardening and plating operations (EKI, 2016a, Figure 2-2f – 1983 Aerial Photograph; Figures 2-1d, 2-1e, and 2-1f – 1949, 1961, and 1952 Sanborn Maps). Marchant likely used and/or stored TCE in this area based on the operations related to the hardening and plating room and Marchant’s use of TCE at its Berkeley Location; by contrast, there is no evidence that Whitney handled TCE in a paved parking area for the facility adjacent to the main entrance to the office area (EKI, 2016a, Figures 2-2d, 2-2e, and 2-2f – 1965, 1971, and 1983 Aerial Photographs, respectively).

High soil vapor concentrations were also detected below the northeastern corner of the Current Building in the area of the presumed sewer line lateral, but at one to two orders of magnitude lower than the concentration observed at SV8 and SV11, which were outside the Current Building's footprint in the area of the presumed sewer lateral (Figures 8 and 9). The northeast corner of the Current Building was the location of Whitney's offices and locker rooms, which likely were connected to the sewer system. Sewer laterals and sewer lines are designed to gravity feed to maintain flow. Therefore, if the sewer lateral was the source point, then similar TCE concentrations would be present in soil vapor along the downgradient extent of the main sewer line. No such TCE concentrations are observed (see Figure 8, sample locations SV9, SV10, and SV14).

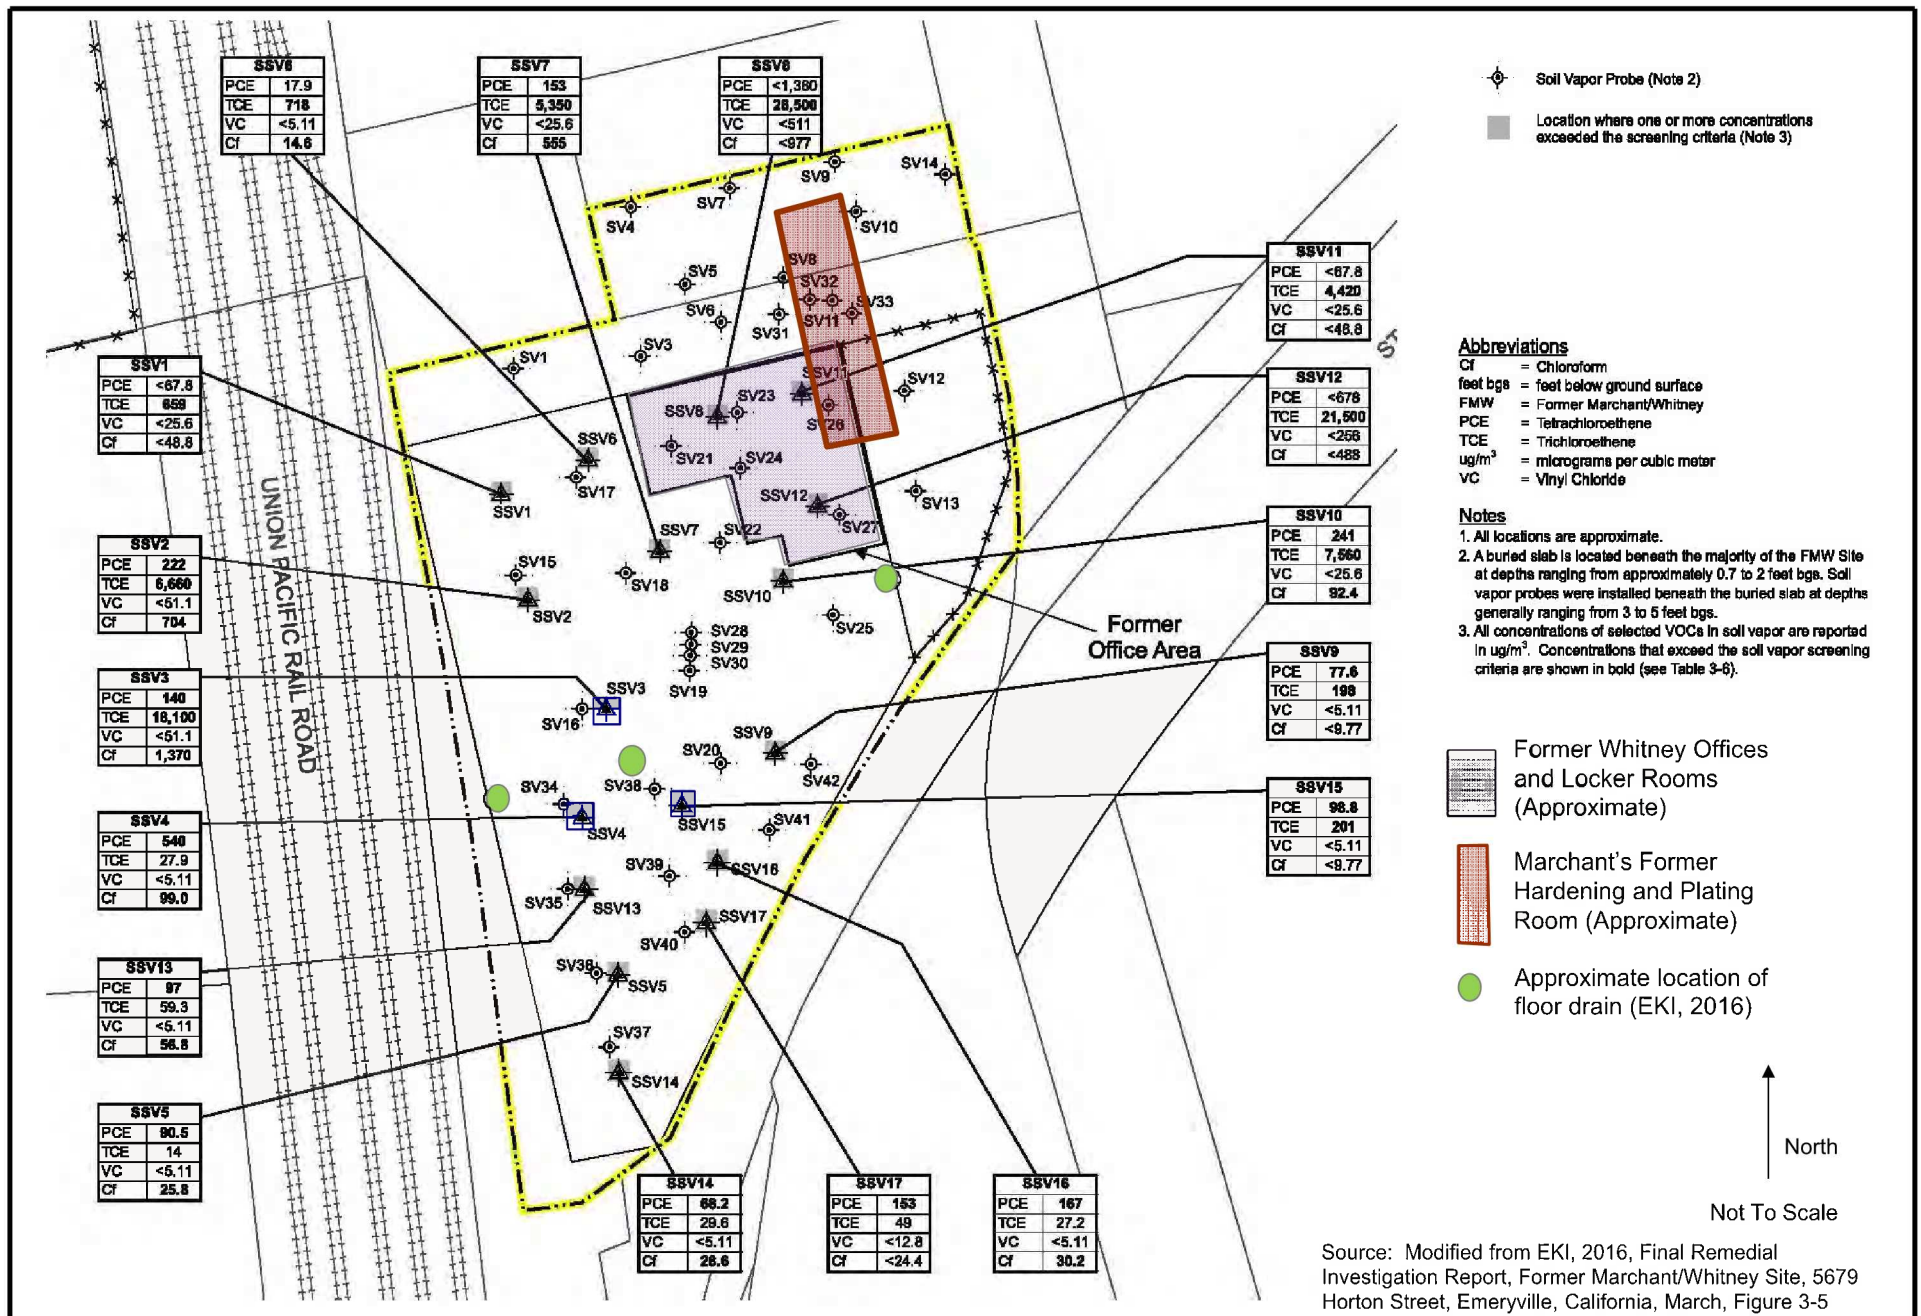
**Figure 9**  
**Sub-Slab Soil Vapor Results**  
 5679 Horton Street, Emeryville, California

TCE concentrations in the sub-slab vapor samples in the Northwestern Area (Figure 9) ranged from 659 to 6,600  $\mu\text{g}/\text{m}^3$ . These concentrations are one to two orders of magnitude lower than the concentrations observed in the Northeastern Area (4,420 to 26,500  $\mu\text{g}/\text{m}^3$ ). The detection of TCE in sub-slab vapor in this area may be attributed to lateral vapor movement from the Northeastern Area in the zone between the Current Building’s slab and the old slab. The potential for movement and connection of VOCs in sub-slab vapor were acknowledged by EKI (2012, page 6-6), where EKI states, “[t]he sub-slab vapor may be more laterally connected than deeper soil vapor due to the more permeable material that is typically used as a base for foundation construction. Therefore, it would not be surprising to see more disperse VOCs in the sub-slab vapor than in the soil vapor.”

Sub-slab soil vapor sample SSV3 (TCE at 18,100  $\mu\text{g}/\text{m}^3$ ) was noted to be in the vicinity of a floor drain network by EKI. The approximate locations of the three floor drains are shown on Figure 3-5 of the 2016 Report, which depicts the central portion of the Current Building; the approximate locations of the floor drains are also shown on Figure 9 of this letter. Two of the floor drains are 60 and 25 feet southwest and south of SSV3, respectively. Sub-slab vapor samples SSV3, SSV4 and SSV15 are each approximately the same distance from the central floor drain (approximately 30 feet), and sample SSV4 is about 30 feet east of the western floor drain.

The TCE sub-slab vapor concentrations at SSV4 (27  $\mu\text{g}/\text{m}^3$ ) and SSV15 (201  $\mu\text{g}/\text{m}^3$ ) are three orders of magnitude lower than the detected concentration at SSV3. This suggests that the floor drains are not the source of the TCE detected at SSV3 (at 18,100  $\mu\text{g}/\text{m}^3$ ); if the TCE at these three locations were all associated with the floor drain, and given that the three samples are approximately the same distance from the floor drain, one would not expect the order of magnitude difference in concentration that is observed. EKI speculated that the floor drains were interconnected and ultimately connected to the sanitary sewer line in the northeastern

The third floor drain is located near the east wall just south of the Current Building's office area (Figure 9). Sub-slab vapor samples collected about 40 feet north (SSV12) and 40 feet west (SSV10) of this floor drain had TCE concentrations of 21,500 and 7,560  $\mu\text{g}/\text{m}^3$ , respectively. The sub-slab vapor concentrations in this area are likely attributed to the higher sub-slab vapor concentrations observed in the Northeastern Area and lateral movement of vapor through the permeable fill material associated with the sub-slab soil.

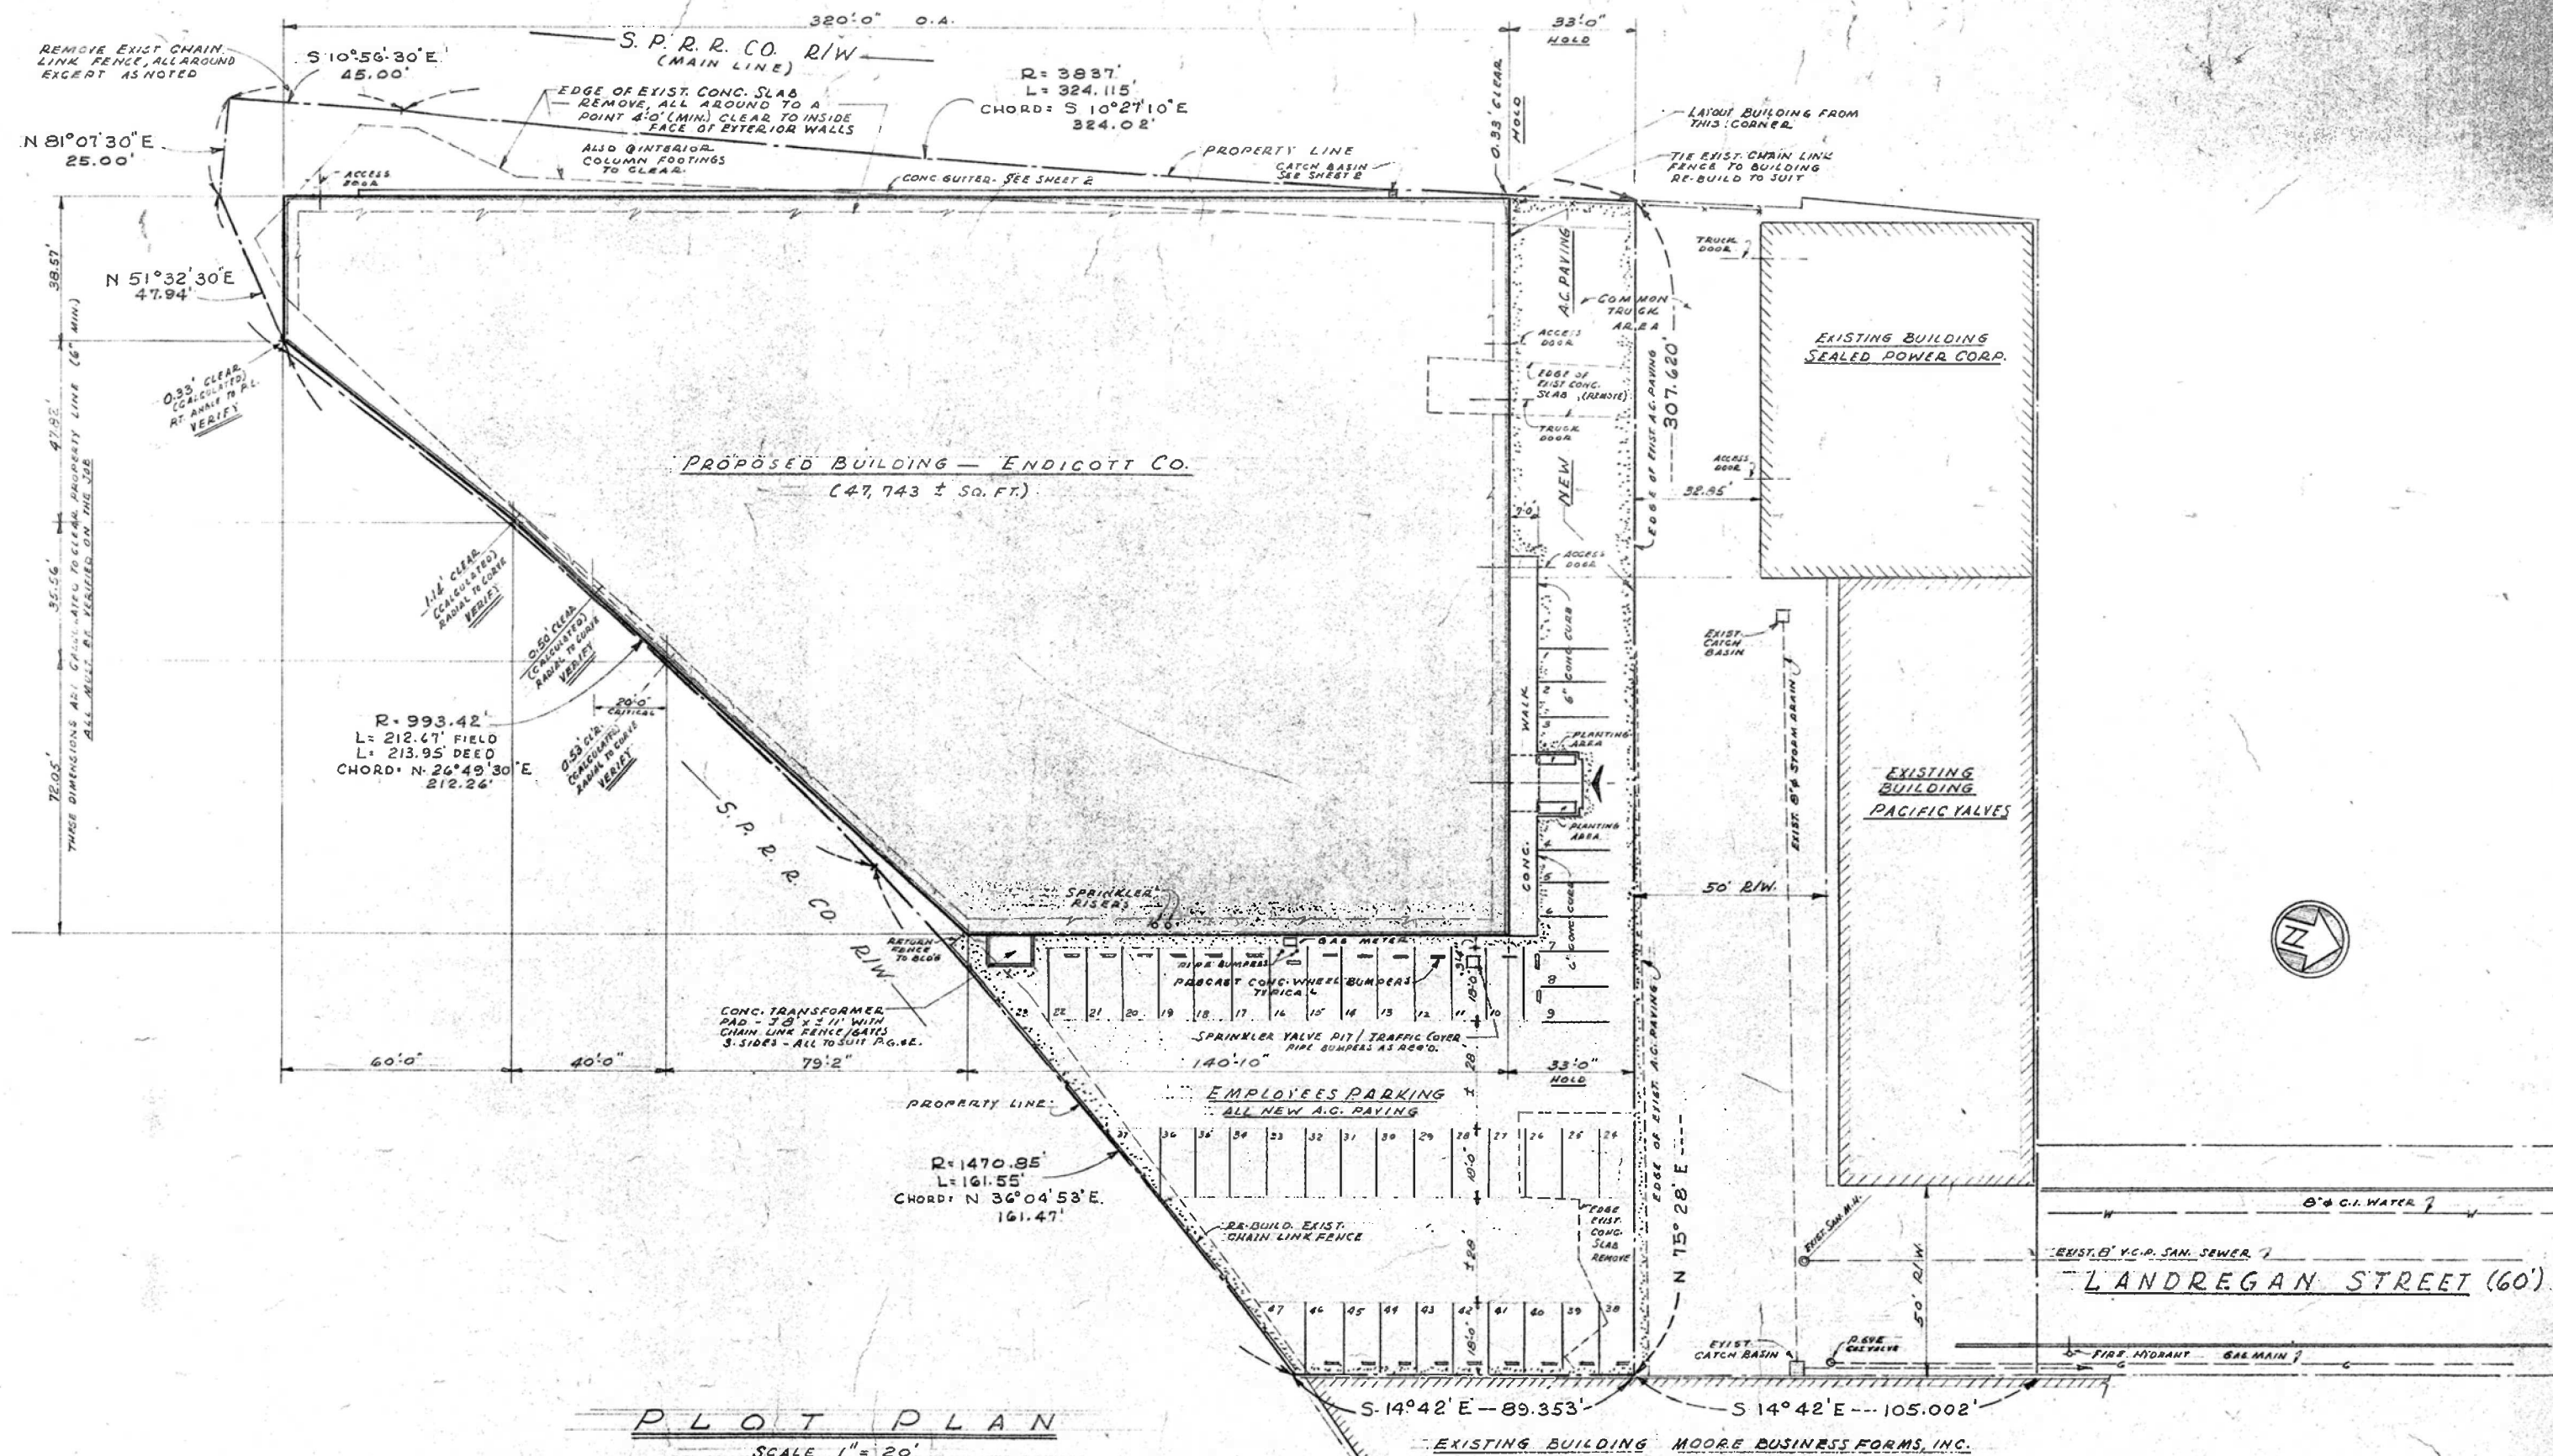
**PLOT PLAN**  
SCALE 1" = 20'

EKI encountered the old slab at depths ranging from 0.5 foot to 2 feet below grade (EKI, 2012, page 2-1, Section 2.1 and EKI, 2016a, page 2-4, Section 2.2.2). As seen on the 1963 as-built titled "Plot Plan" (Attachment 2), the old slab remains in place beyond the footprint of the Current Building to the north and east, and its presence was observed by EKI at nine soil vapor sample locations in the parking area around the northeast corner of the Current Building (EKI, 2016, Table 3-6). Up to 2 feet of fill material was placed above the old slab, and a new concrete floor slab was constructed on the fill material during construction of the Current Building. The fill material observed above the old slab reportedly consisted of coarse sand and gravel and backfill material (EKI, 2012, page 4-1). EKI (2012) also indicated that fill was observed below the old slab to a depth of 3 to 5 feet and consisted of silt, sand, and gravel fill (containing concrete and some other debris). As discussed below, the presence of the old slab beneath and outside the footprint of the Current Building is important to understanding the chemical releases at the FMW site.
