Subject: Tree Removal Recommendation

Species: Japanese Pagoda Tree (*Sophora japonica*)

Project: Horton St, Sherwin Williams

Tree #3 – This tree is on the western side of Horton St, located second from Park St. The tree was assigned #3 in arborist report “Valuation of 54 trees on Horton Street”, submitted on 2-12-18.

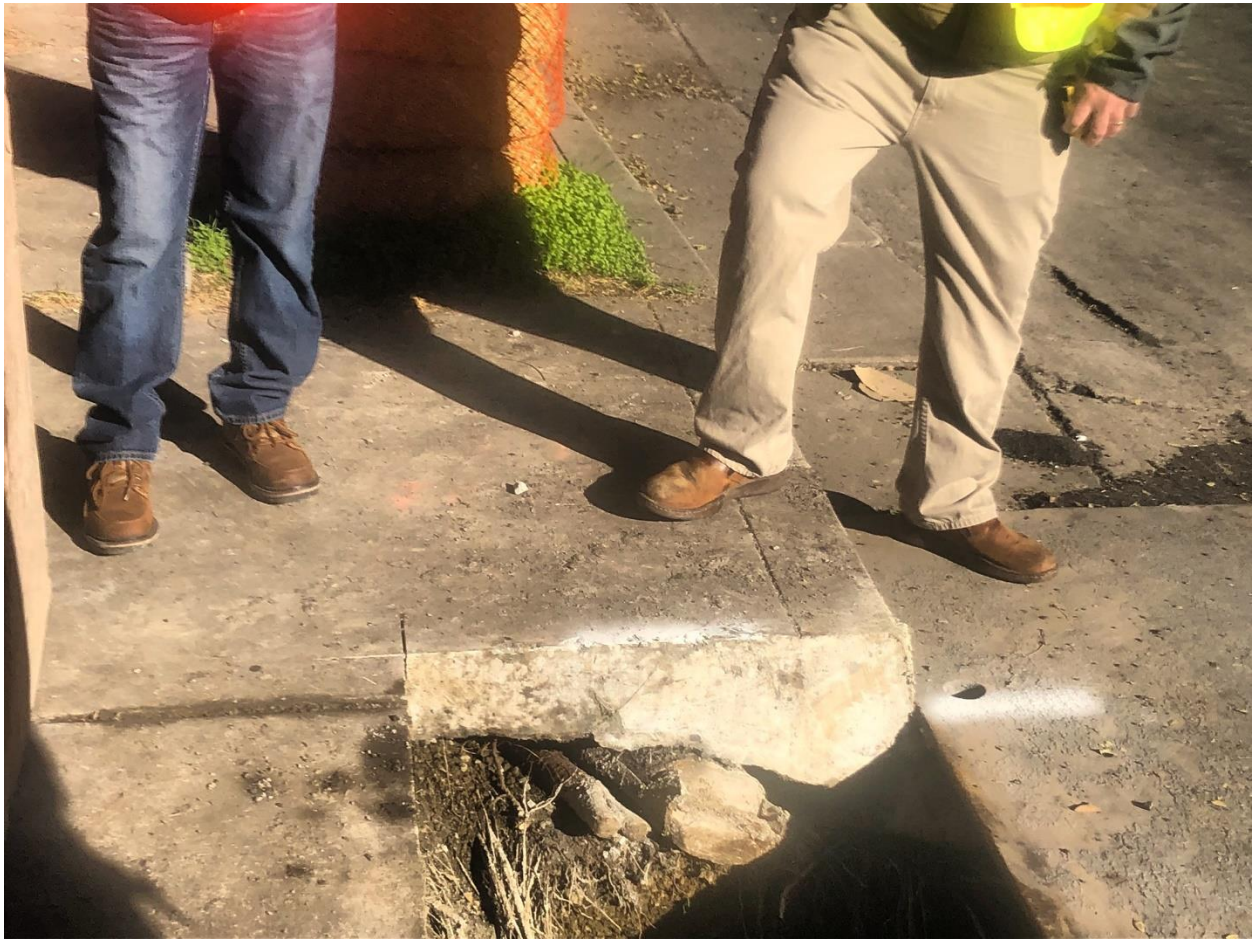
DBH<sup>1</sup> was recorded at 8.5 inches. A 7” root and 3” root were severed when the pavement was saw cut. Although the severance occurred outside the Primary Root Plate<sup>2</sup>, it is likely that tree stability has been compromised due to the size of the root. The significant root loss also has compromised future tree health.

**Photo 3.** Photo left shows the 7" and 3" roots that were severed during hardscape removal.

It is recommended the tree be removed as soon as can reasonably accomplished. As Project Arborist, I assume no liability if it is decided the tree should remain. It is my professional opinion that the tree requires removal to eliminate the associated high risk<sup>3</sup>.
