April 28, 2021

Subject: **Utility Undergrounding Arborist Report**  
Horton St., Emeryville CA

I visited the site on March 12, 2021. A total of 22 trees were included in the assessment, with 16 located on the west side of Horton St. and 6 on the east side. Descriptions of individual trees are provided in the **Tree Assessment Form** and locations are shown on the **Tree Assessment Map**.

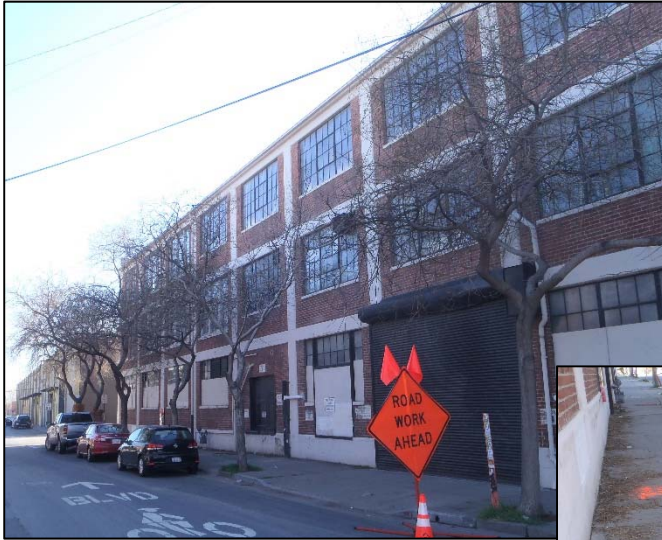
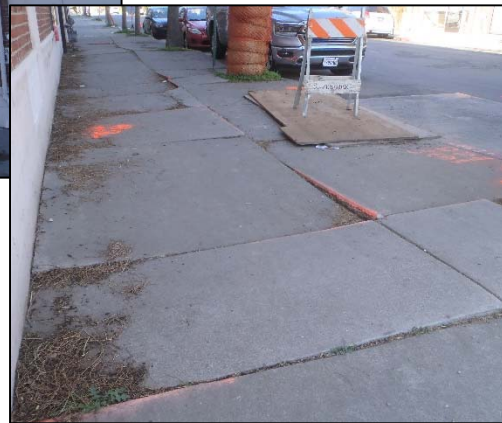
Eleven (11) of the Japanese pagodas had displaced the surrounding concrete sidewalk by an estimated 6" to 10", and the curb and gutter by 2" to 8", including #1, 2, 4, 6, 8-12, 16 and 19.

The trees had developed shallow roots between the base material and concrete sidewalk, curb and gutter as a result of a combination species characteristics and insufficient soil volume. This has created significant tripping hazards for pedestrians along the west side of Horton Street.

**Photo 1 (L):** Looking southwest at Japanese pagoda trees #6-11 (R to L). Condition was variable but almost all had displaced the surrounding sidewalk, curb and gutter from 2" to 8" (inset). Inset was taken at tree #11 looking northeast.

I recommend removing and replacing all of the Japanese pagoda street trees on the west side of Horton Street. This would provide for both continuity of design and assures the new trees will have more soil volume, larger cut-outs and an overall better growing environment. The new growing conditions can be expected to produce healthier and larger trees and reduce the potential for future infrastructure displacement.

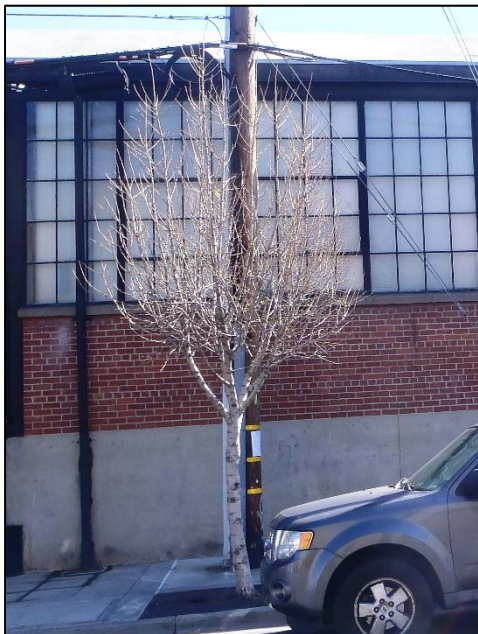
The ginkgos were new plantings, with trunk diameters from 4" to 6". All of the ginkgos were in either good or excellent condition, but #21-23 were already starting to outgrow the metal grates placed around their bases (**Photo 2**).

**Photo 2 (L):** Looking east at ginkgo #21. The trees were all young and in good condition but had already started to grow into the metal grates placed around them.

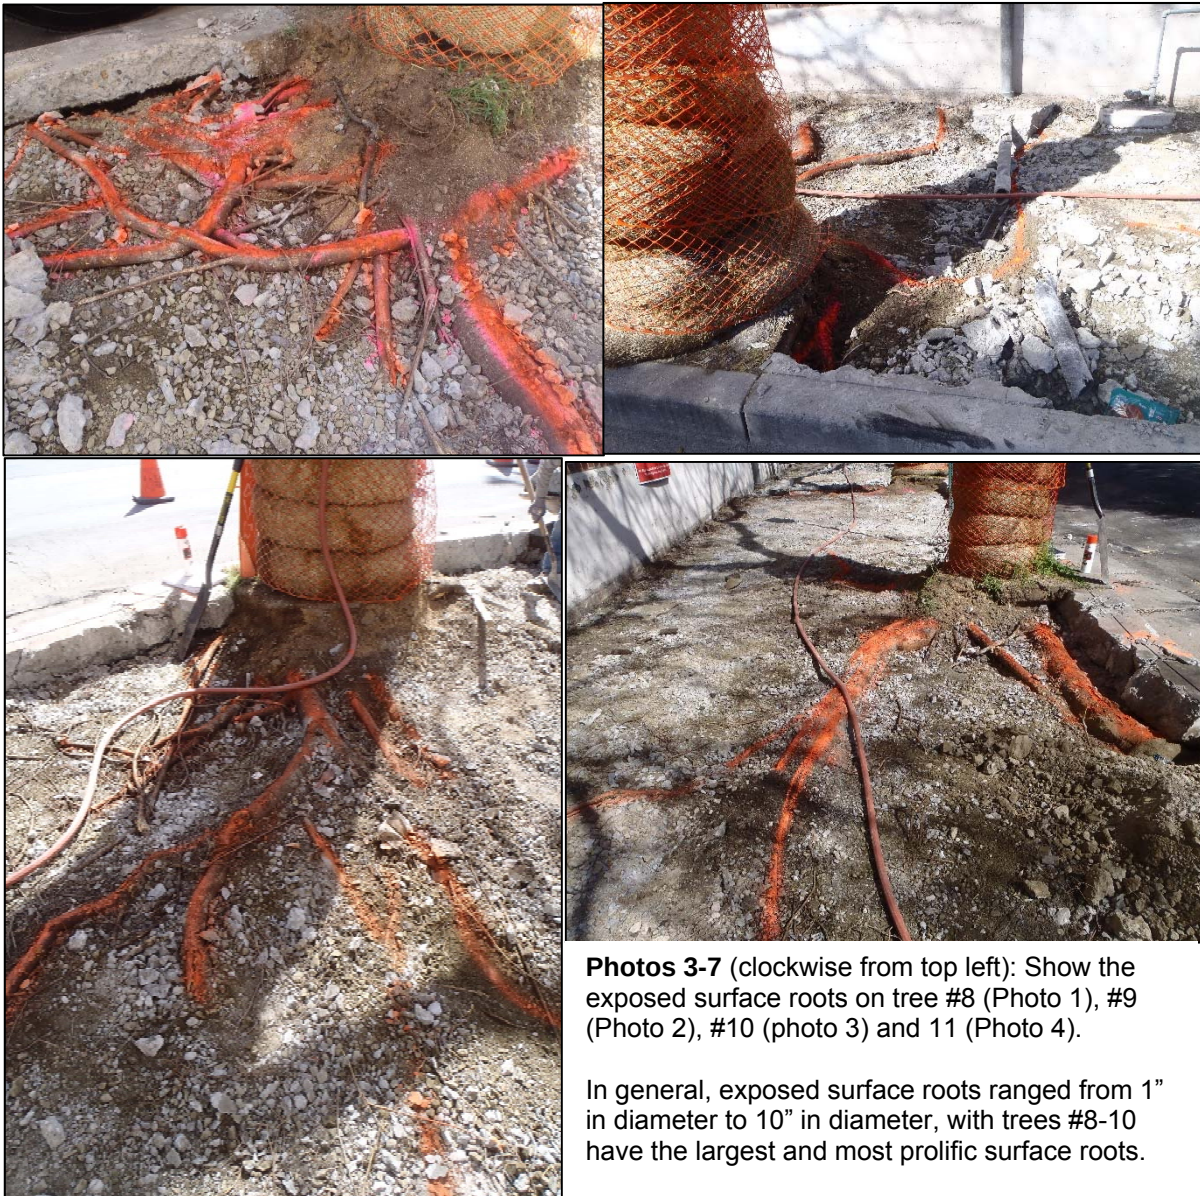
In anticipation of the proposed work and to better understand the number, size and location of surface roots, the sidewalk adjacent to trees #6-10 was removed. Table 1, following page, provides a brief description of the number and size of the surface roots exposed.

Surface roots ranged from approximately 1" to 10" in diameter, with trees #8-10 having the greatest number and largest sized surface roots (**Table 1** and **Photos 3-7**, following page).
