# SBCA TREE CONSULTING

Project: 1270 64<sup>th</sup> St.

Subject: Tree Removal Recommendation

Species: American Sweetgum (*Liquidambar styraciflua*)

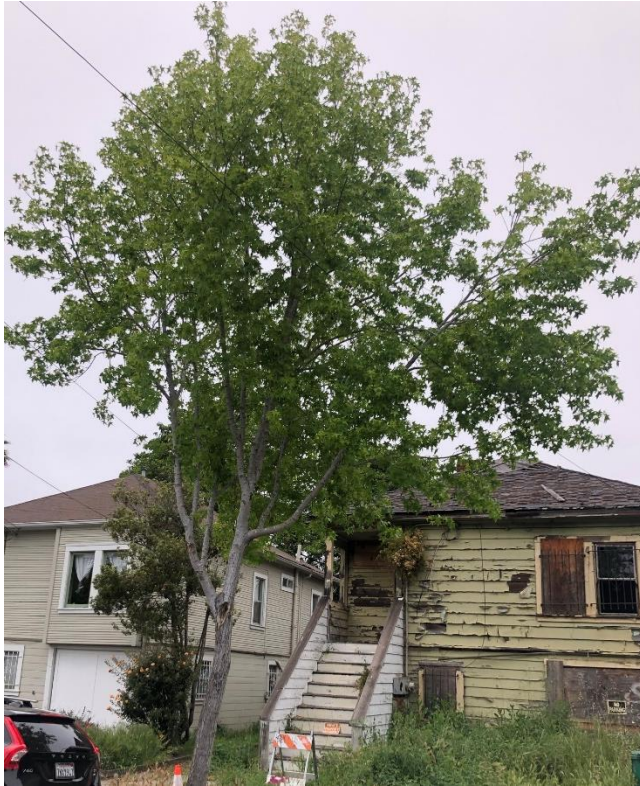
**Photo 1.** Photo above left shows the tree with sparse foliage, possibly due to root damage when pavement was repaired.

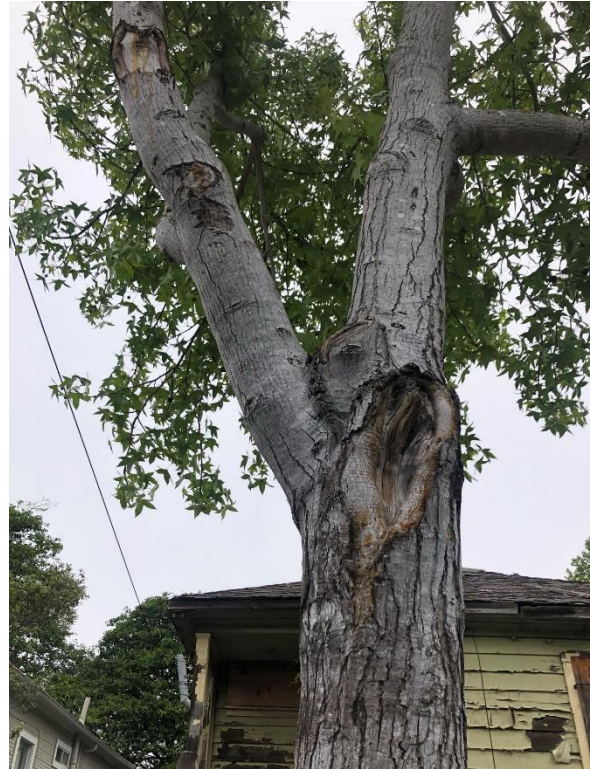
**Photo 2.** Photo above right shows a close up of the rip outs on the main stem. Such wounds will decay in time and compromise the tree.

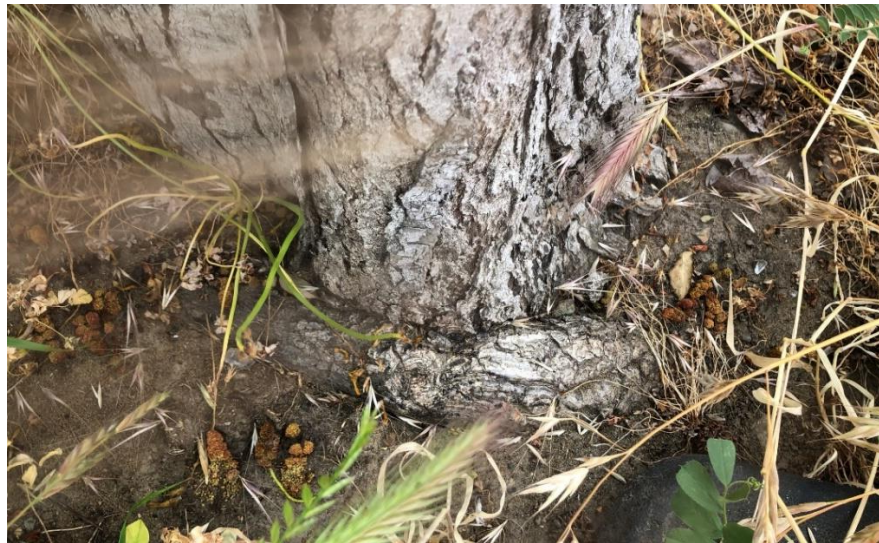
**Photo 3.** Photo left shows red arrow and large circling root which could affect future root stabilization and/or tree health.
