Emeryville Art Center

Feasibility Study

City of Emeryville

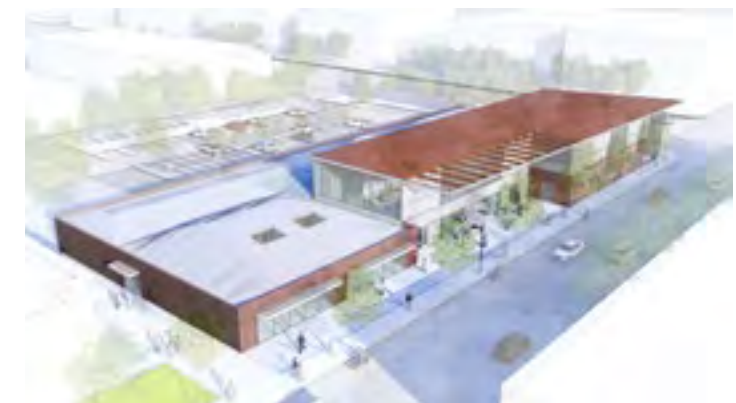
Adaptive reuse option, view of north west corner

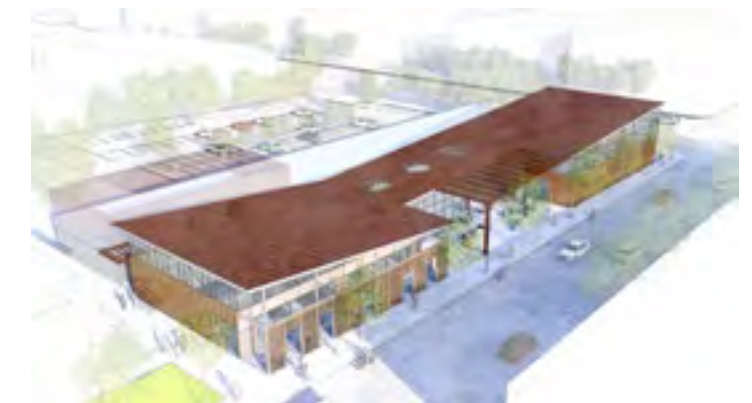
New construction option, view of north west corner

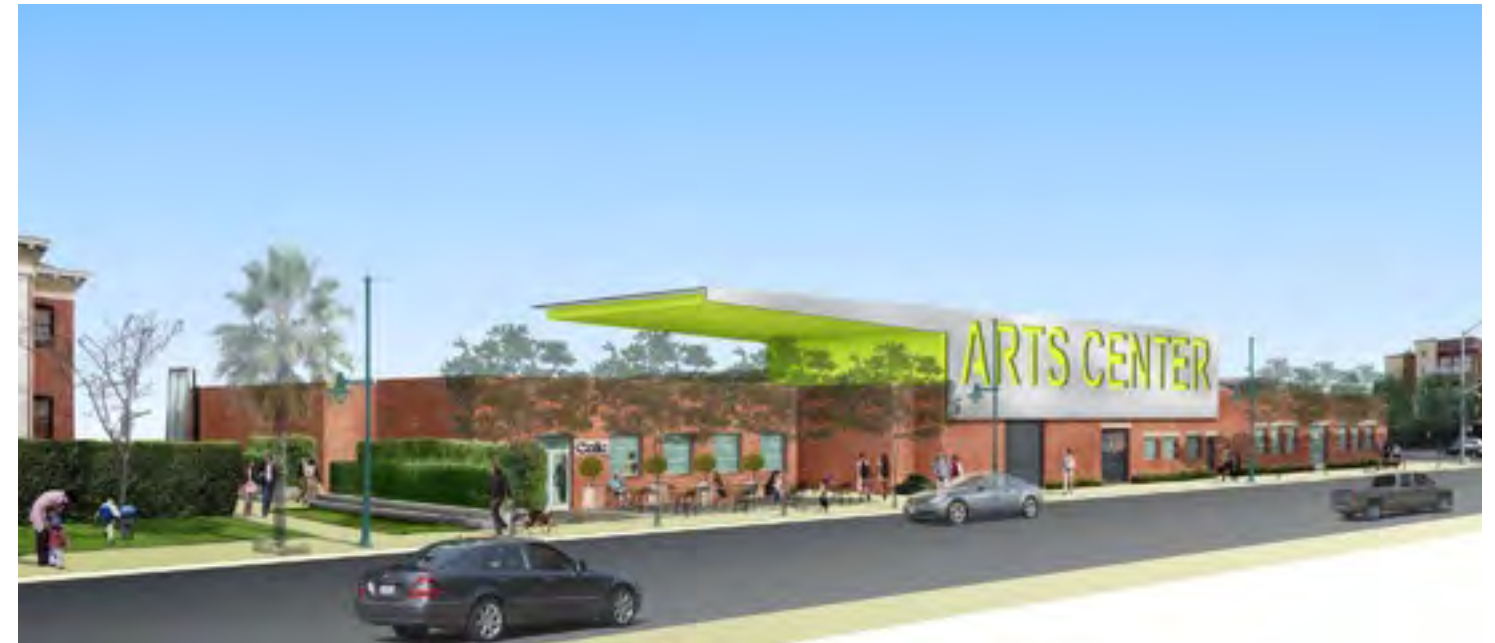
2009 Conceptual Design — Architect: Marcy Wong & Donn Logan. The design proposed the greatest modifications to the northernmost section of the existing building, where an interior courtyard is carved out and wrapped in administrative functions. The four structural bays to the south are dedicated to exhibition, theater, and multipurpose space with the insertion of a tall theater volume along Hollis St.

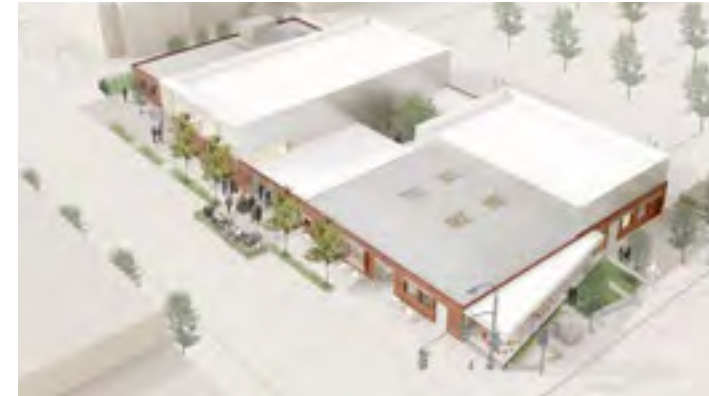
2011 Proposal — Architect: Jensen. The design proposed two large new volumes within the existing footprint in the middle and southern bay to accommodate the theater and gallery programs creating a presence from the street.

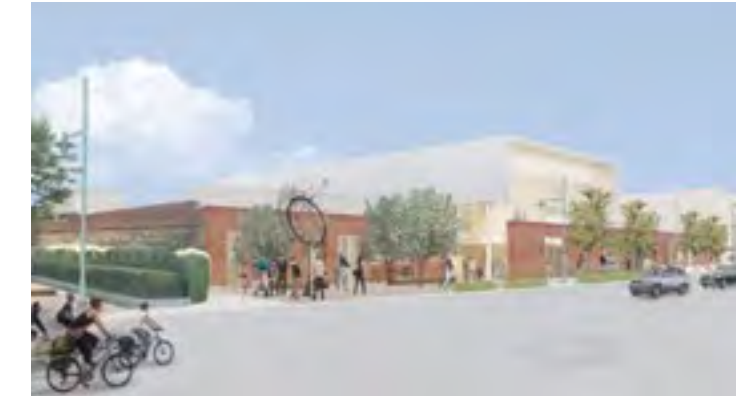
2011 Proposal — Architect: Jensen. The proposal responds well to prior community vision and goals for the project with a “community art hub” approach to the layout of the program and a strong architectural presence for the building that would reinforce the center as a premier arts destination.

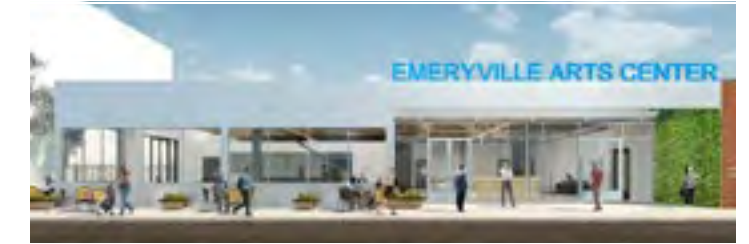
ODI proposal west facade

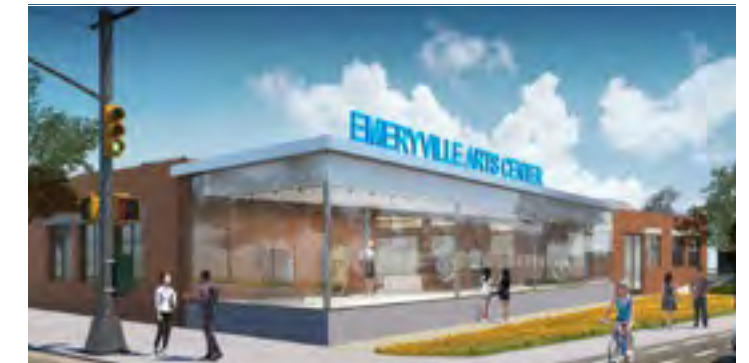
ODI proposal south west corner

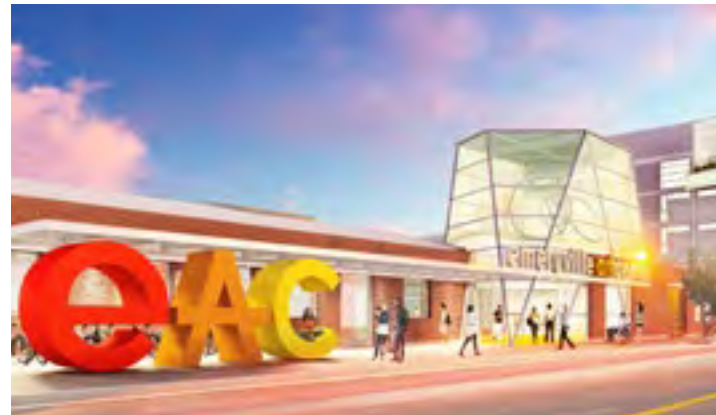
CAST proposal

The program includes a main gallery space, designated auditorium/event space located centrally. A courtyard lobby, cafe, and gift shop are located on the building perimeter with an emphasis on community access and visibility. There are four combinable multi-purpose rooms located along the north wall with access to the Civic Center Sculpture Courtyard, allowing for the space to extend to the outdoors. Skylights are proposed to be restored with daylight control through baffles and operable blinds in the main gallery. A line of sight is provided from the 40th Street entry to the landscaped Civic Center Courtyard, simplifying circulation for visitors.

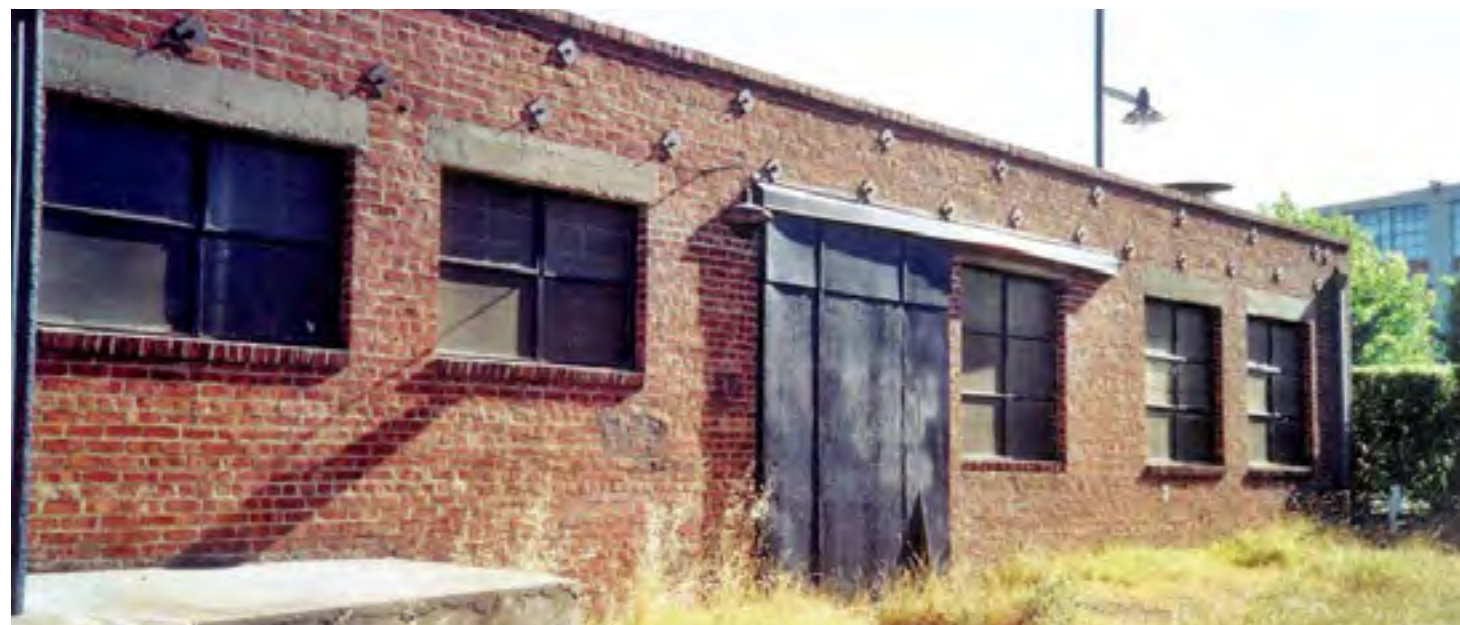
Historical character defining features depicted including brick facade, concrete lintels and horizontal repeating elements | image source: Emeryville Historical Society (EHS) Photo Archive

4060 Hollis Street is classified as a Tier 2 significant building in Emeryville's Park Avenue District Plan that identifies architecturally significant buildings. Some of the features that contribute to the building's classification as such include the brick facade, symmetrical punched openings, continuous linear

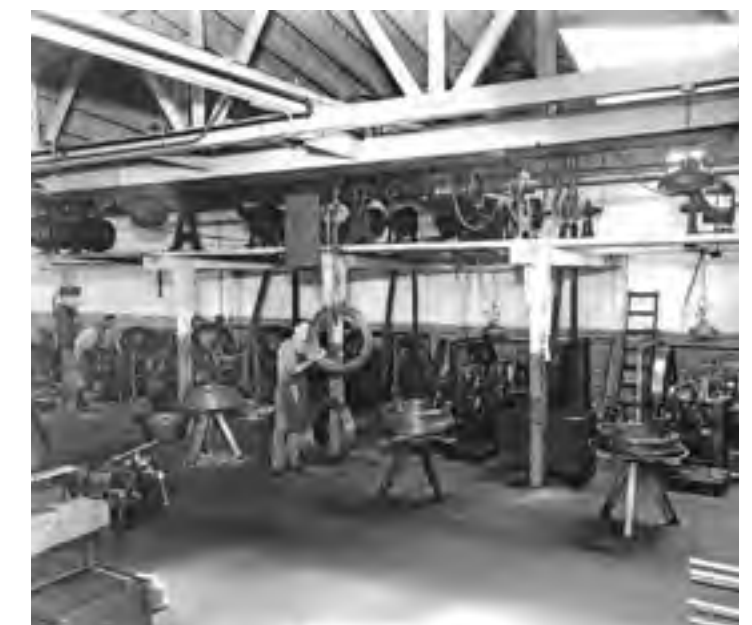
Albert Wright Co. overhead pulleys transfer power to machinery on floor | image source: (EHS) Photo Archive

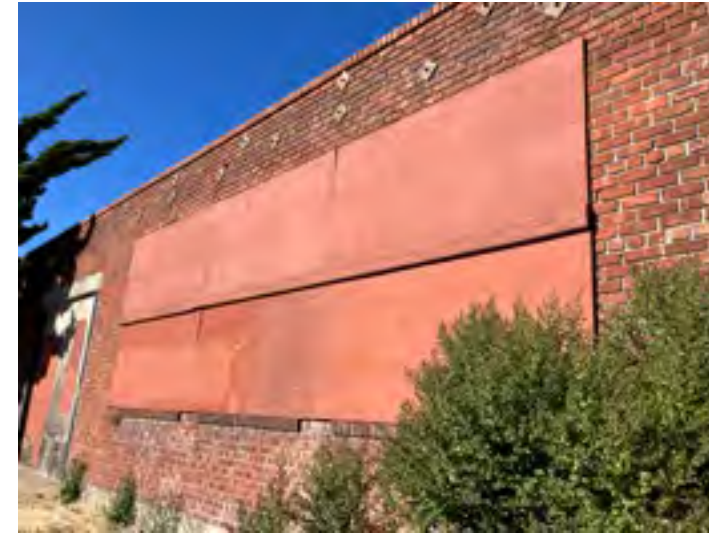
1. Example of west facade brick condition and boarded window openings.

Existing: The building is an unreinforced masonry structure, with walls approximately 14' -9" high. The exterior south and east brick elevations appear to be in fair condition. The east brick elevation visible from the parking lot is in poor condition with what looks like grout or plaster on the face of the bricks. The North facade is solid brick with no windows or openings. The east facade is primarily a solid wall with openings at the south that have been boarded up. The south elevation has remaining windows and transitions to a loading dock which is elevated on a concrete plinth and clad in corrugated metal.

Repointing of the brick facade assembly where compromised is suggested in order to restore the historic character of the building materiality. Previous proposals suggest to sandblast the brick which would be recommended to help restore its appearance. They also propose the demolition and replacement of the 40th street metal-clad facade which would be recommended as an opportunity to present as a more inviting street-facing facade.

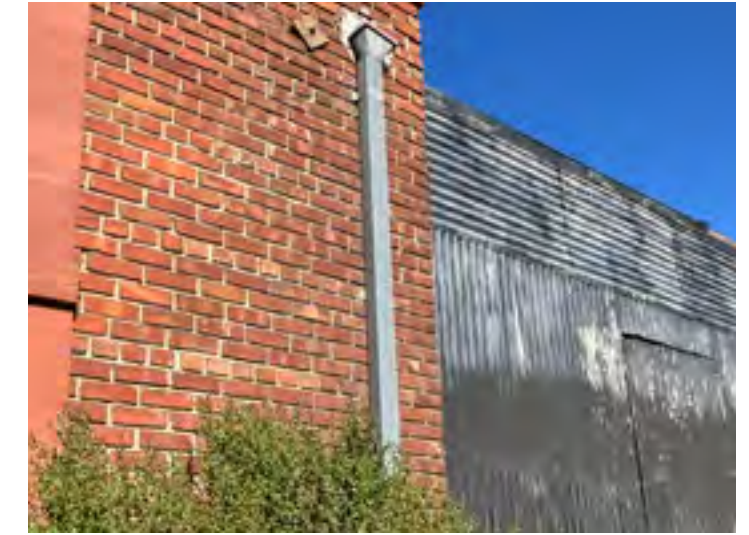
3. South brick facade meeting metal cladding.

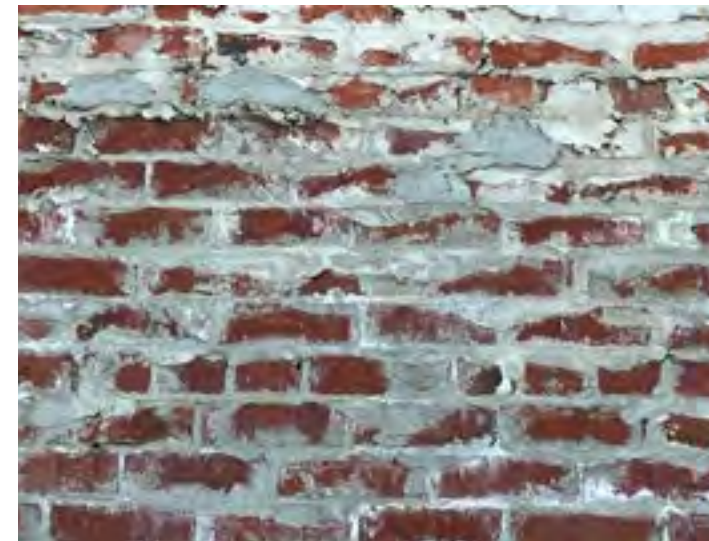
2. Example of east facade brick condition.

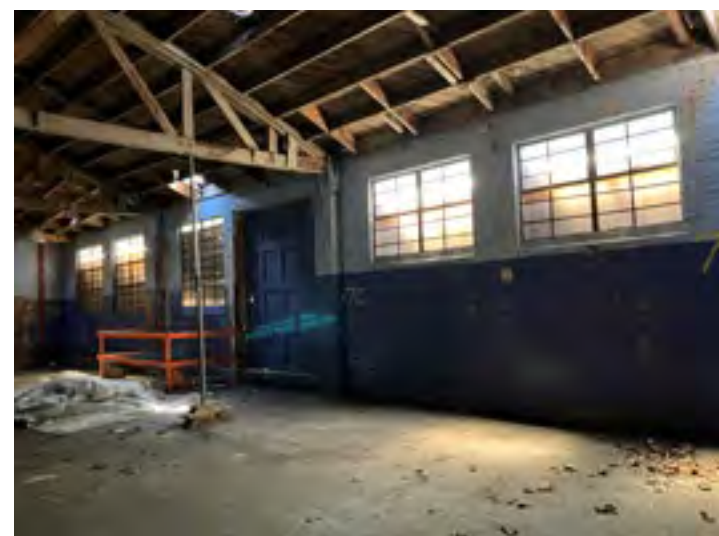
5. The door and windows along 40th Street remain.

Existing: The building's existing windows are single pane with metal frames and divided lights. Windows along Hollis Street remain but are in poor condition with rusted frames. Some glazing is broken and the windows and doors on the Hollis Street building face have been removed between Gridlines 4-7 with temporary wood frames placed appearing to be supporting the remaining window openings. The roll-up door on Hollis Street was scheduled to be demolished, however, it is still in place. The entry door on Hollis Street also remains.

Proposed: Previous proposals suggest preserving the existing roll-up door as it contributes to the character of the industrial building and neighborhood, so it is recommended to preserve this feature so long as future programmatic functions allow. They also suggest preserving the windows and existing door openings throughout which is recommended as they have qualities that contribute to the historic character that defines this building as significant. The rusted condition of the existing window frames may not be repairable, however, so windows may need to be replaced.

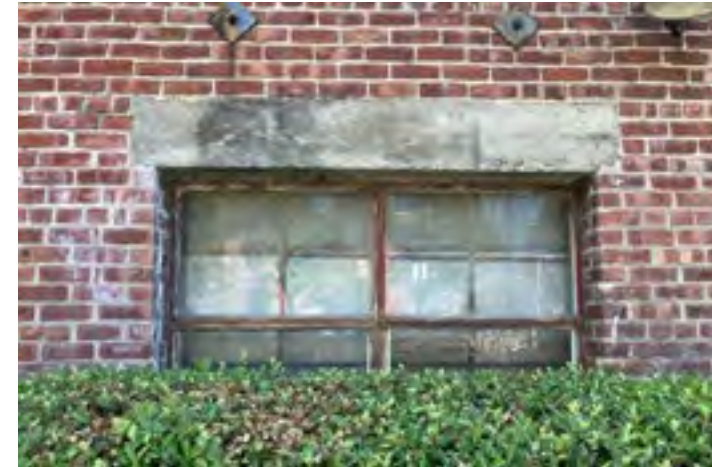
7. Example of existing west facade window with historic concrete lintel.

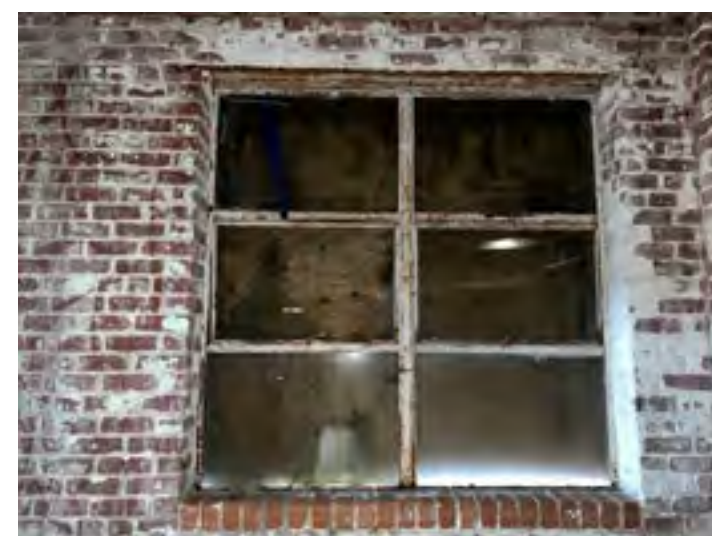
8. Interior view of Hollis Street window. The windows on this west facade remain and are boarded from the exterior.

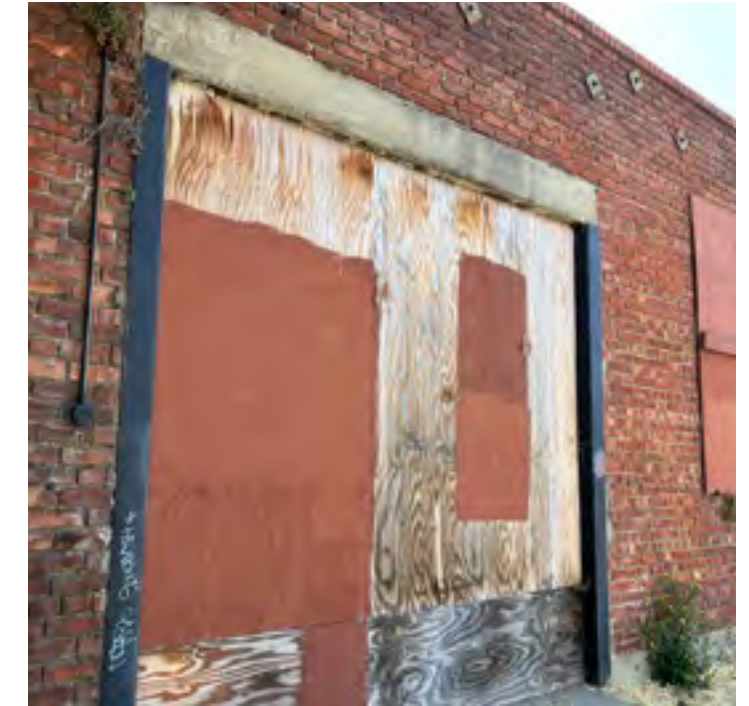
9. Previously demolished door with concrete lintel boarded up on Hollis Street.

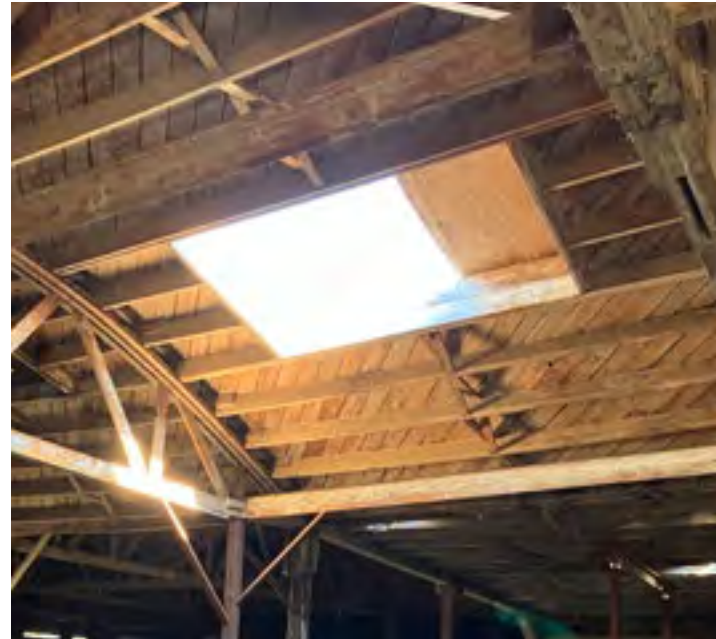
11. Some previously demolished skylight openings have been left uncovered.

Skylights and other equipment have been demolished and removed leaving large openings in the roof which have allowed for significant water intrusion that have compromised the condition of the roof throughout, though some areas appear to be in better condition than others. Generally, the roof structure appears to be in its worst condition between bays 1-3 and seems to improve towards the south. Given its domed shape, the roof is in worse condition at its low points, with some perimeter areas showing significant deterioration. The wood structure and sheathing are rotted in certain areas and temporary shoring has been installed to support the structure where most compromised.

Proposed: Most previous proposals demo portions of the roof to create taller volumes for theater and exhibit spaces, which may be recommended if it facilitate the accommodation of those programmatic needs. Previous proposals intend to demolish sections of the existing roof to create openings for courtyards which may be recommended to allow for greater access to daylight and the outdoors as it relates to the adjacent program. With all skylights having been demolished, it is recommended to replace with new skylights or patch and restore the remaining roof openings. It is recommended that the roof structure and sheathing be replaced wherever it has been compromised. It is assumed that the entire roof receive new roofing.

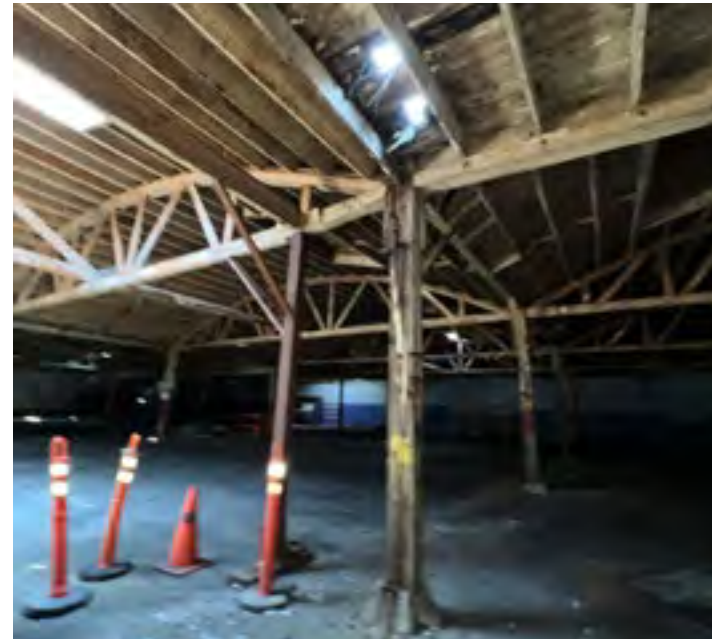
13. Roof deterioration requires shoring in some locations.

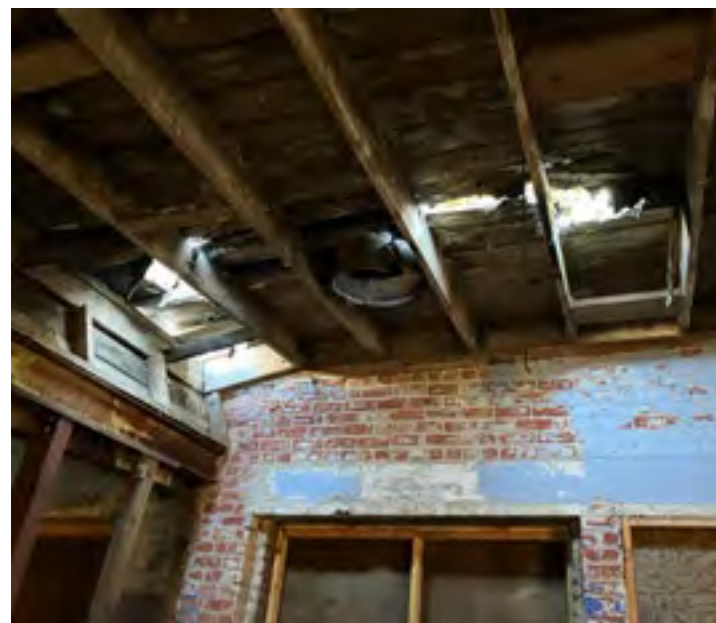
12. Roof deterioration at low point.

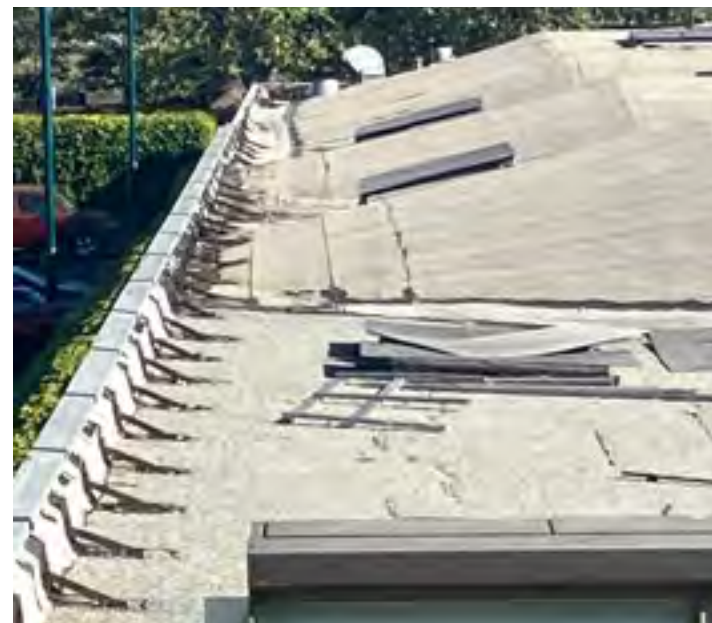
14. View of roof condition from the north. Generally, demolished skylights are covered. Some roof bracket supports are missing.

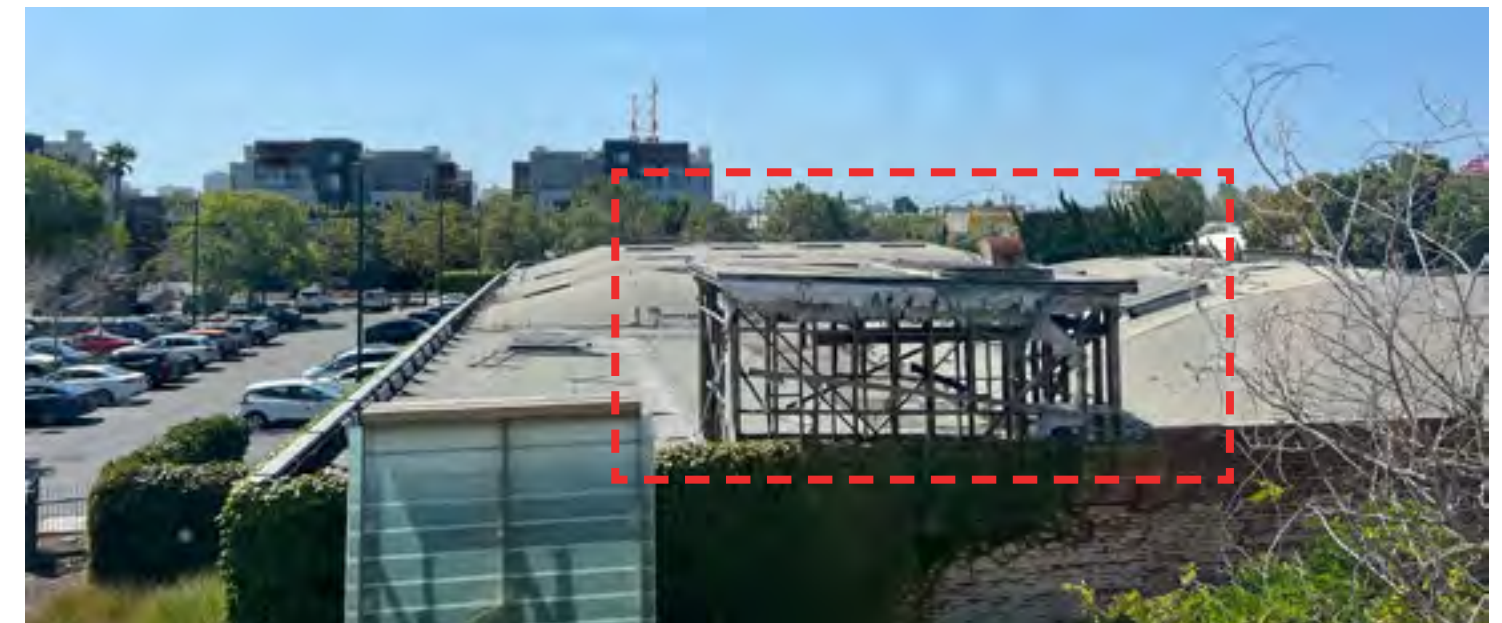
15. North roof view from upper level of adjacent Emeryville Civic Center.

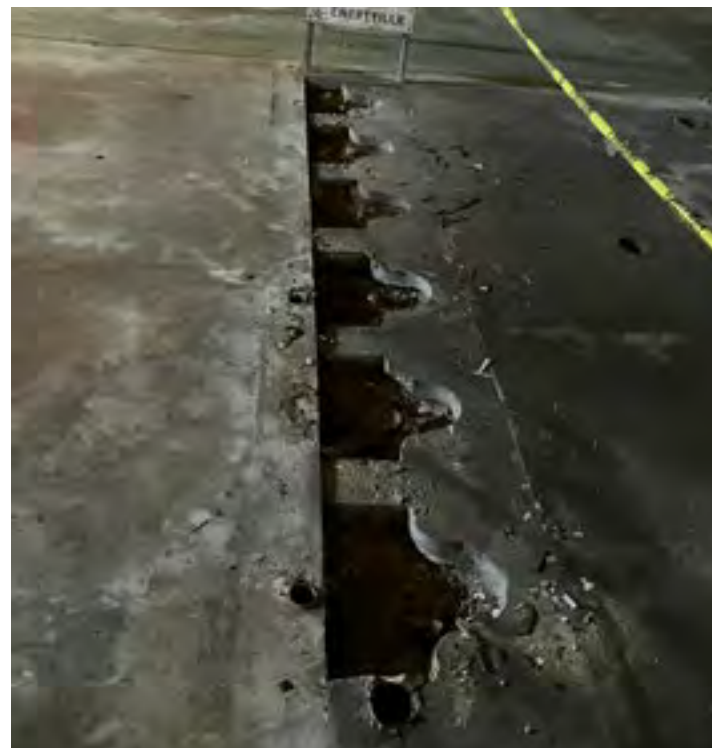
16. Slab condition from demolished restroom lavatories.

The residual effects of demolition leave uneven slab conditions throughout. There are several locations with holes in the existing slab. Existing timber columns are supported by concrete bases that are elevated above the concrete floor slab.

Proposed: It is recommended that infill and leveling be required to remediate the existing uneven slab condition.

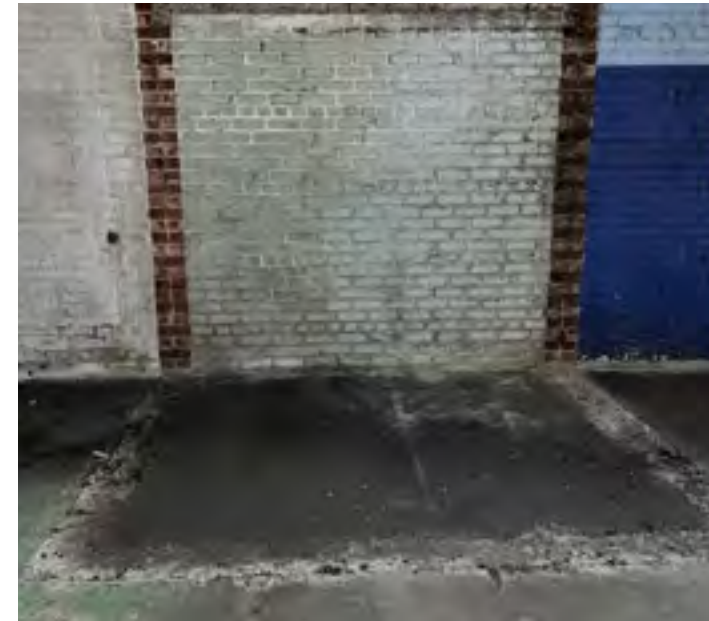
18. Previously demolished interior walls leave existing concrete slab damaged.

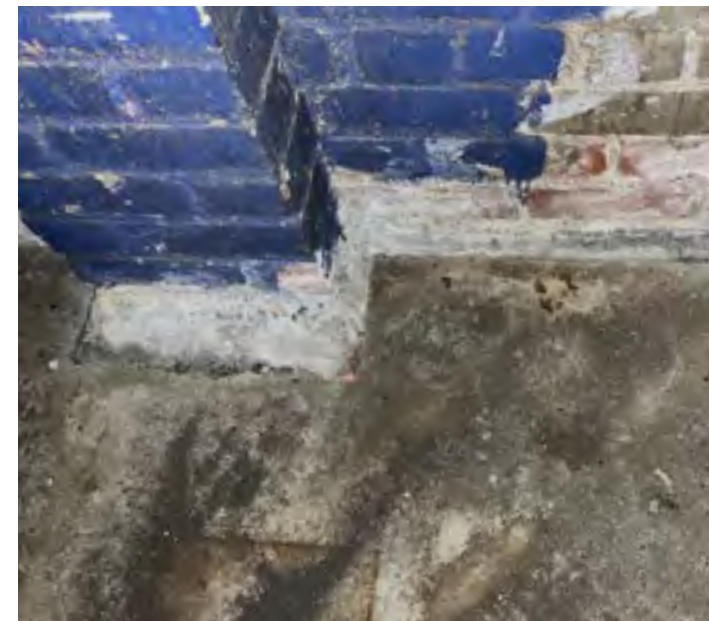
19. Concrete slab condition at perimeter brick wall.

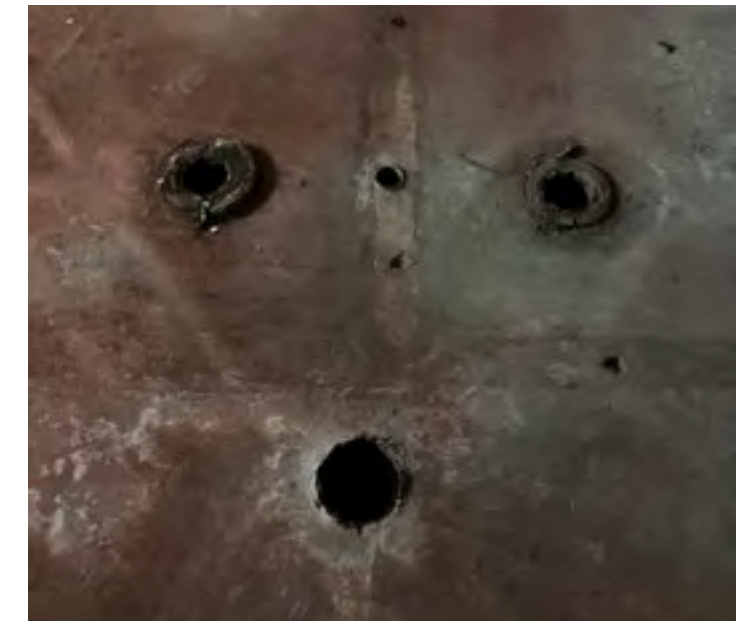
20. Existing holes in concrete slab from demolished toilets.

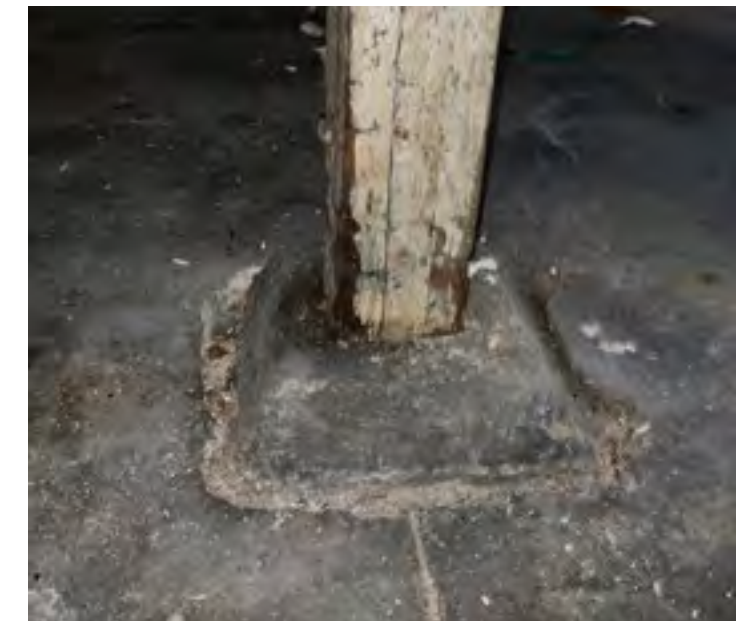
21. Existing concrete column base elevated above concrete slab in several locations.

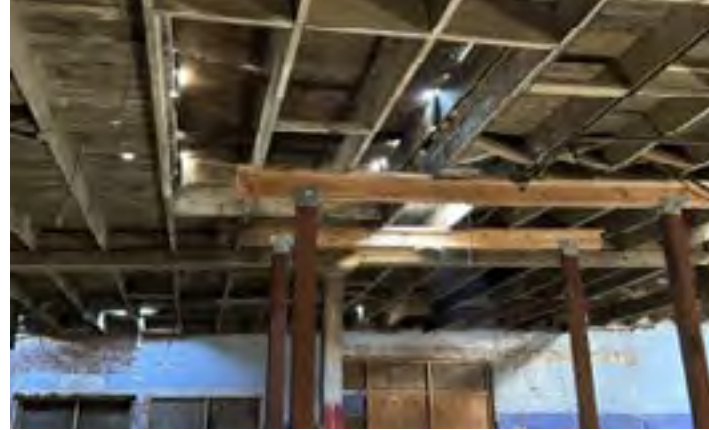
22. Damaged portion of roof with shoring.

- A couple portions of the roof structure have collapsed, likely due to overstressing of the main members. This has caused the remaining primary structure to be exposed to weather over time. Temporary shoring was installed to support the structure surrounding the collapsed areas.
- The 1x sheathing generally appears to be in fair condition, though there were several locations where daylighting has occurred.
- The existing joists vary in condition. Some joists appear to be in good condition while others have deteriorated or failed due to overstressing.
- Several trusses have failed due to overstressing as shown by the splitting of bottom chords. Temporary shoring has been installed to support the failed truss members.

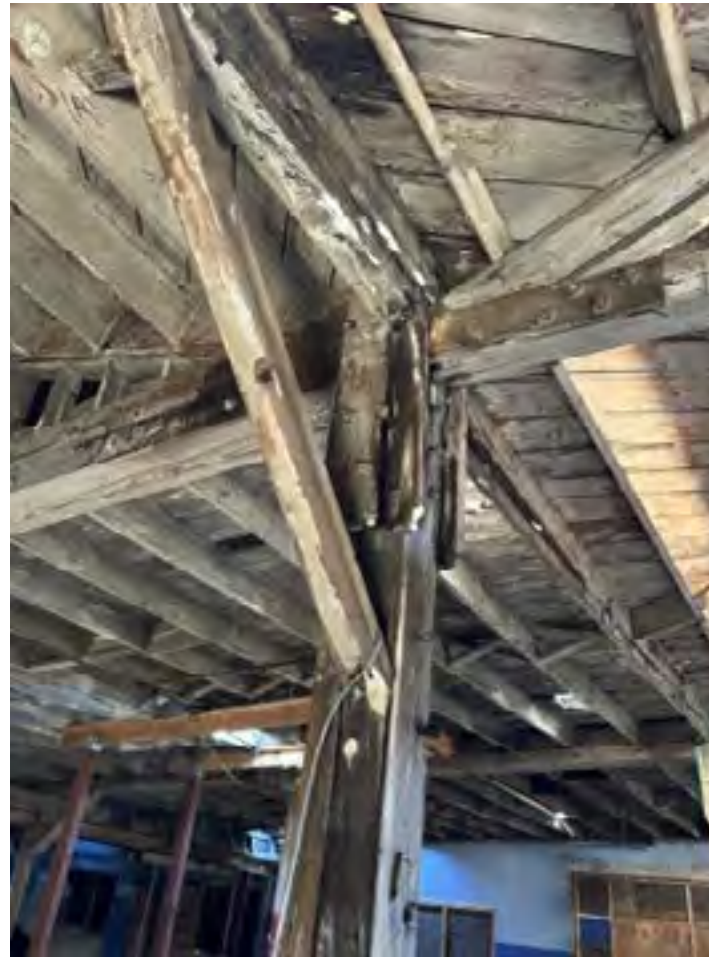
23. Failed connection at interior timber column.

- The timber wood columns appear to be in generally good condition. Wood checking is visible on several columns. Additionally, several connections between the roof truss members and columns have failed.

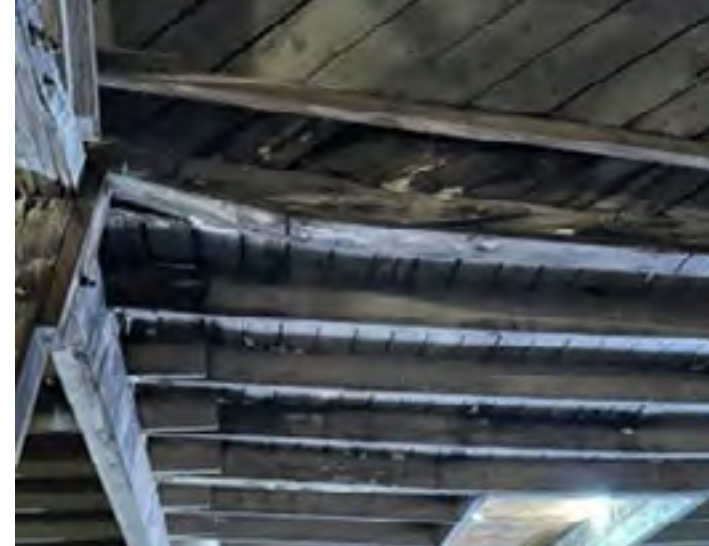
24. Overstressed joint causing failure.

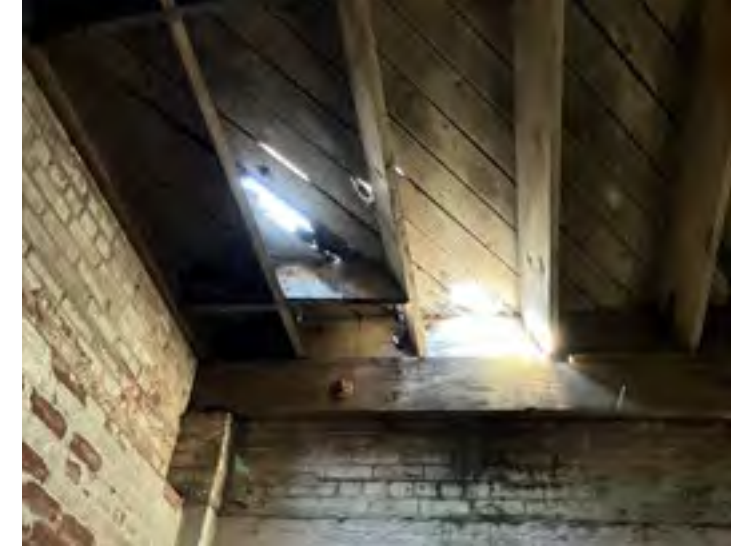
26. Example of daylighting.

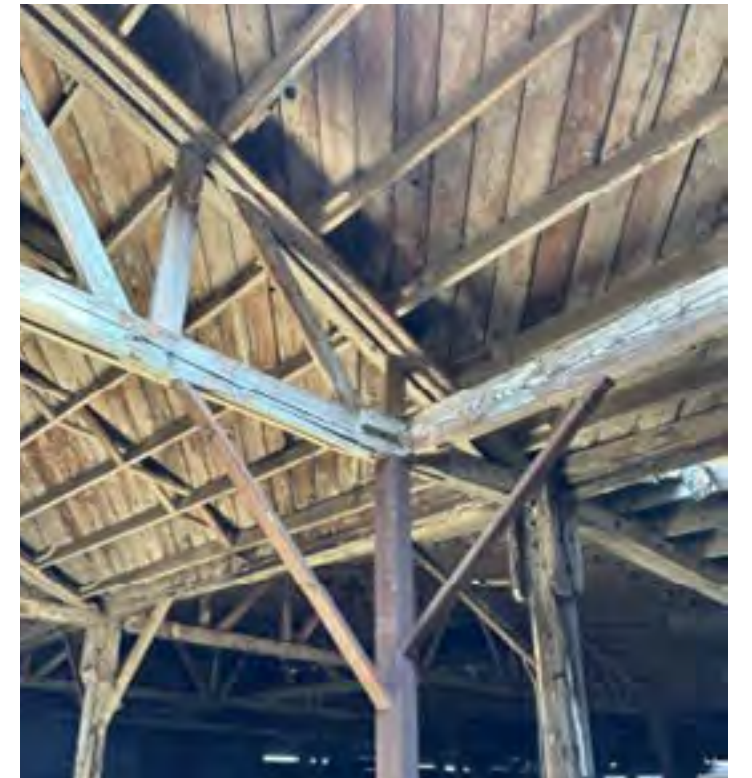
27. Bottom chord failure at truss member with shoring.

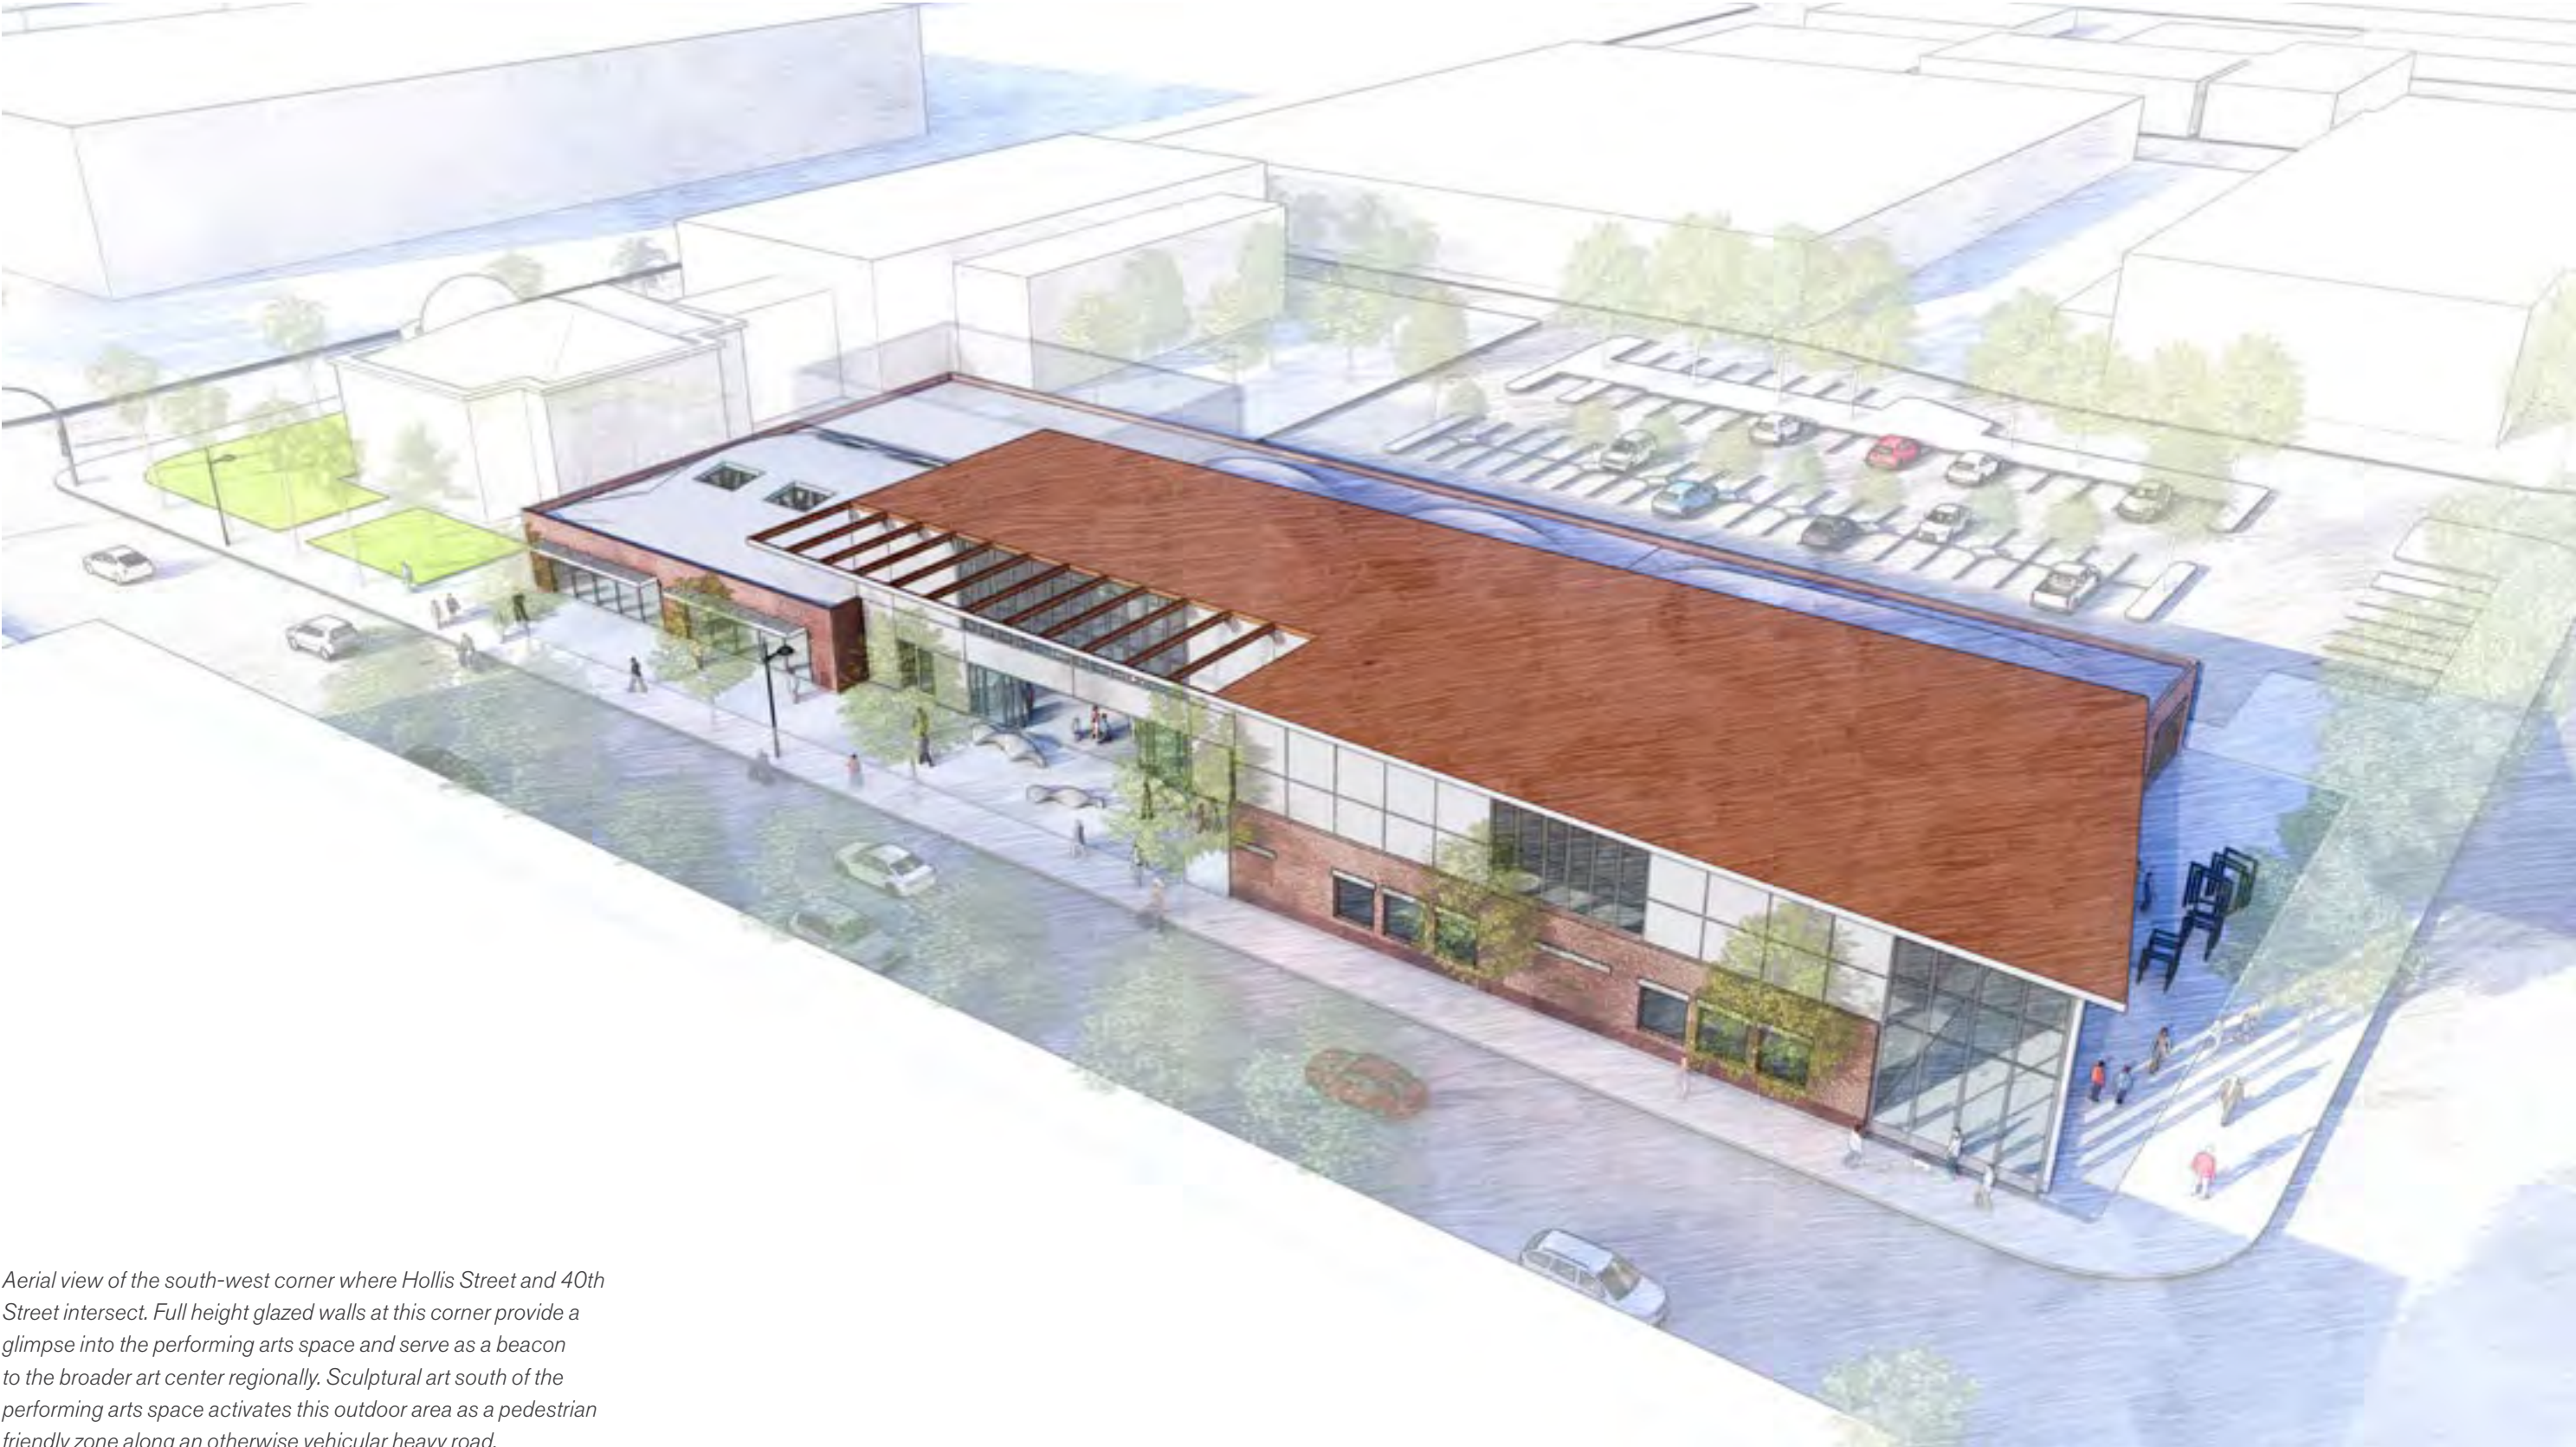
Aerial view of the south-west corner where Hollis Street and 40th Street intersect. Full height glazed walls at this corner provide a glimpse into the performing arts space and serve as a beacon to the broader art center regionally. Sculptural art south of the performing arts space activates this outdoor area as a pedestrian friendly zone along an otherwise vehicular heavy road.

The adaptive re-use base case design for the purposes of this study builds off previous iterations of the project. As discussed in the previous pages, the program layout is intended to work with rather than against the existing structure, locating demising walls along existing structural grid lines as much as possible. In an adaptive re-use approach, the design goal is to celebrate existing elements to remain, such as the brick facade and the wood trusses.
