Emeryville Art Center

Feasibility Study

City of Emeryville

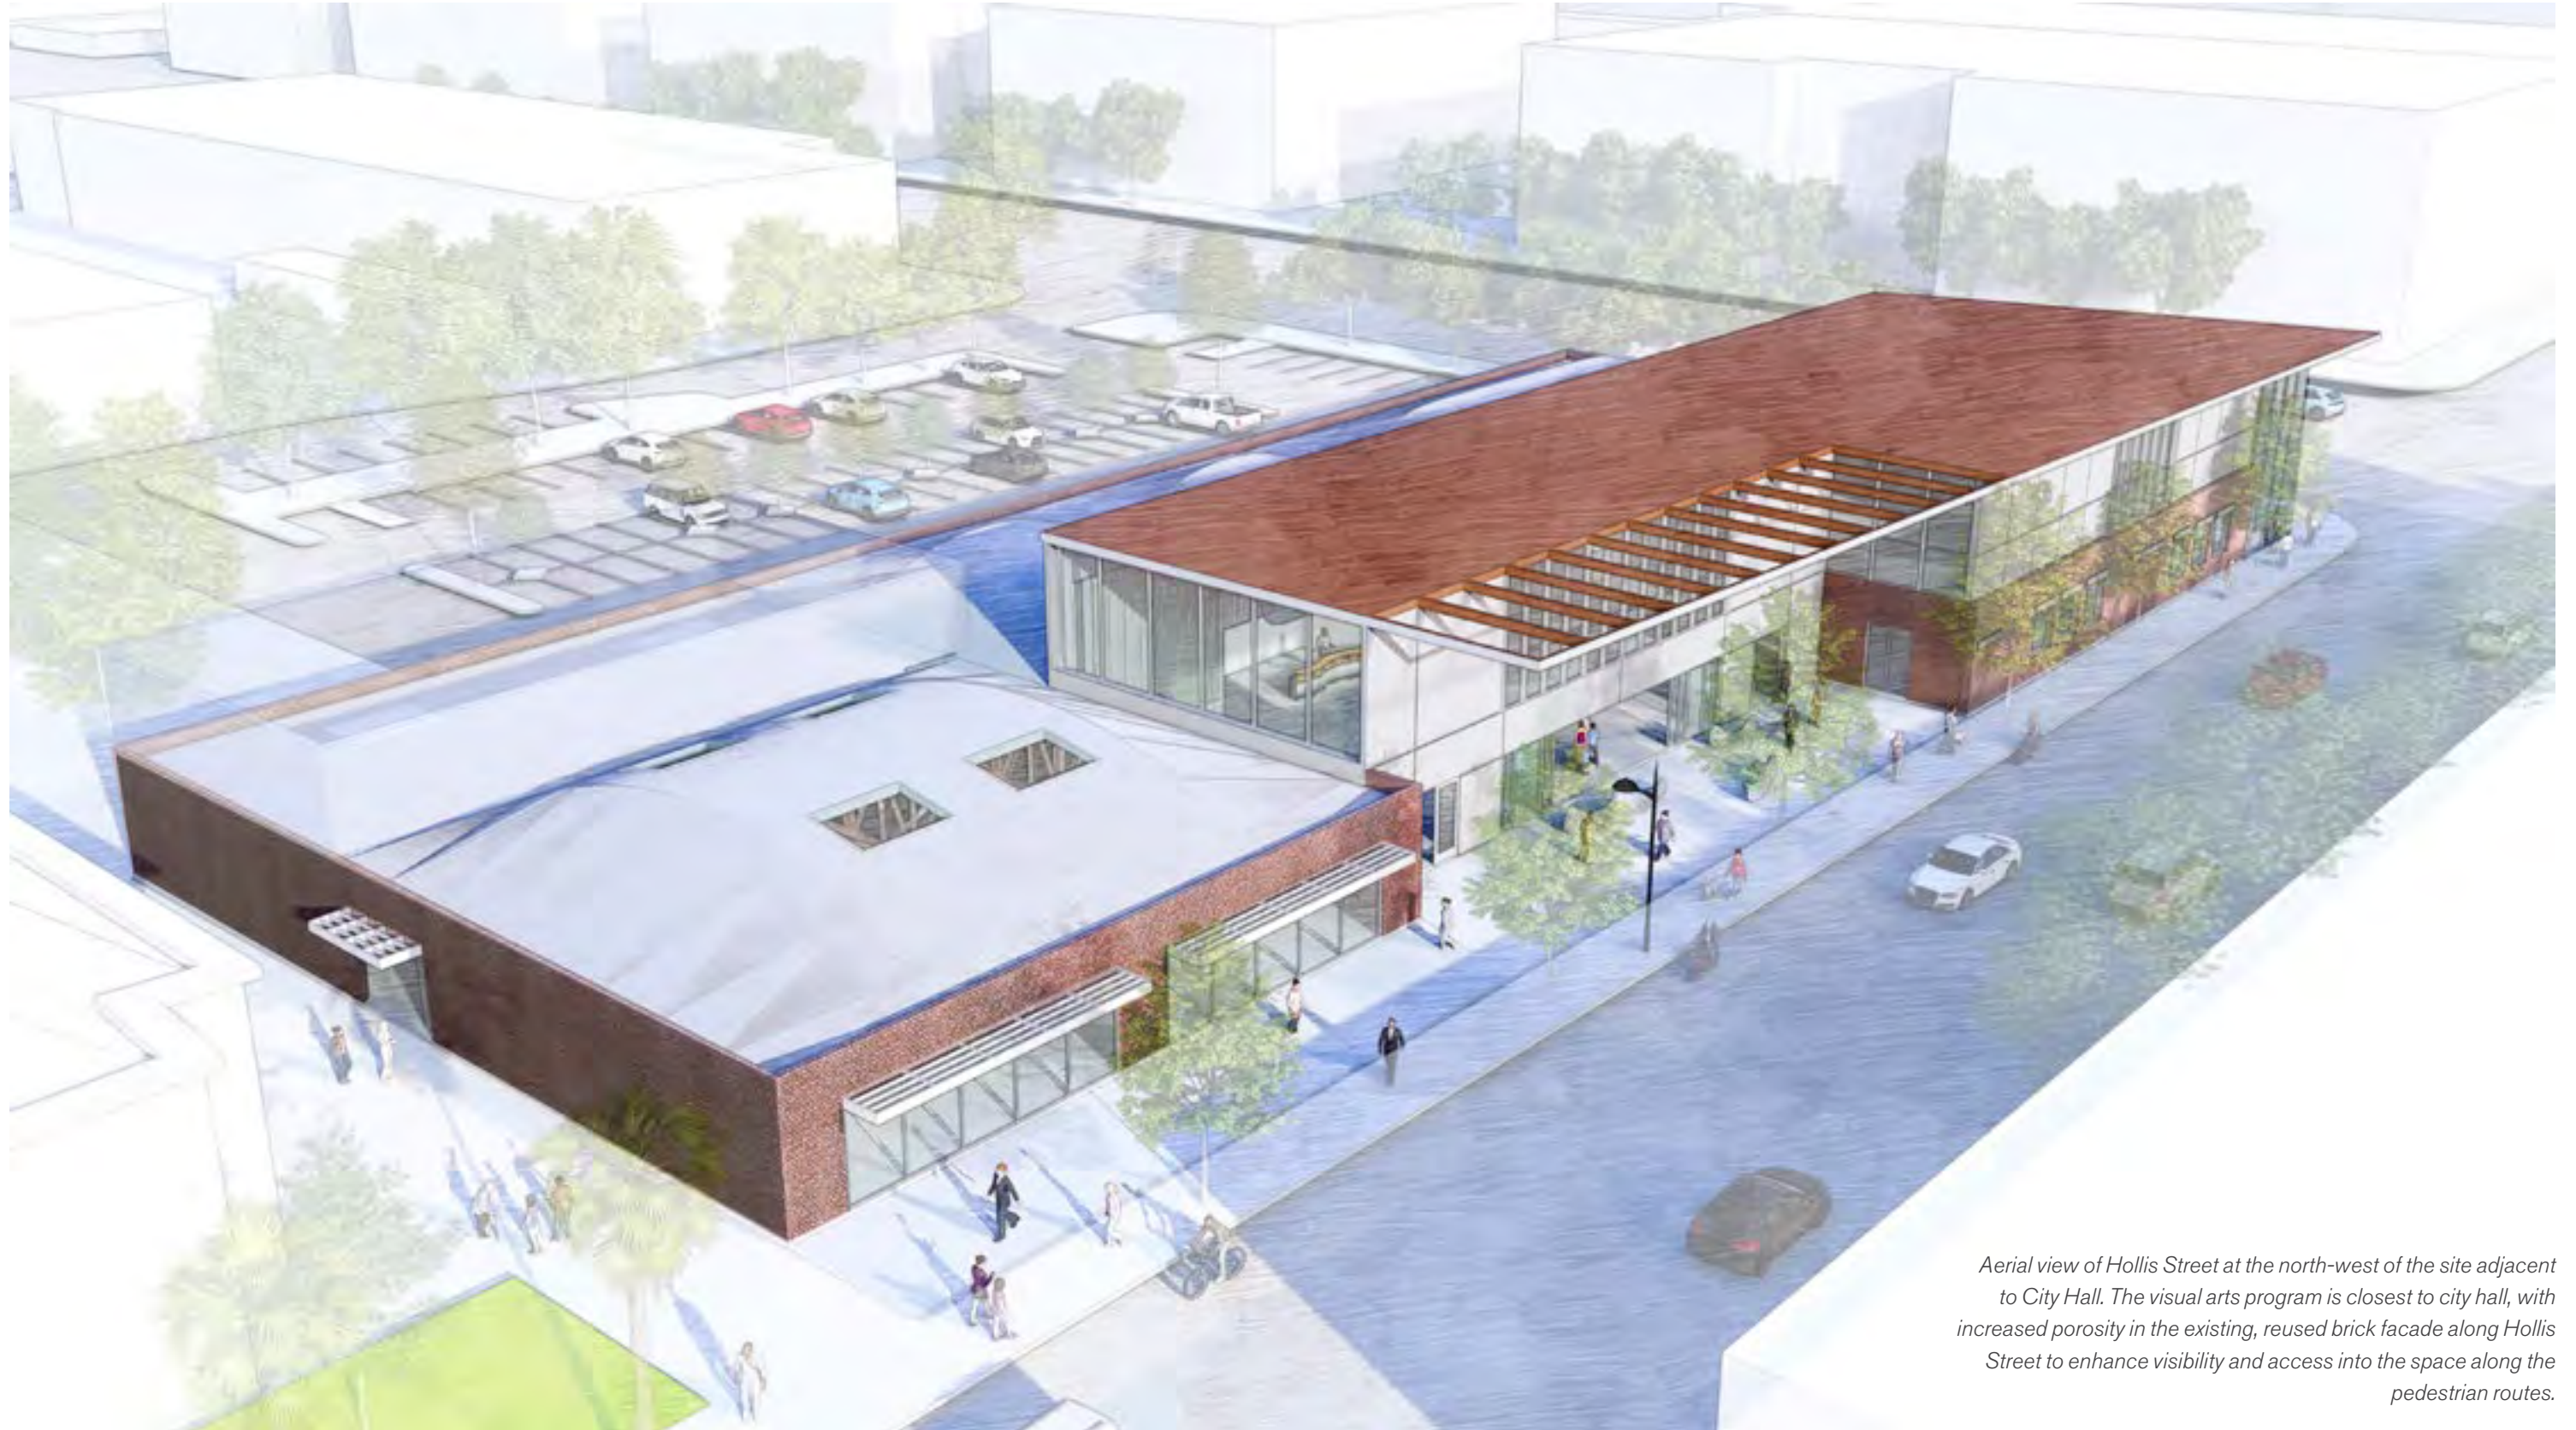
Aerial view of Hollis Street at the north-west of the site adjacent to City Hall. The visual arts program is closest to city hall, with increased porosity in the existing, reused brick facade along Hollis Street to enhance visibility and access into the space along the pedestrian routes.

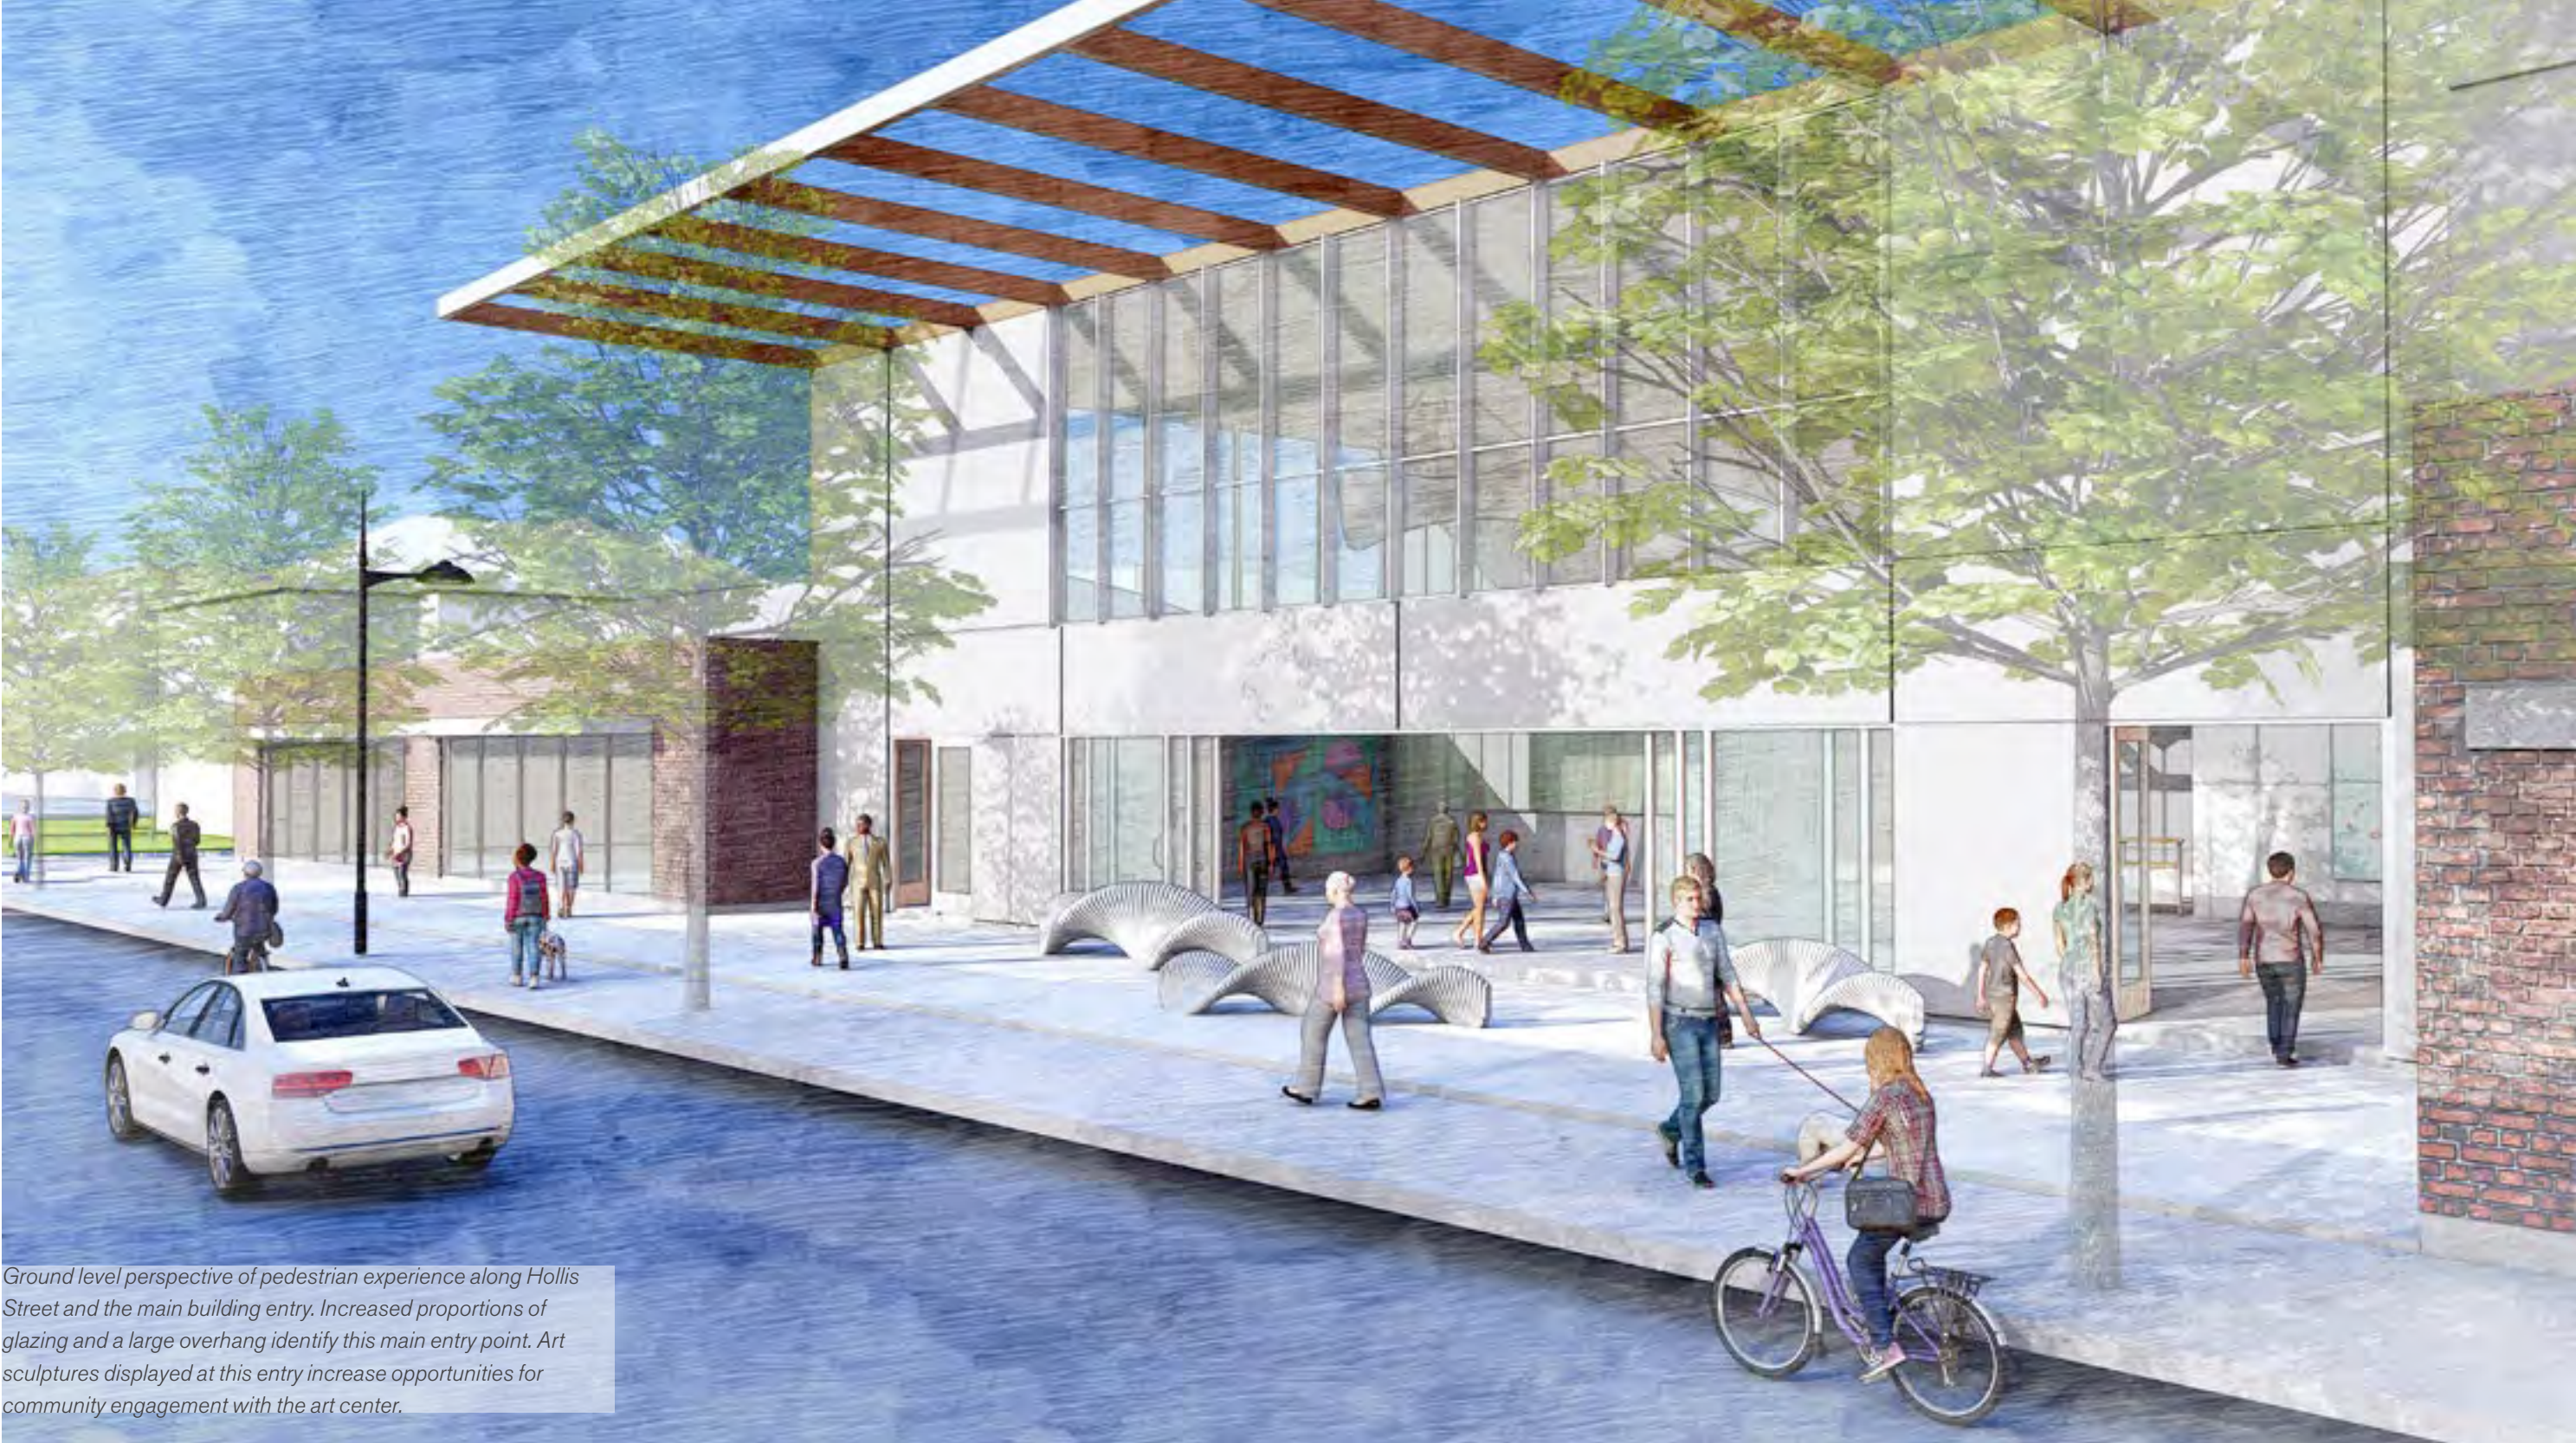
Ground level perspective of pedestrian experience along Hollis Street and the main building entry. Increased proportions of glazing and a large overhang identify this main entry point. Art sculptures displayed at this entry increase opportunities for community engagement with the art center.

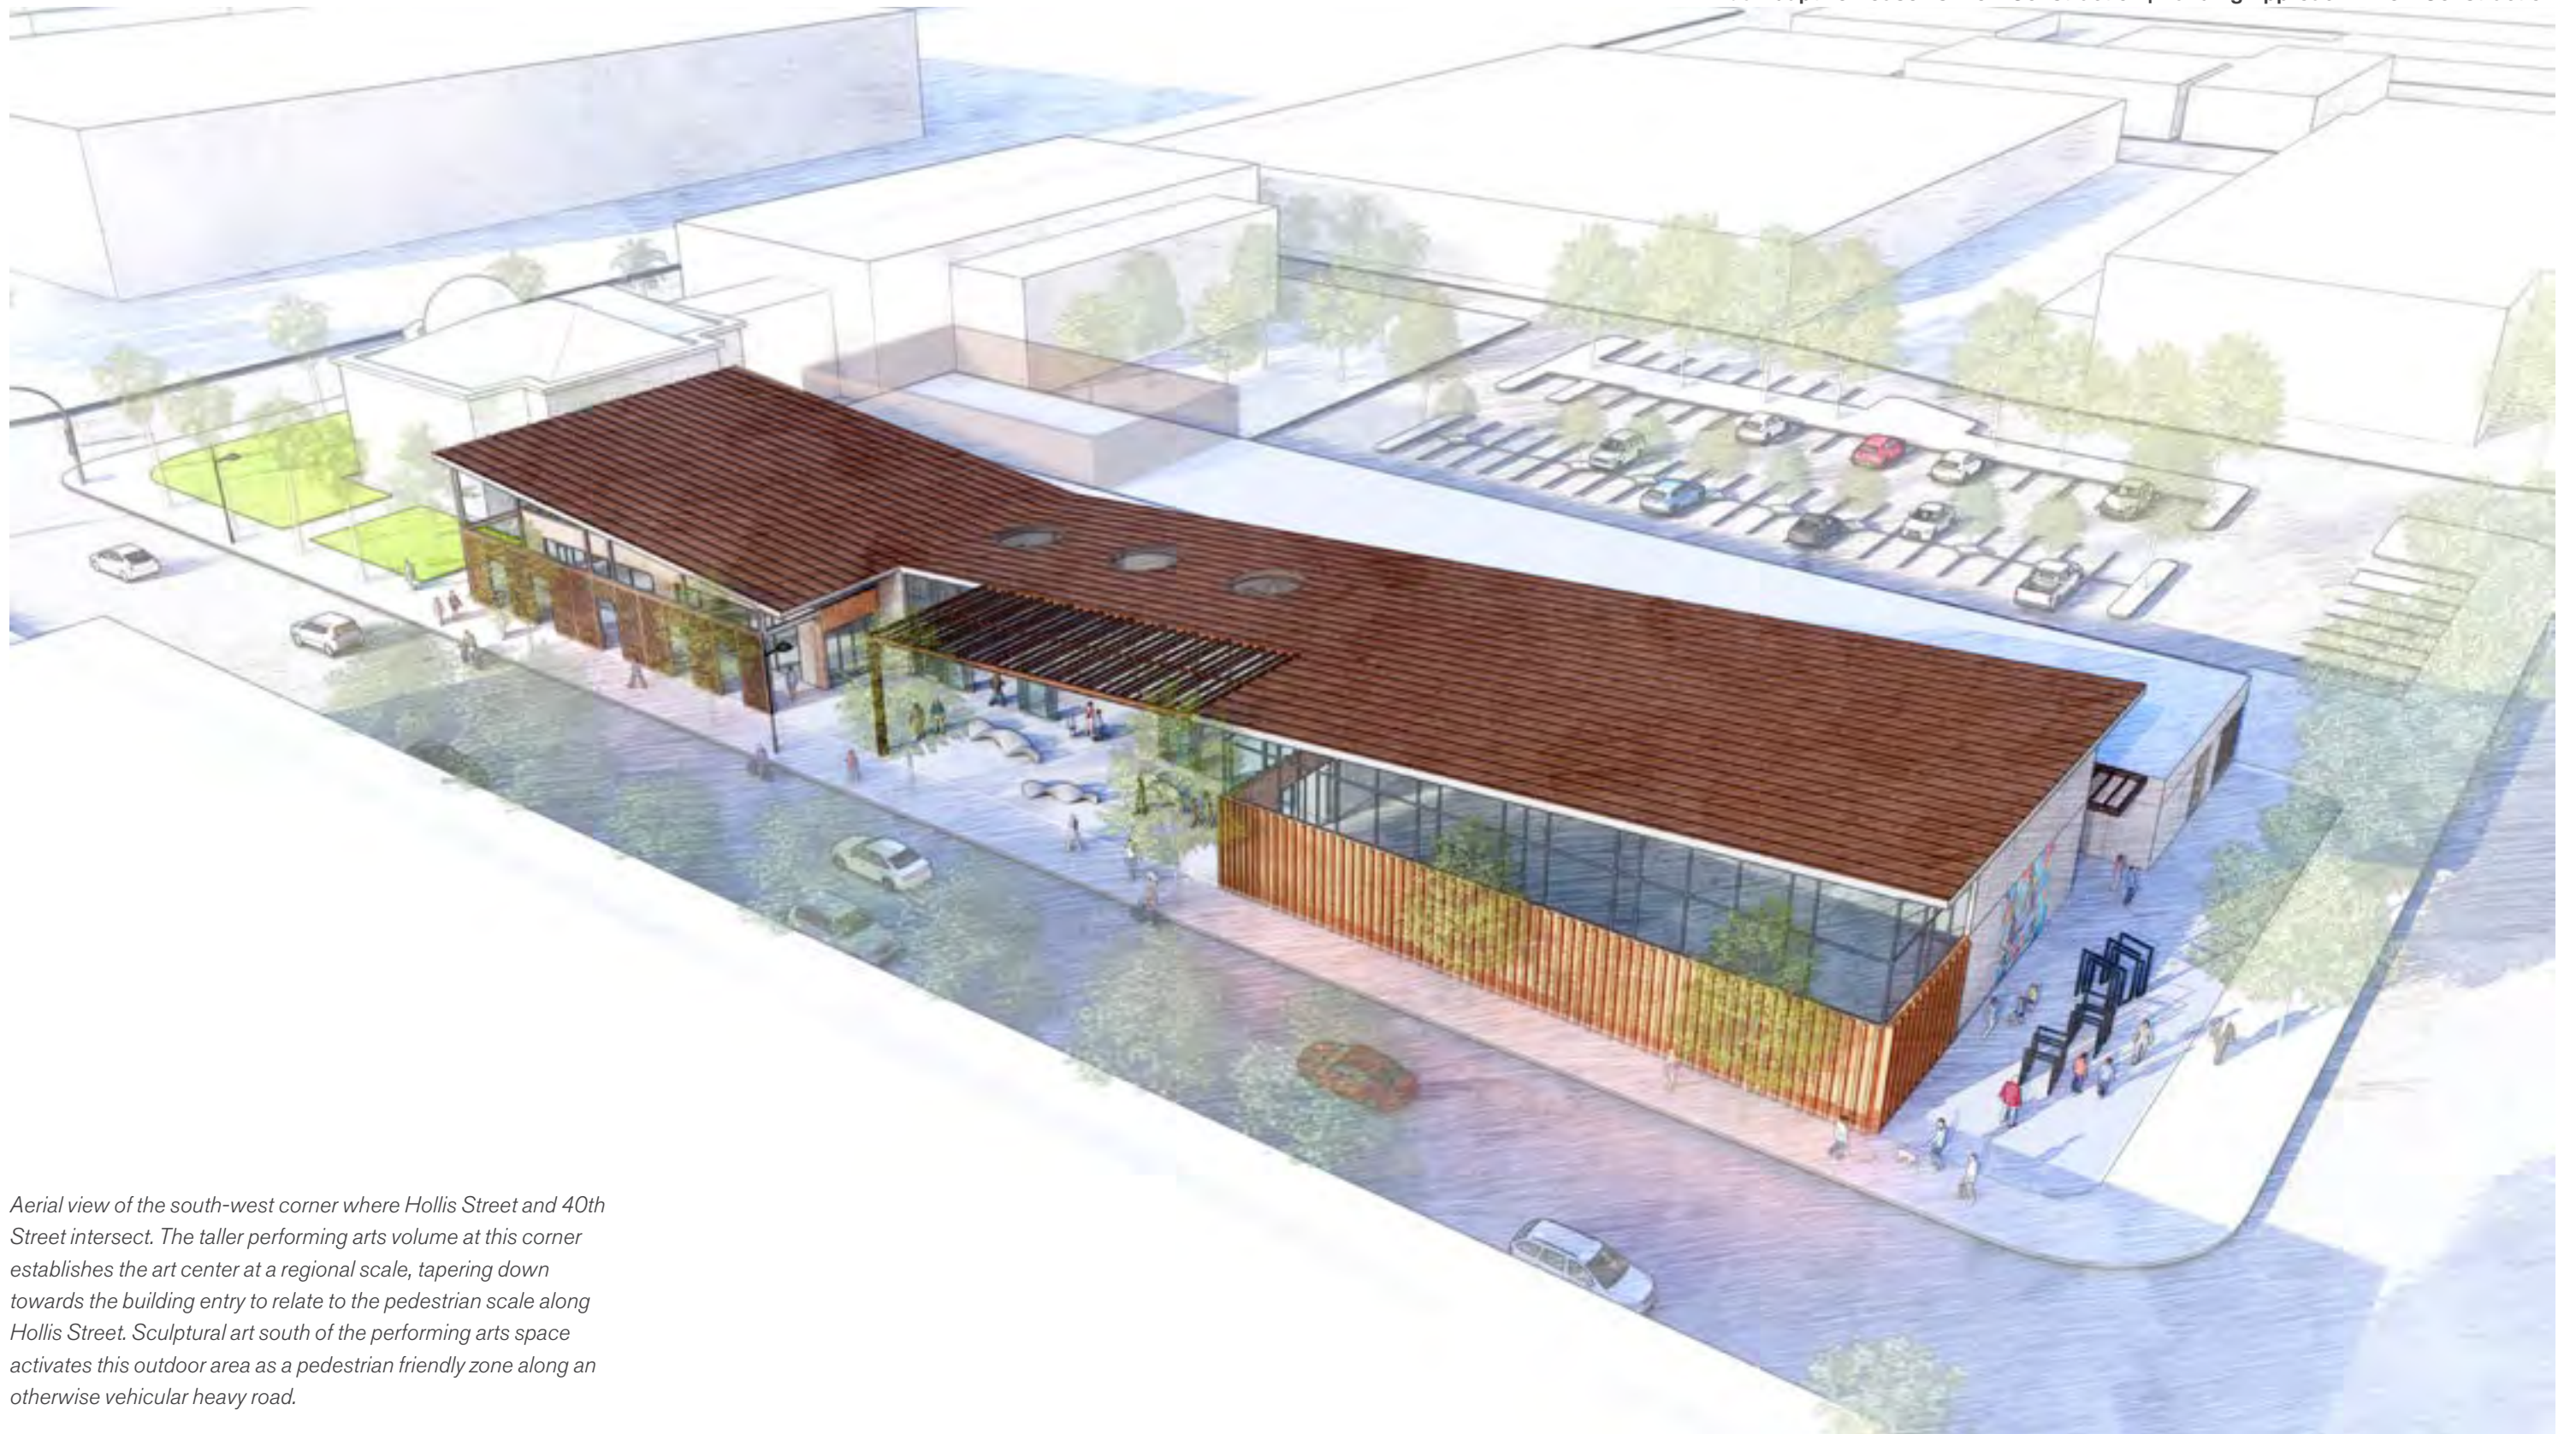
Aerial view of the south-west corner where Hollis Street and 40th Street intersect. The taller performing arts volume at this corner establishes the art center at a regional scale, tapering down towards the building entry to relate to the pedestrian scale along Hollis Street. Sculptural art south of the performing arts space activates this outdoor area as a pedestrian friendly zone along an otherwise vehicular heavy road.

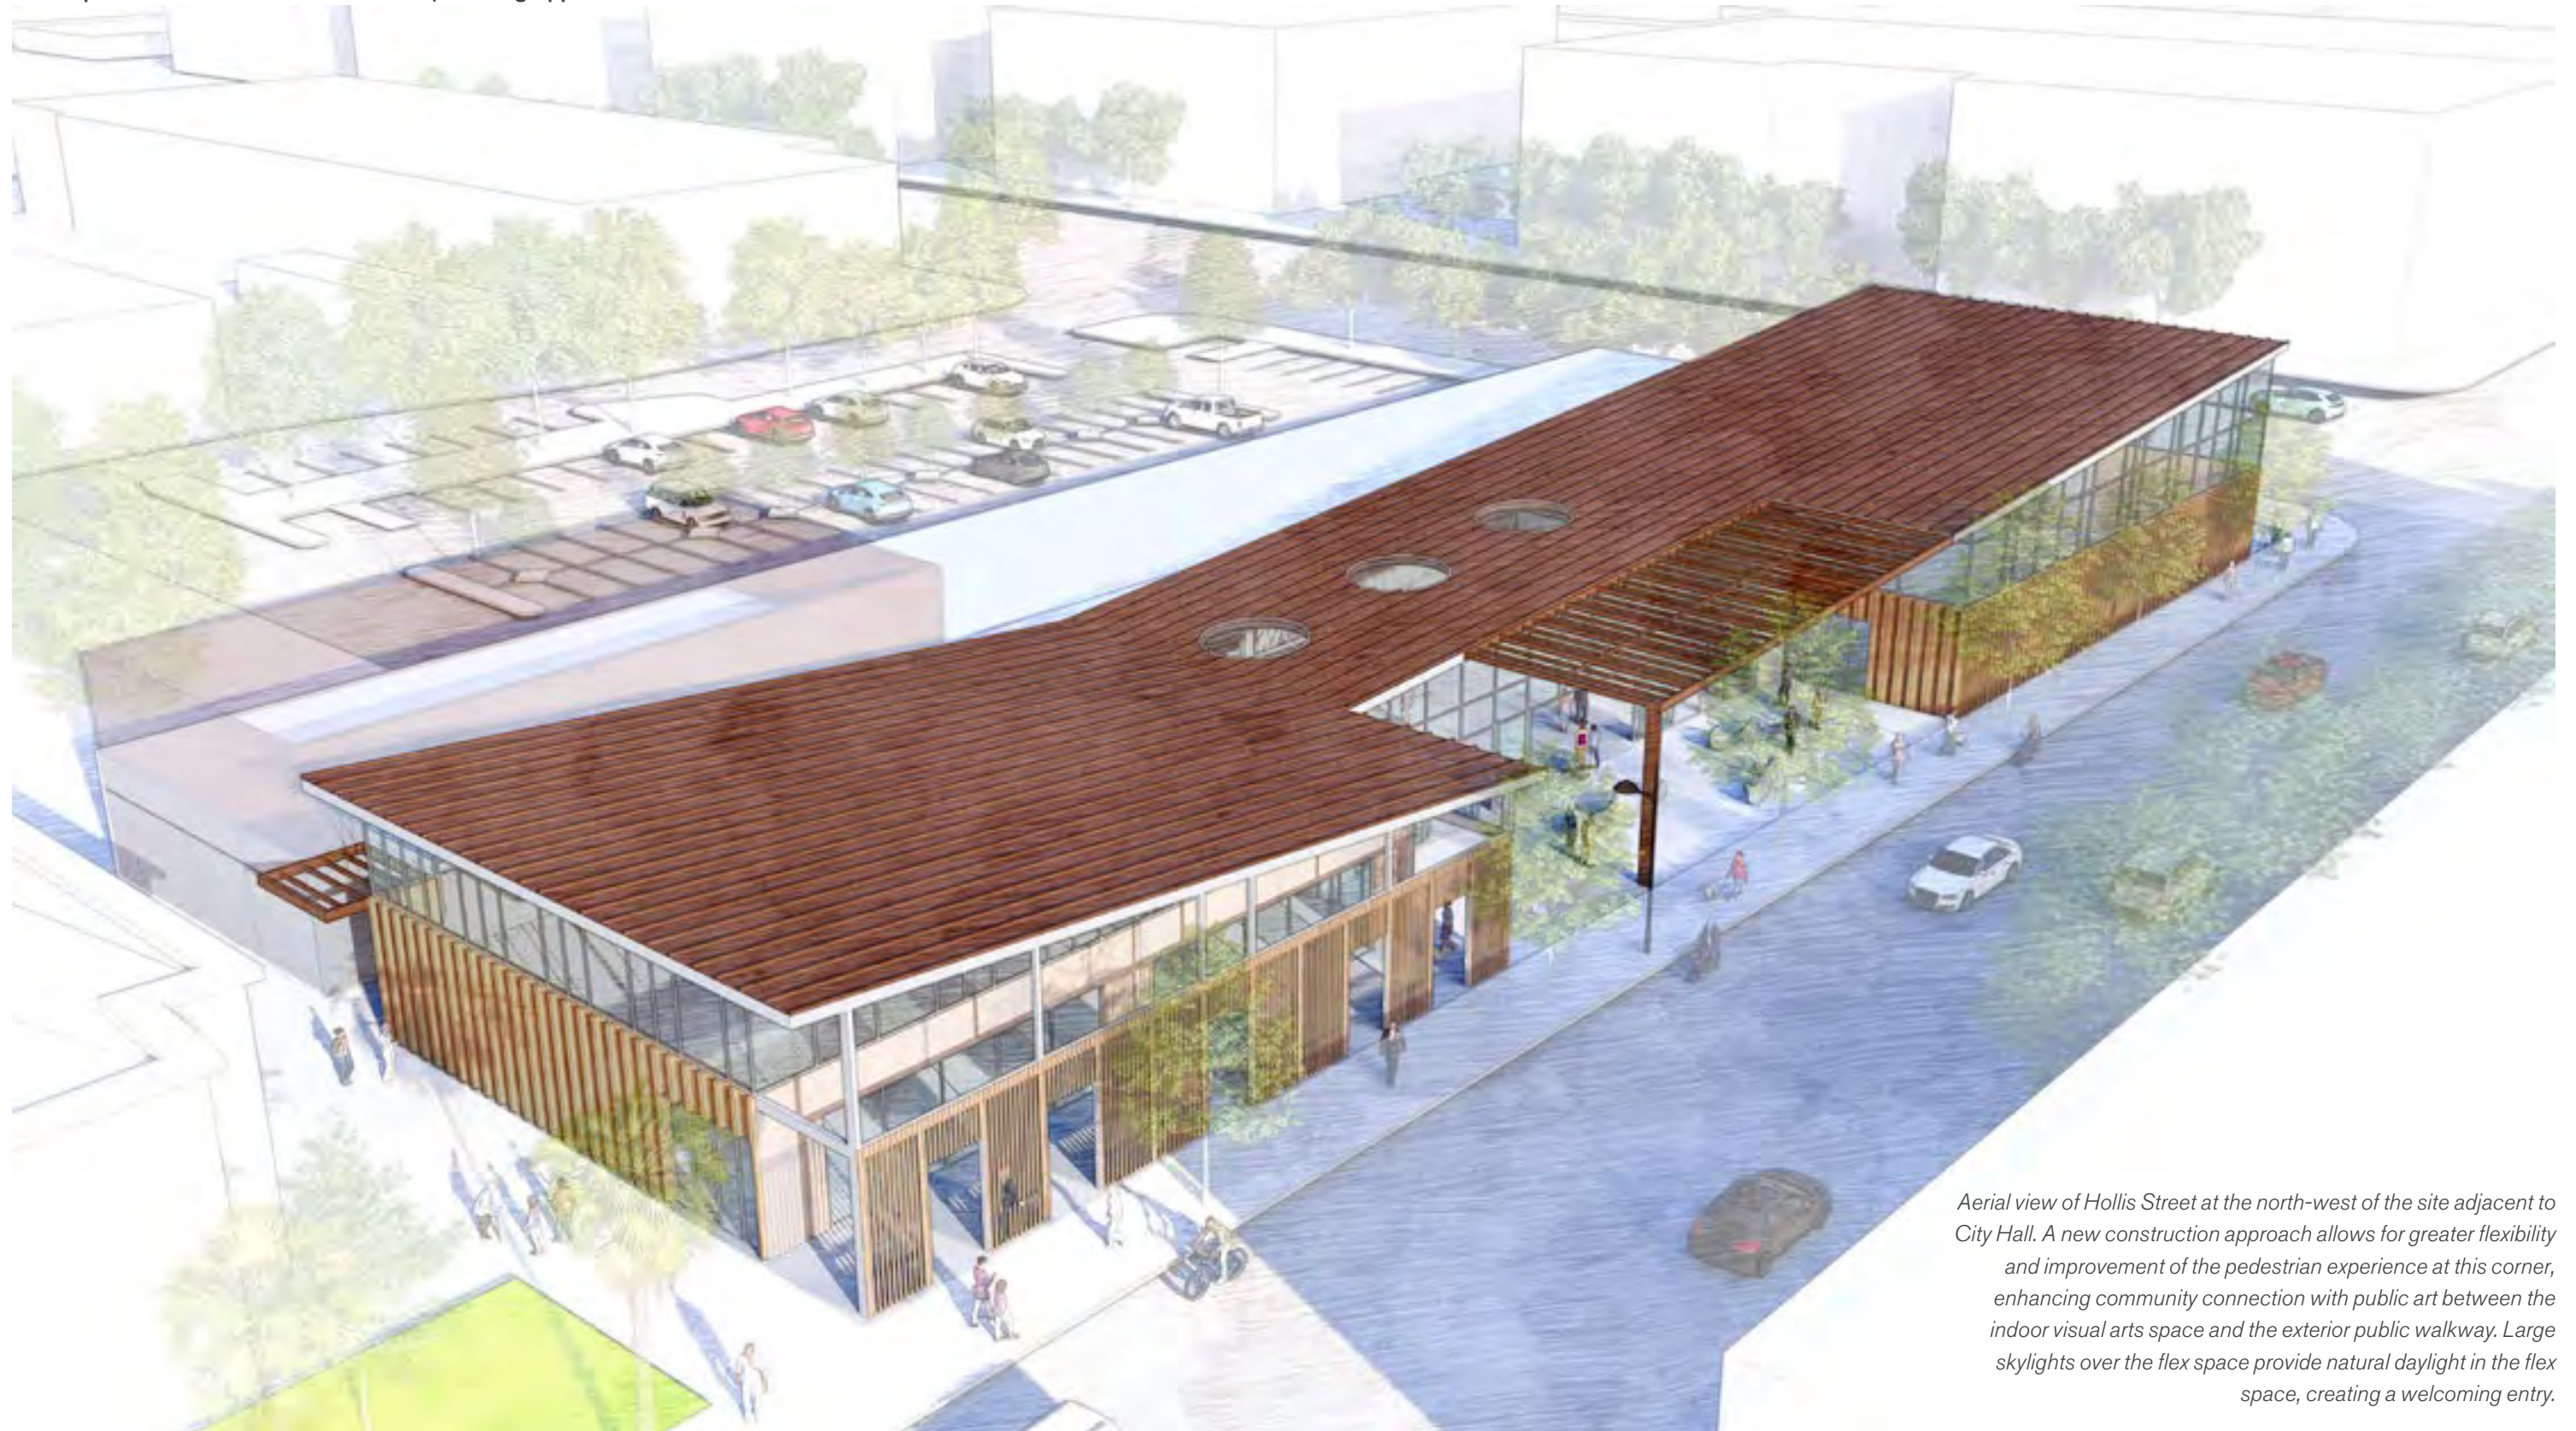
Aerial view of Hollis Street at the north-west of the site adjacent to City Hall. A new construction approach allows for greater flexibility and improvement of the pedestrian experience at this corner, enhancing community connection with public art between the indoor visual arts space and the exterior public walkway. Large skylights over the flex space provide natural daylight in the flex space, creating a welcoming entry.

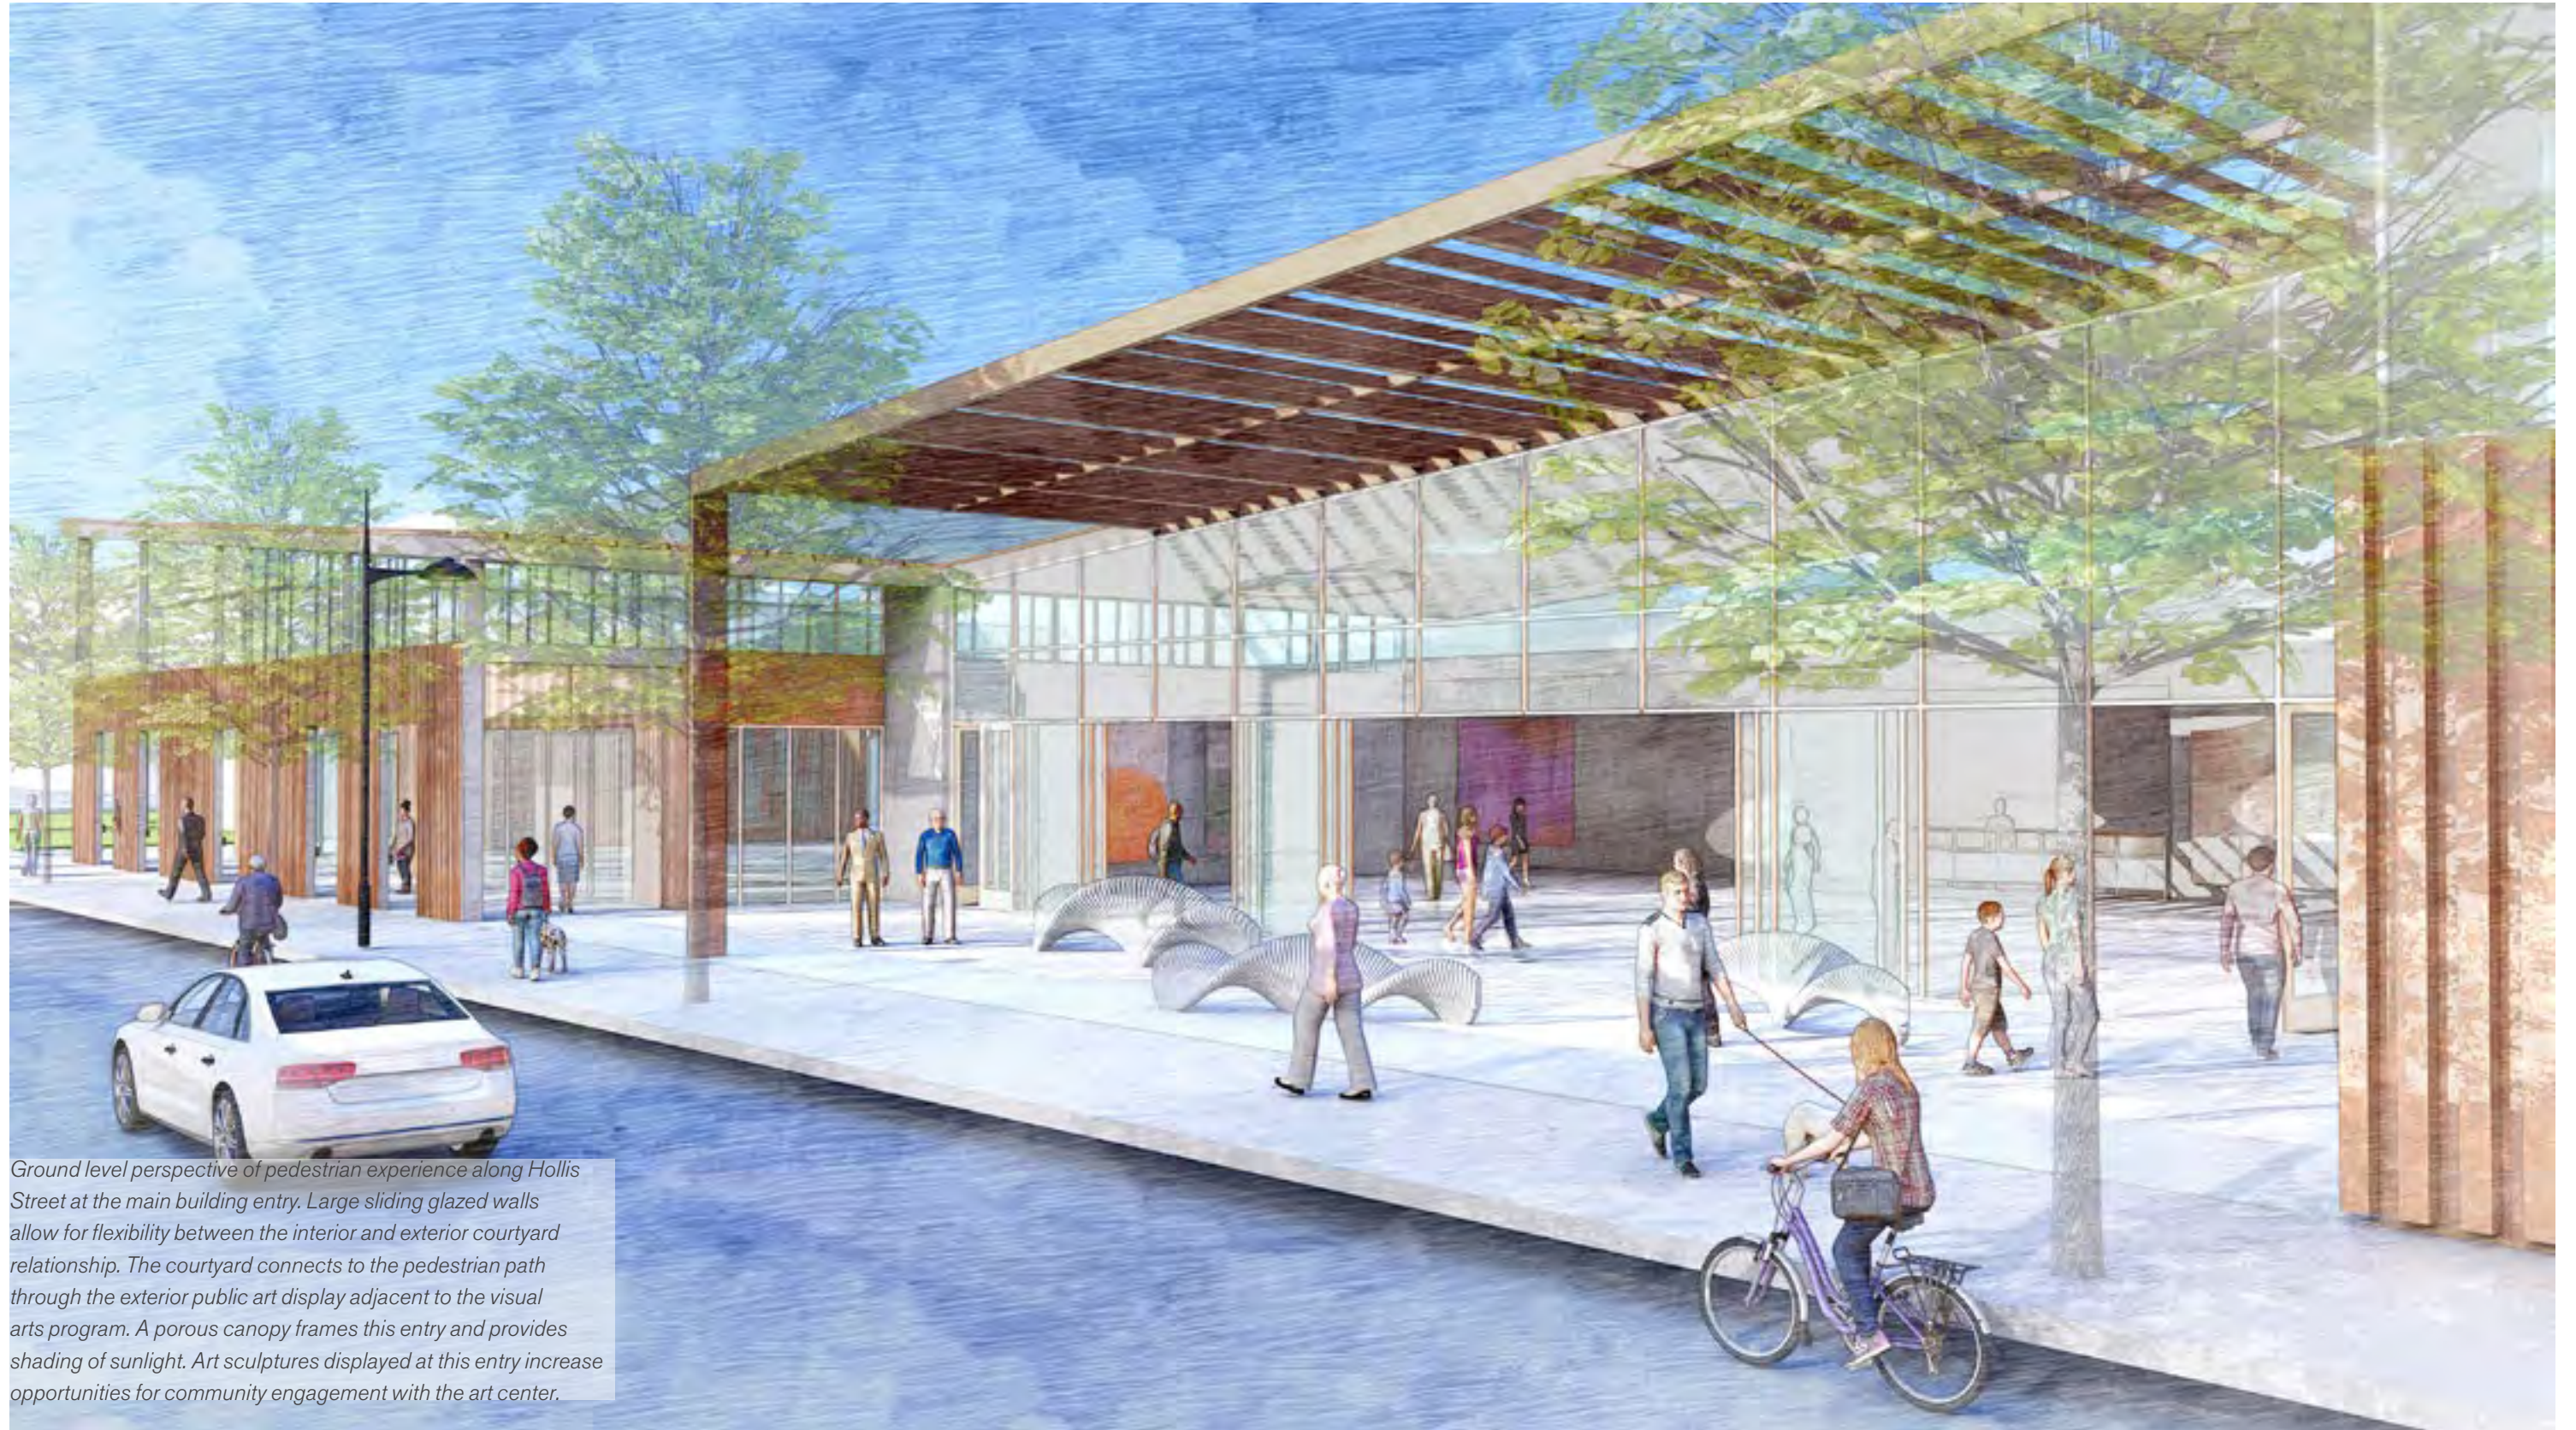
Ground level perspective of pedestrian experience along Hollis Street at the main building entry. Large sliding glazed walls allow for flexibility between the interior and exterior courtyard relationship. The courtyard connects to the pedestrian path through the exterior public art display adjacent to the visual arts program. A porous canopy frames this entry and provides shading of sunlight. Art sculptures displayed at this entry increase opportunities for community engagement with the art center.

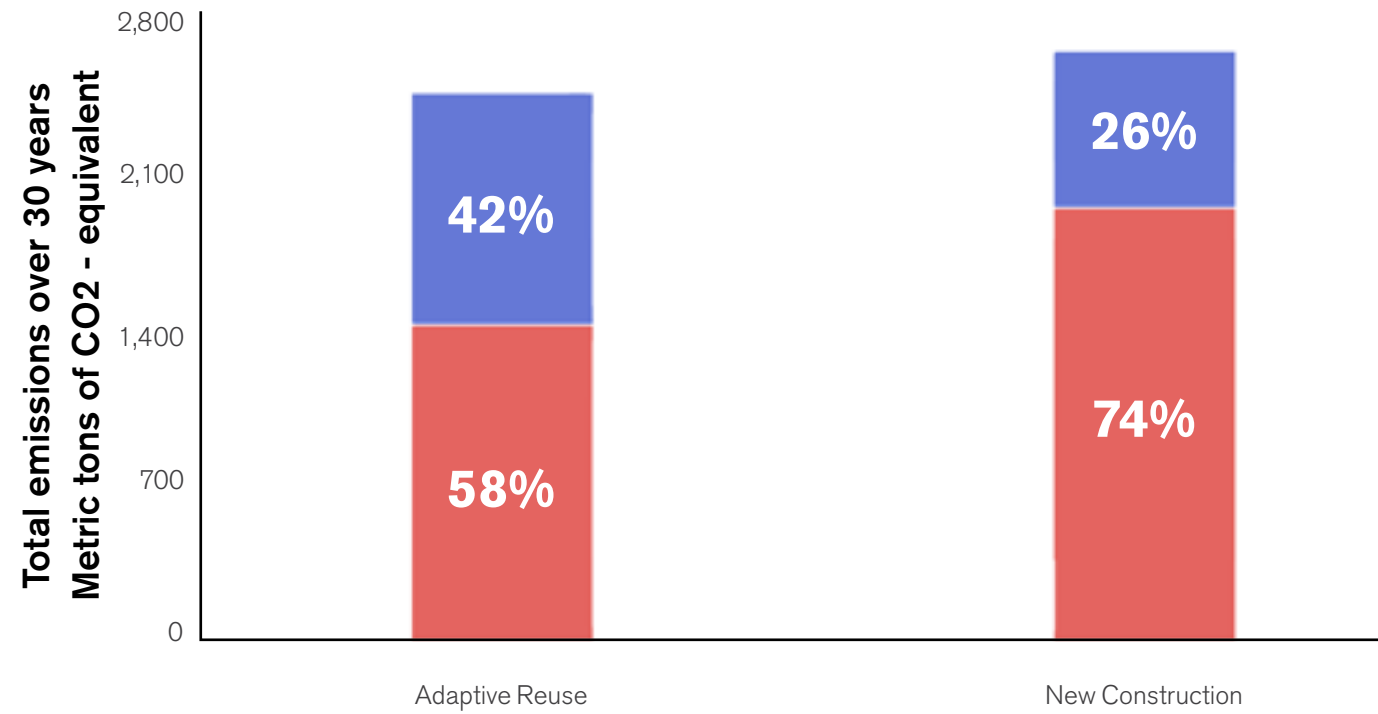
Net Emissions	2,480 tCO2e
• Embodied Carbon	1,430 tCO2e
• Operational Carbon	1,050 tCO2e
• Carbon Storage	0 tCO2e
EUI	78 kBtu/ft ² /yr
Embodied Carbon Intensity	542 kgCO2e/m ²

Net Emissions	2,680 tCO2e
• Embodied Carbon	1,960 tCO2e
• Operational Carbon	710 tCO2e
• Carbon Storage	0 tCO2e
EUI	50 kBtu/ft ² /yr
Embodied Carbon Intensity	742 kgCO2e/m ²

- New Construction has 30% greater **embodied carbon**
- Adaptive Reuse has 30% greater **operational carbon**
- Similar carbon emissions over 30 year time horizon
