1034-1040 47th St., Emeryville, CA

Housing Conditions

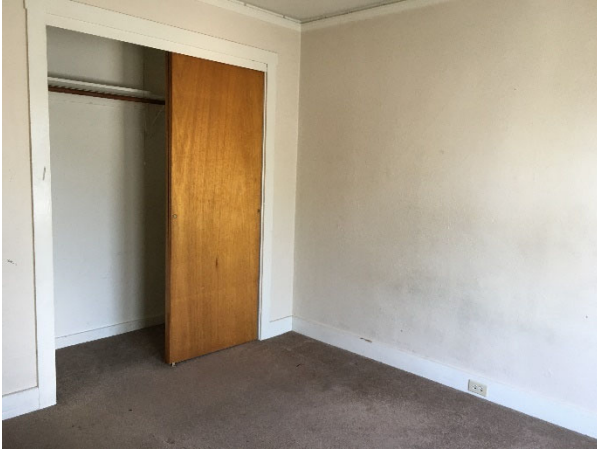
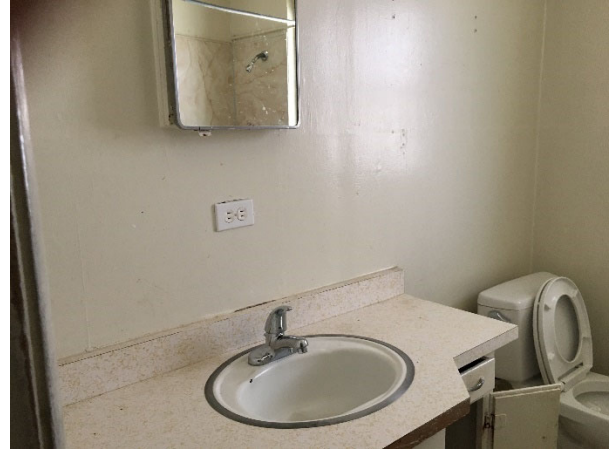
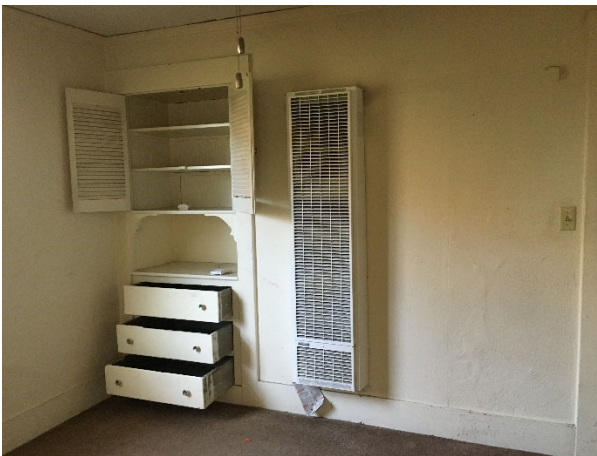
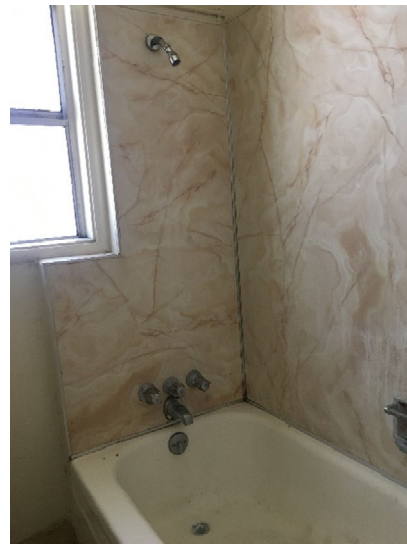
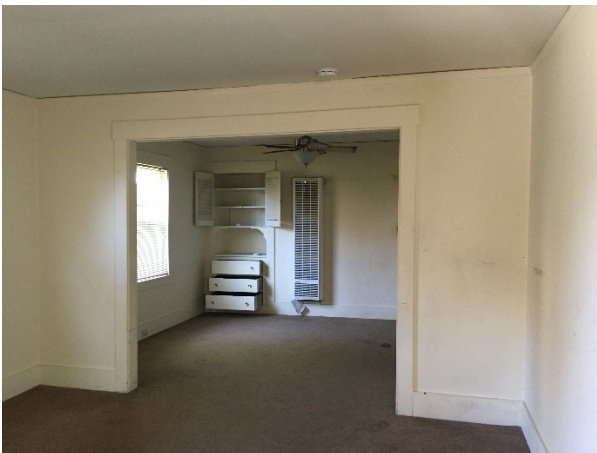
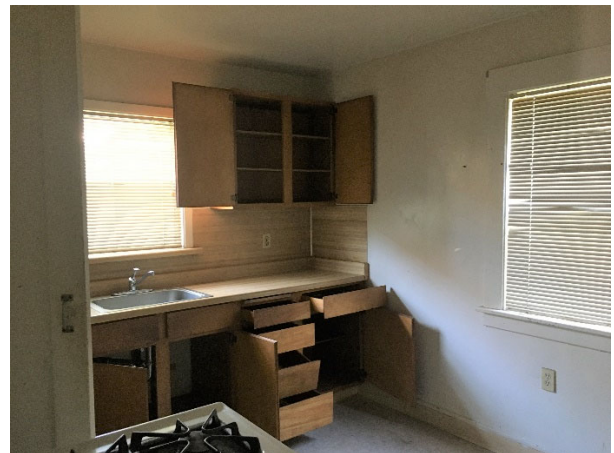
Whereas the units have out of date utility systems and structural issues, unit interiors are older, but generally acceptable
